EA12-005 Reconstruction Testing for KJ Jeep Liberty and ZJ Grand Cherokee

July 2014

U.S Department of Transportation
National Highway Traffic Safety Administration

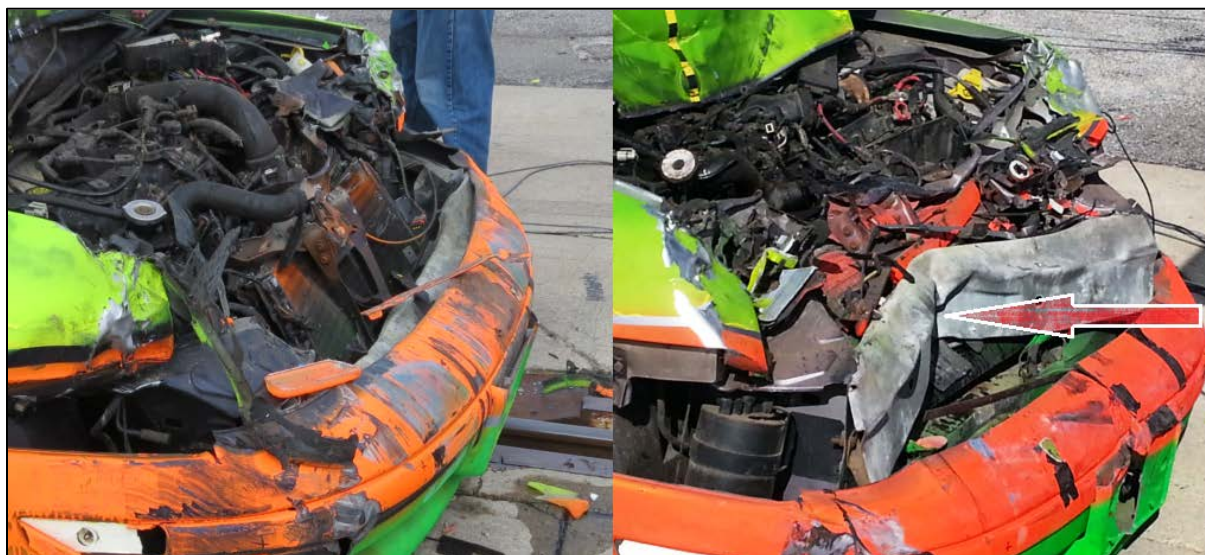
Figure 7 - Neon bumper reinforcement Test 1 vs. Test 2. Arrow at hitch-receiver contact

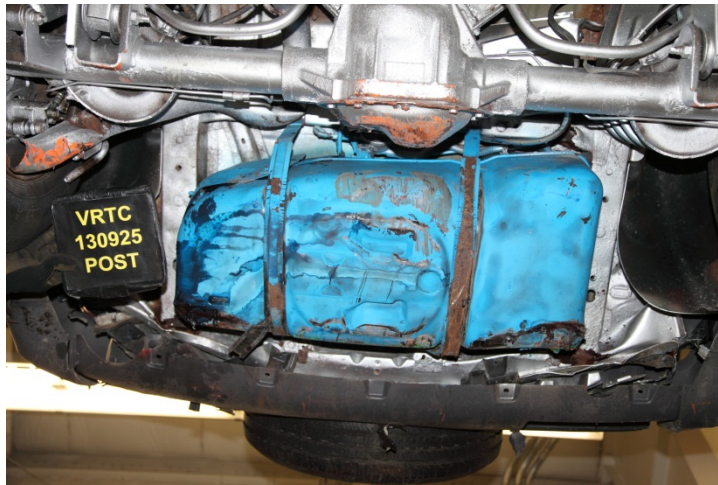
Figure 9 – Test #1 Post-test target vehicle fuel tank close-up view without hitch-receiver

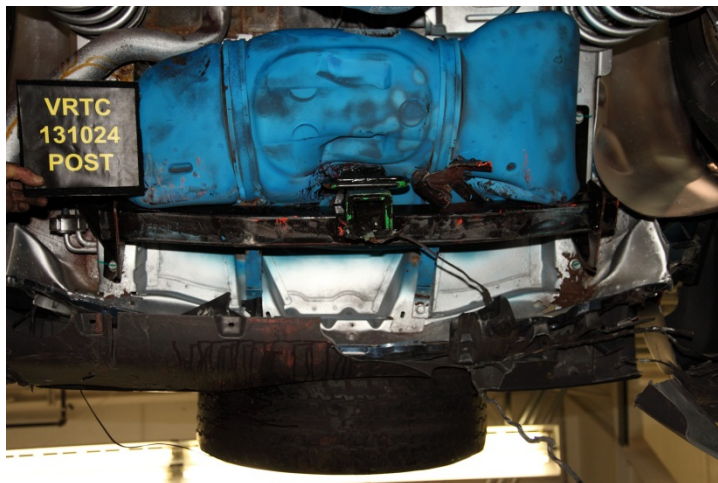
Figure 10 – Test #2 Post-test target vehicle fuel tank close-up view with hitch-receiver

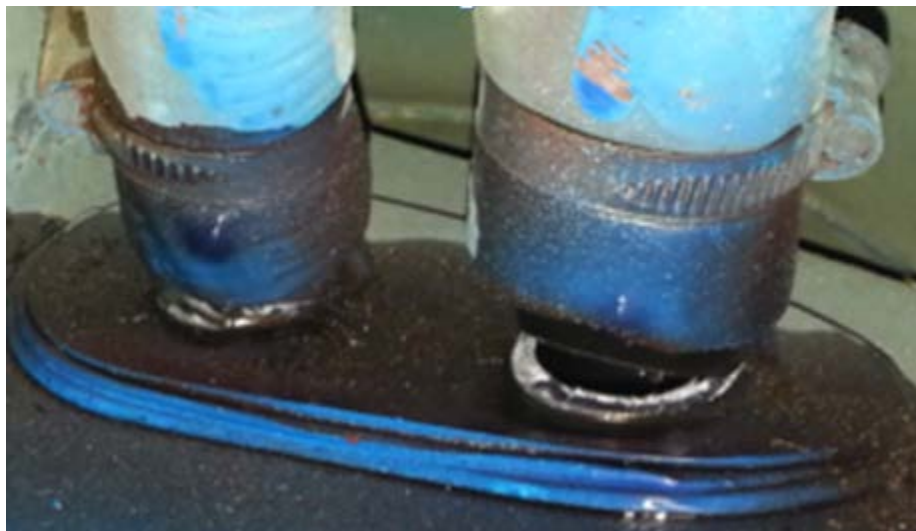
facts to support pre-impact braking. At the conclusion of the first test, it was evident that the Cadillac struck the Jeep with an impact point at least two inches higher than in the real-world crash based on intrusion patterns into the rear gate of the Jeep. At least one known source of the fuel leak in the real-world crash was a several inch long cut along the bottom of the tank. It is possible that other leak sources existed, but no other sources were documented. In the baseline crash, a fuel leak was produced; however it originated at the fuel filler hose connections. There is a relief tunnel (hole) through the left frame rail that routes the fuel filler hose along the path to the filler cap shown in Figure 11. The tunnel in the frame rail was crushed due to the force of the crash, combined with significant rust originating from the hollow, inside of the rail, and this resulted in the hoses being captured in the frame rail, shown in Figure 12. As the frame rail bent, it pulled upward on the fuel tank hose connections and broke them at their bases on the plastic tank, resulting in a significant leak, as shown in Figure 13.

Figure 13 - Test #3 Broken fuel connections on plastic fuel tank

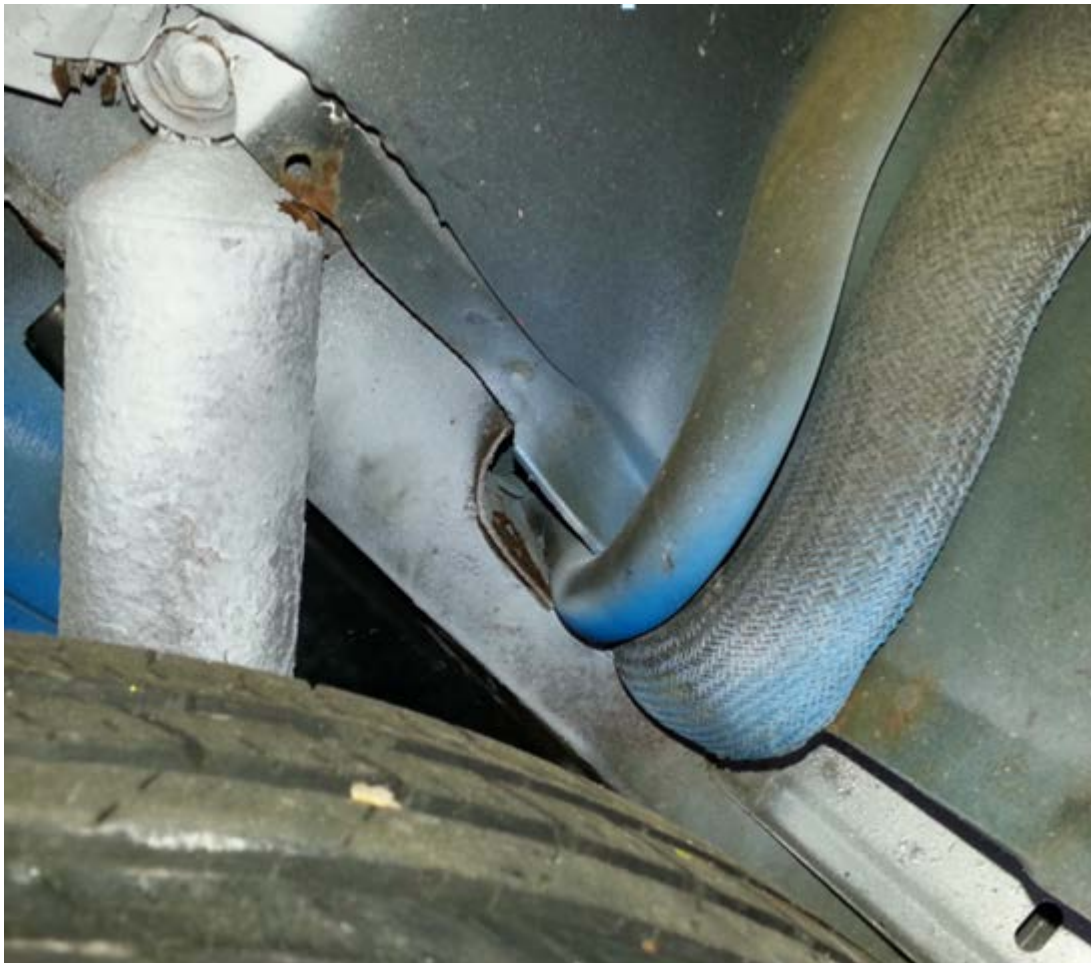
The last ZJ Grand Cherokee test was Test #7. This test was conducted to determine whether the frame rail reinforcement properties demonstrated in Test #6 would also sufficiently benefit a rusted frame rail relief tunnel. The Jeep used for Test #7 had up to 18 years of road salt exposure. The Cadillac was set to normal ride height, similar to baseline Test #3. At the conclusion of the crash, there was no fuel leak. The Cadillac again directly struck the hitch-receiver and the frame rails did not bend near the tank. The hitch support bracket bridged the frame rail relief tunnel and transferred the impact force to a forward point on the frame rail away from the tank (Figure 16). Scraping between the Cadillac and fuel tank was minimal.

Figure 16 Test#7 Rail with rust reinforced by hitch-receiver bracket, hose not captured – moderately rusted vehicle

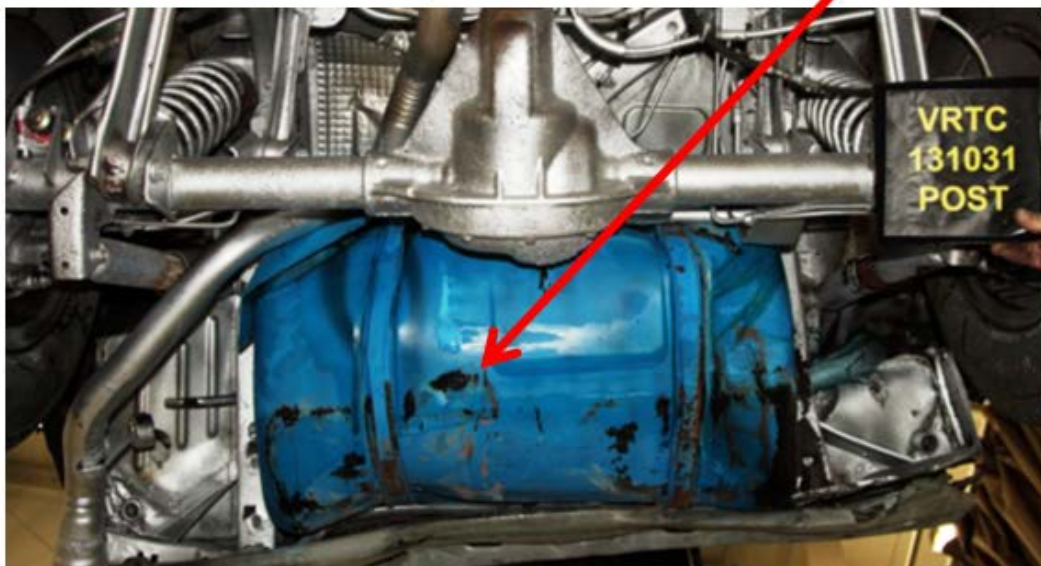
Fuel filler frame pass-through collapsed and pulled away from tank – Known source of leak from testing, Unknown if this occurred in the real-world crash

Significant sliding interaction between tank & bullet vehicle – Known source of leakage from real-world crash

Figure 21 – Post-test damage from Test #3 – No hitch-receiver

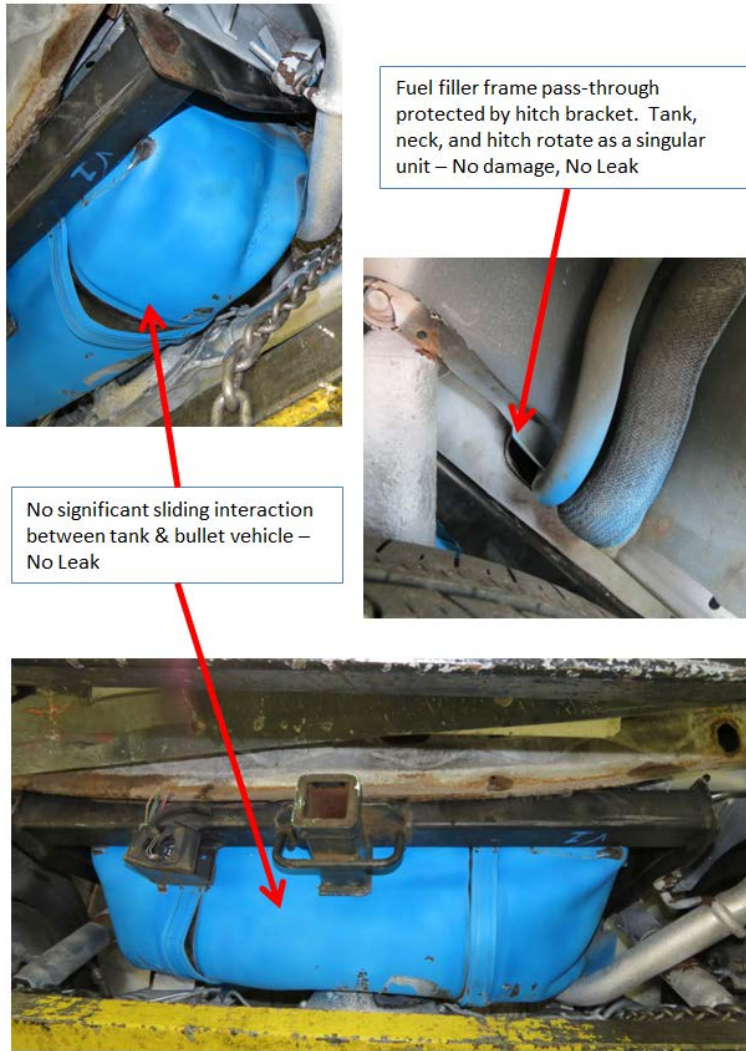
Figure 22 - Post-test damage from Test #7 - With hitch-receiver

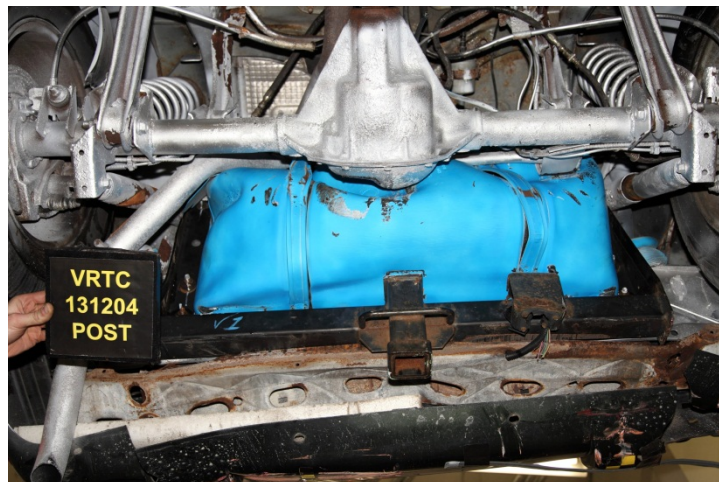
Figure 25 - Test #7 Post-test target vehicle fuel tank close-up with hitch-receiver
