ATTACHMENT T

EXPERT WITNESS REPORT - 2 January 2012 REVISION

Kline v. Loman Auto Group, Victoria Morgan-Alcala, et al.

Defendant Lomans: Knowledge of Fuel System Defect Safety Recalls

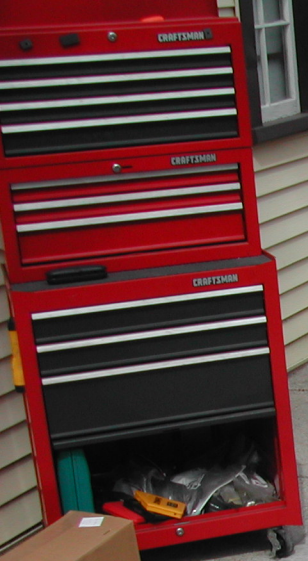
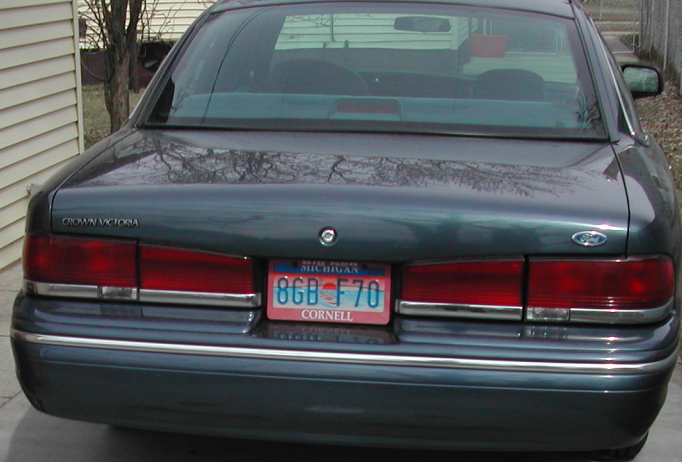
Regarding O&C-3-a-i, I have personally performed this retrofit on my 1997 Ford Crown Victoria vehicle, on my back in my driveway. This retrofit required simple hand tools, a floor jack and safety stands (Please see sub-attached photographs).

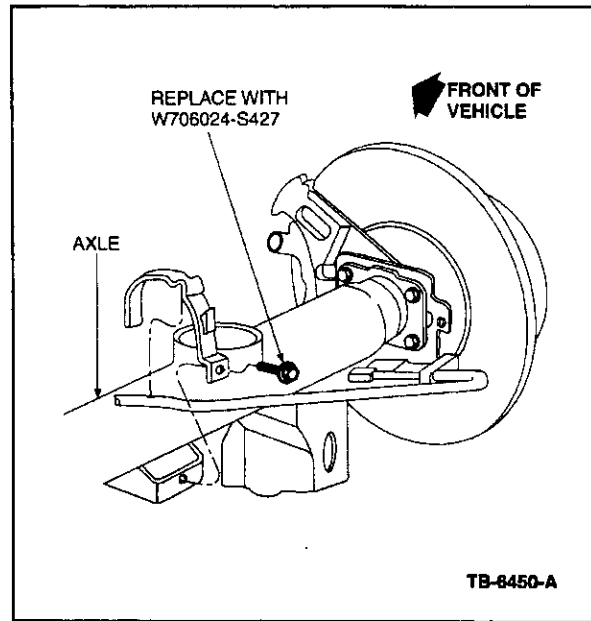
Figure 1 - Article 01-21-14

1. On 1992-1997 vehicles, replace Park Brake Cable to Axle attaching hex head bolt part N806900-S2 with round-headed fastener part W706024-S427. Model year 1998 and later vehicles are of a different design and do not use this bolt (Figure 1).

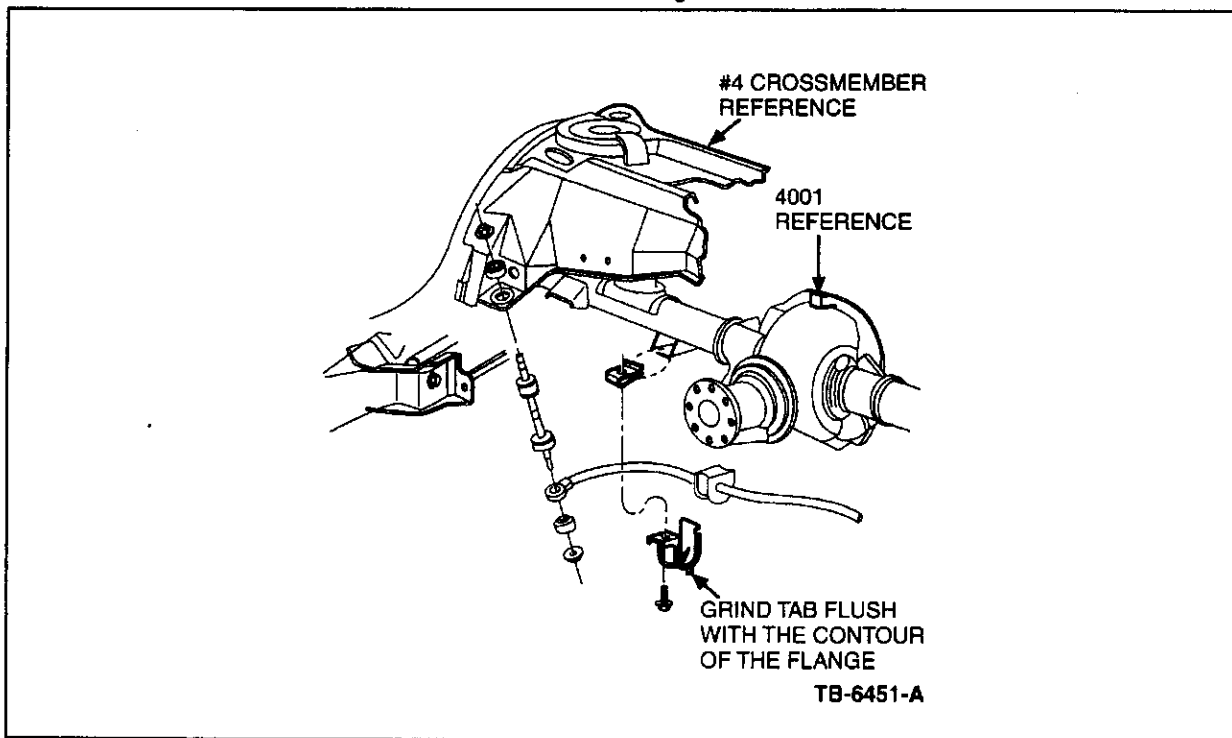
Figure 2 - Article 01-21-14

2. On 1992-2001 vehicles, use a die grinder or electric grinder with suitable carbide or grinding wheel to remove the 4 mm high by 6 mm wide tab which protrudes down from one flange of the rear stabilizer bar axle attachment "U" bracket. There is a "U" bracket at each end of the center section of the rear stabilizer bar (Figure 2).

The "U" brackets do not need to be removed from the vehicle.

The tab should be ground until it is flush with the contour of the flange.
