Center for Auto Safety White Paper on Concerns With  
Chrysler Recall of the Jeep Grand Cherokee and Liberty  
Presented to NHTSA July 1, 2013

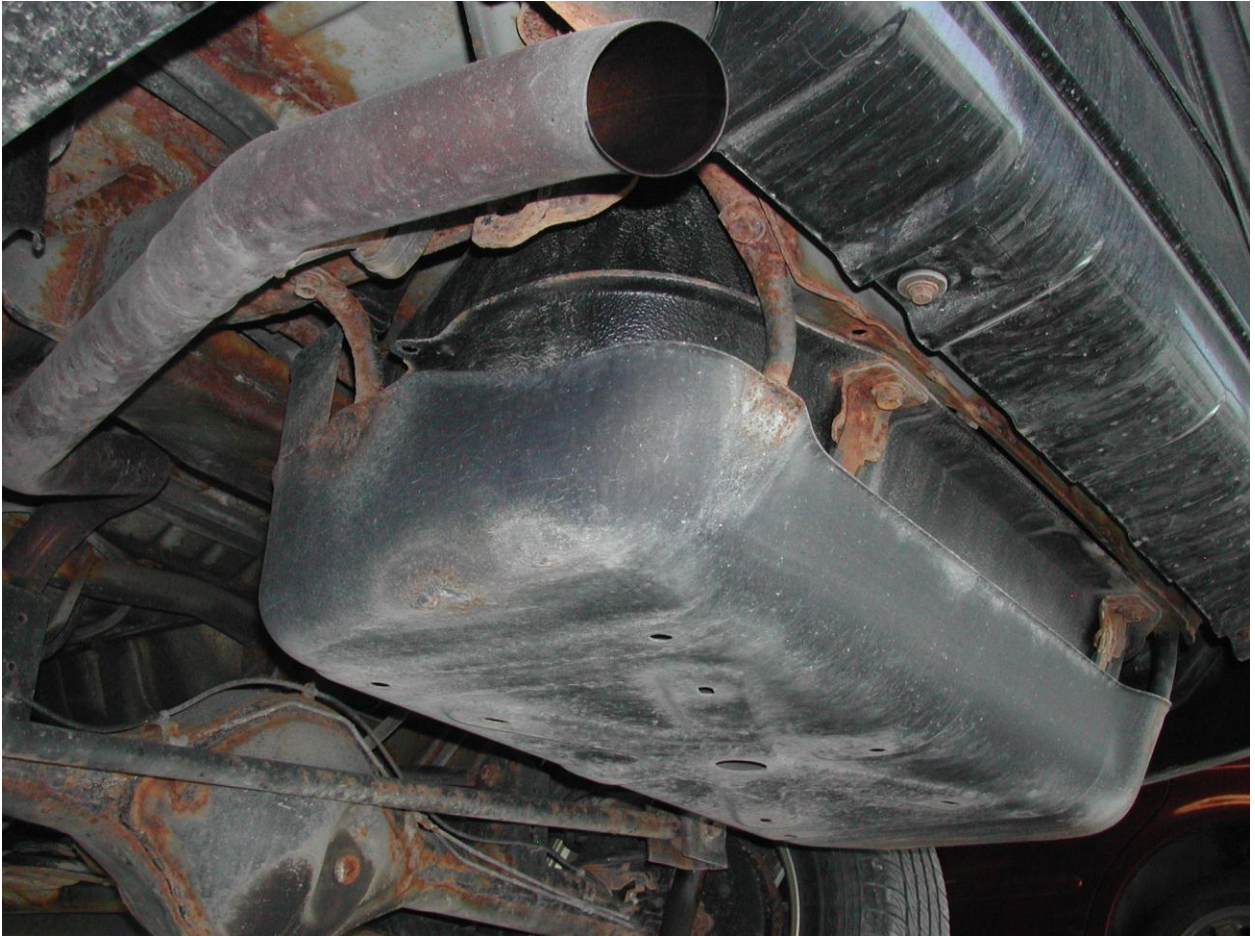
Exhibit A – Encapsulated Suzuki SL-7 Fuel Tank

There is no significant production vehicle currently sold in the U.S. with the fuel tank located behind the rear axle. Even at the time the subject Jeeps were sold, only a few vehicle lines had fuel tanks in this location. And ones like the Suzuki XL-7 have a steel structure encapsulating the fuel tank. (Attachment A.)

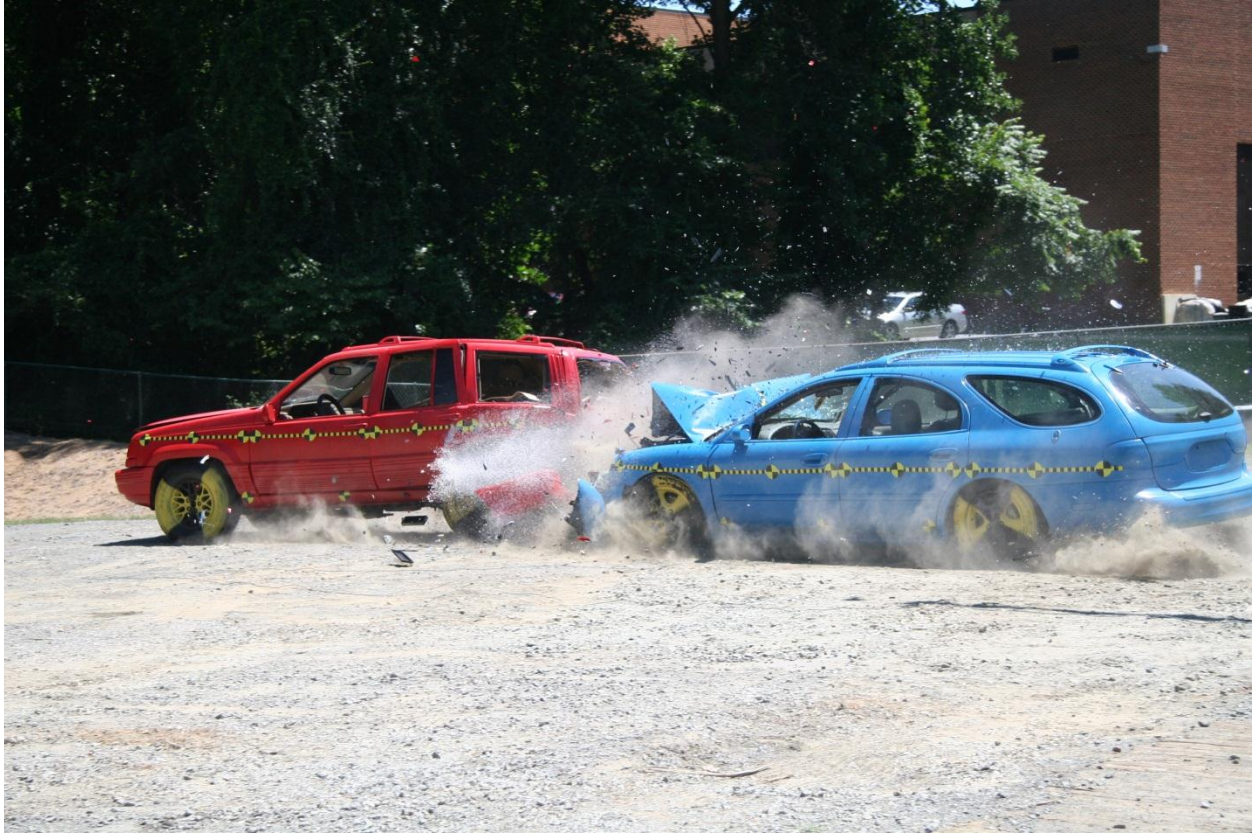
- The plastic fuel tank hangs well below the rear bumper by six to eight inches, and can easily be struck by a passenger car that underrides the rear bumper. This situation can easily occur, particularly if the striking vehicle is sustaining brake dive.
- The frame around the tank is relatively weak, particularly in the early models that have a large hole in the left frame member through which the filler tube is routed.<sup>7</sup>
- The fuel filler neck has a weak connection to the fuel tank itself and the connection point is constrained so that if the rear frame rail is deformed, it can be subject to a shearing force that can dislodge it from the tank.
- The gas filler cap can be relatively easily dislodged by deformation of the rear fender to which the filler neck is attached.
- The fuel tank itself lacks an effective check valve to contain the fuel if the filler neck is damaged.

Exhibit B Fuel Spray from FHWA Due to Filler Hose Pulling Loose

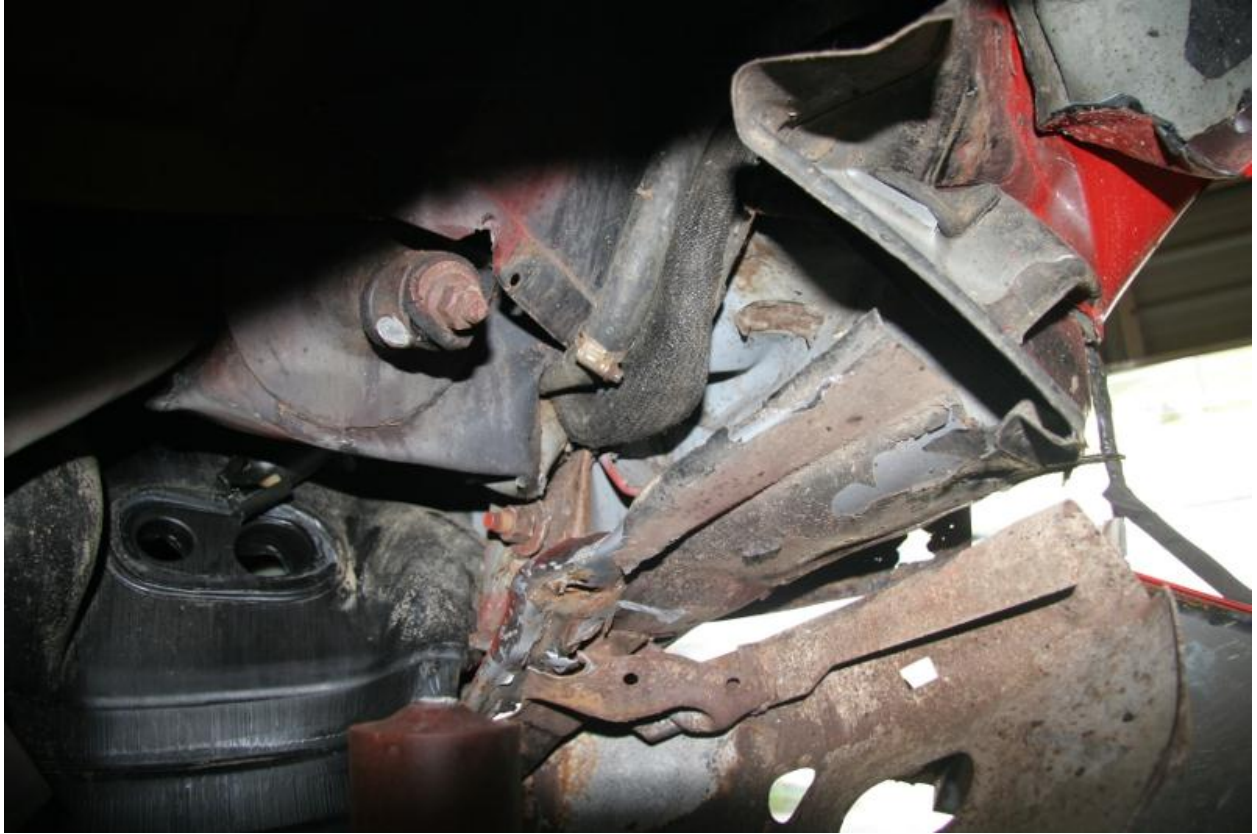
The Jeeps do have a check valve in the tank to preclude back flushing when the gas cap is removed on a hot day. However, this valve lacks a simple spring that would keep it closed under any circumstances where the pressure in the tank is equal to or greater than atmospheric pressure. Such a spring would ensure that the fuel in the tank remained there (assuming that the tank itself is not damaged) even when the filler tube is damaged.

Exhibit C – Fuel Tank Connection Where Filler Tube Pulled Loose

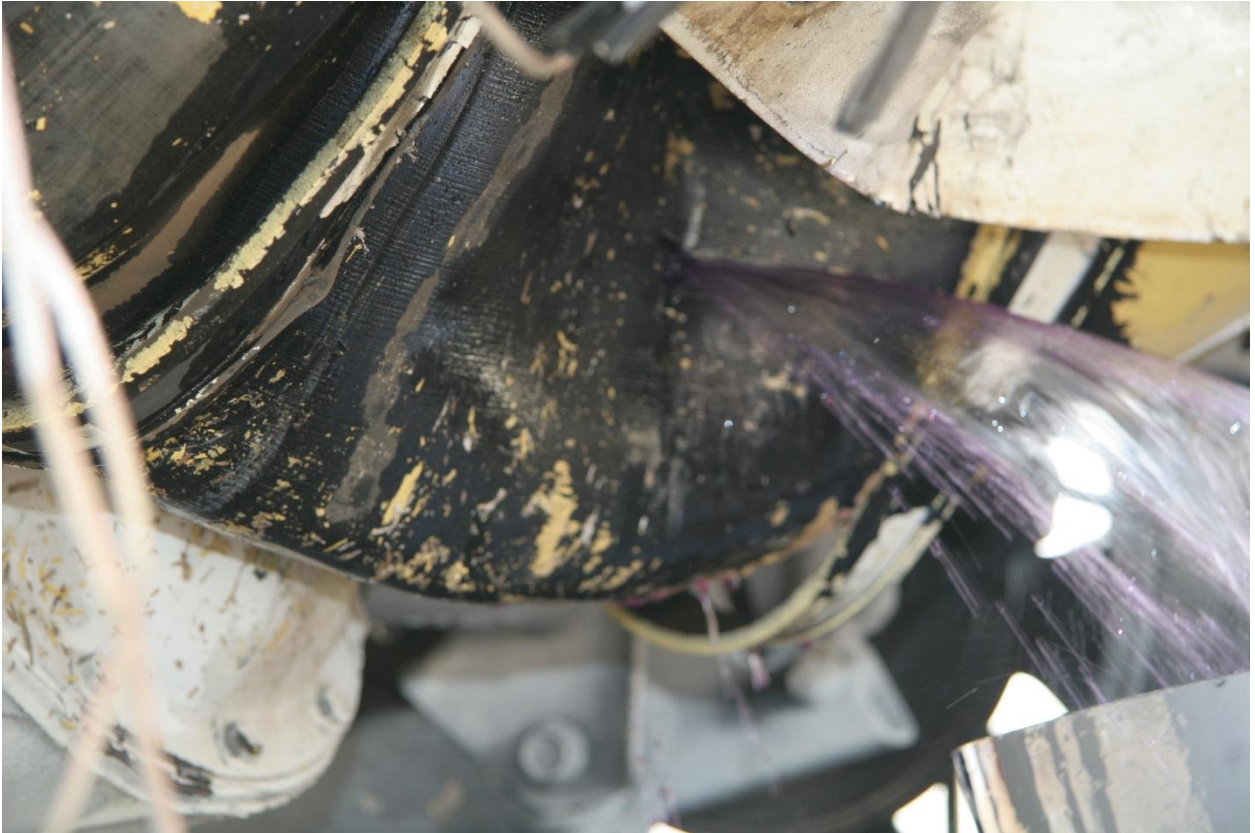
We are confident that the subject Jeeps could not pass the current FMVSS 301 despite Chrysler's claim that virtually all of the fatal fire crashes of Jeeps were more severe than this test. The last test conducted for the Center for Auto Safety was similar to the current fuel system integrity test except that it was conducted at 40 mph rather than 50 mph (about two-thirds of the energy). The tank failed in that test.

Exhibit D –Leak from Ruptured Grand Cherokee Fuel Tank in 40-mph Impact

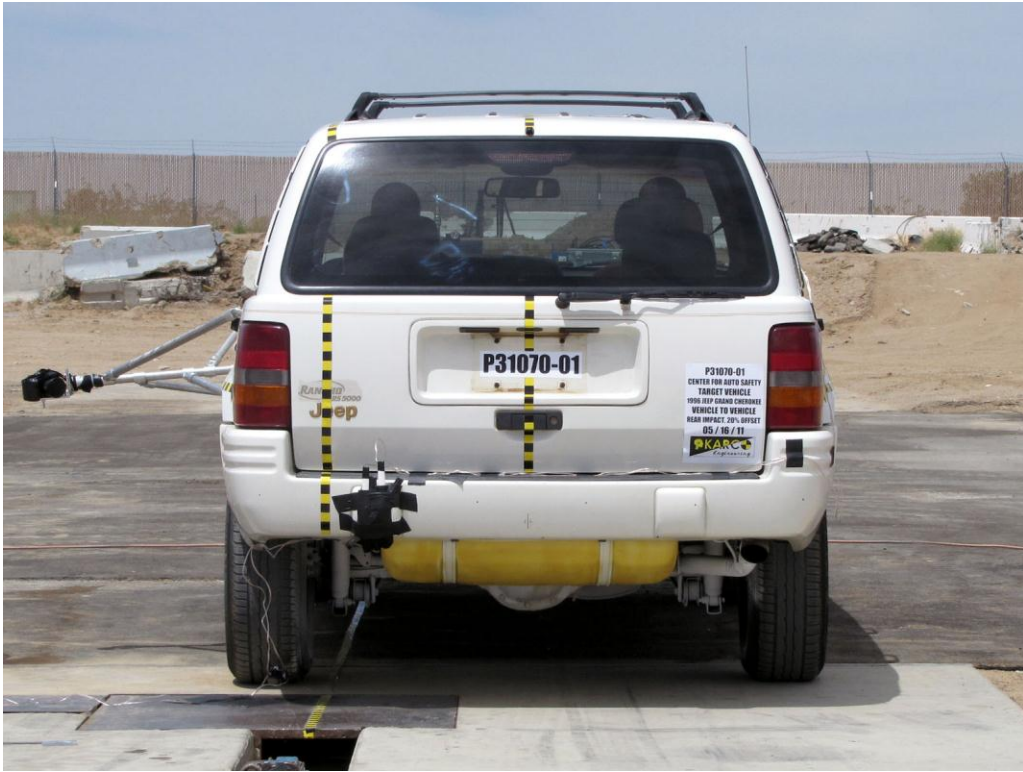
The trailer certainly provides no protection for rear impacts in which the nose of the striking vehicle goes under the Jeep's bumper which it will also go under the trailer hitch because the fuel tank extends downward 8.5" below the rear bumper. At best the trailer hitch extends downward only 1.2 inches below the bumper leaving more than 7" of the fuel tank exposed.

Exhibit E – Pre-Crash Photo Showing Exposed Fuel Tank
