Center for Auto Safety White Paper on Concerns With
Chrysler Recall of the Jeep Grand Cherokee and Liberty
Presented to NHTSA July 1, 2013

Chrysler has responded to the National Highway Traffic Safety Administration's request that it recall the Jeep Grand Cherokee and Liberty that have fuel tanks installed behind the rear axle for defects in their fuel systems with several specious arguments

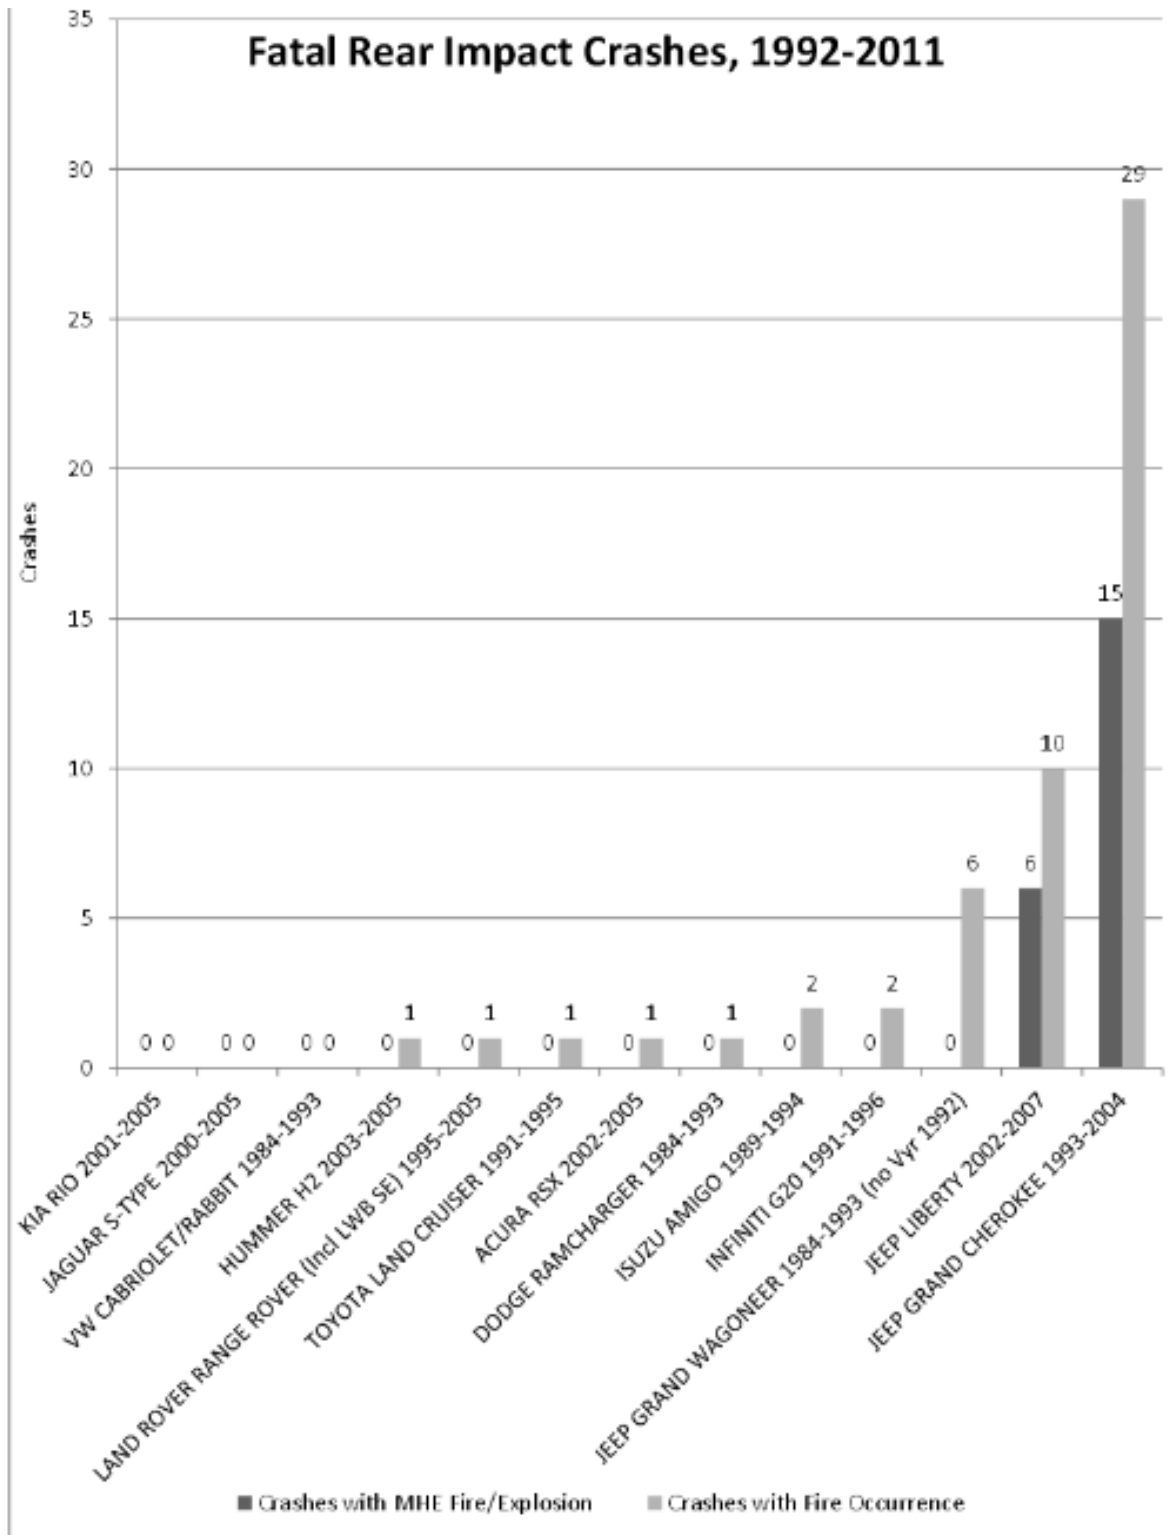
Figure 1. A comparison with the subject Jeeps and other vehicles that Chrysler had purported to show had worse rear impact fire performance but which had no deaths due to fire in FARS in rear impacts where there was a fire in the listed vehicle.

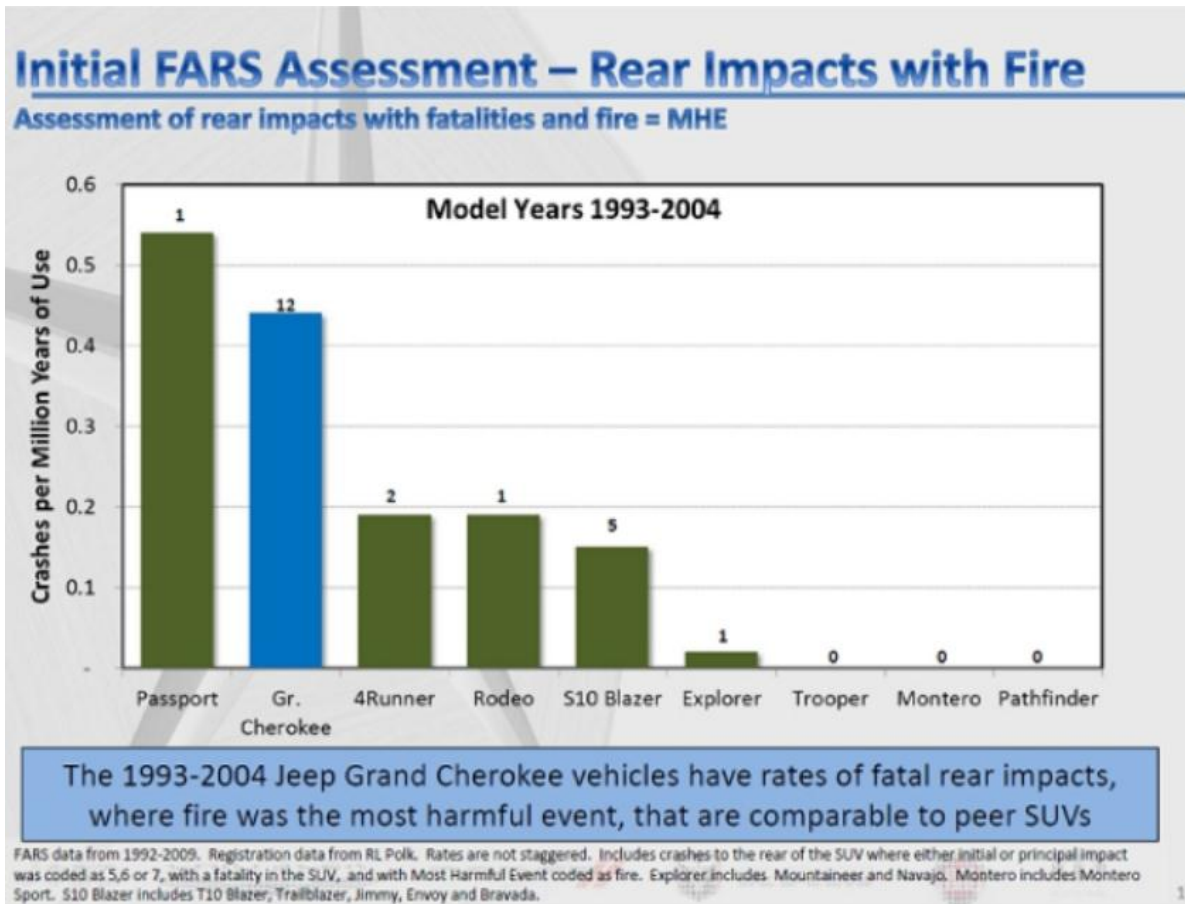
Looking at Chrysler's own chart which normalized these results (Figure 2) for the Grand Cherokee – with 12 cases where fire was the most harmful fatal event – had 4.4 per hundred thousand vehicle-years of use. The Honda Passport, which is a sister of the Isuzu Rodeo and should have been included with them, had only one crash on this chart, but when we looked at this case it was not even a rear impact but rather a frontal with a Chevrolet Tahoe.⁶ (Also, because of the small population of these vehicles, there were a

Figure 2. A chart submitted by Chrysler as part of their early response to NHTSA's investigation. Note that while Chrysler combined sisters and clones in most cases, it did not combine the very small volume Honda Passport with its sister Isuzu Rodeo.

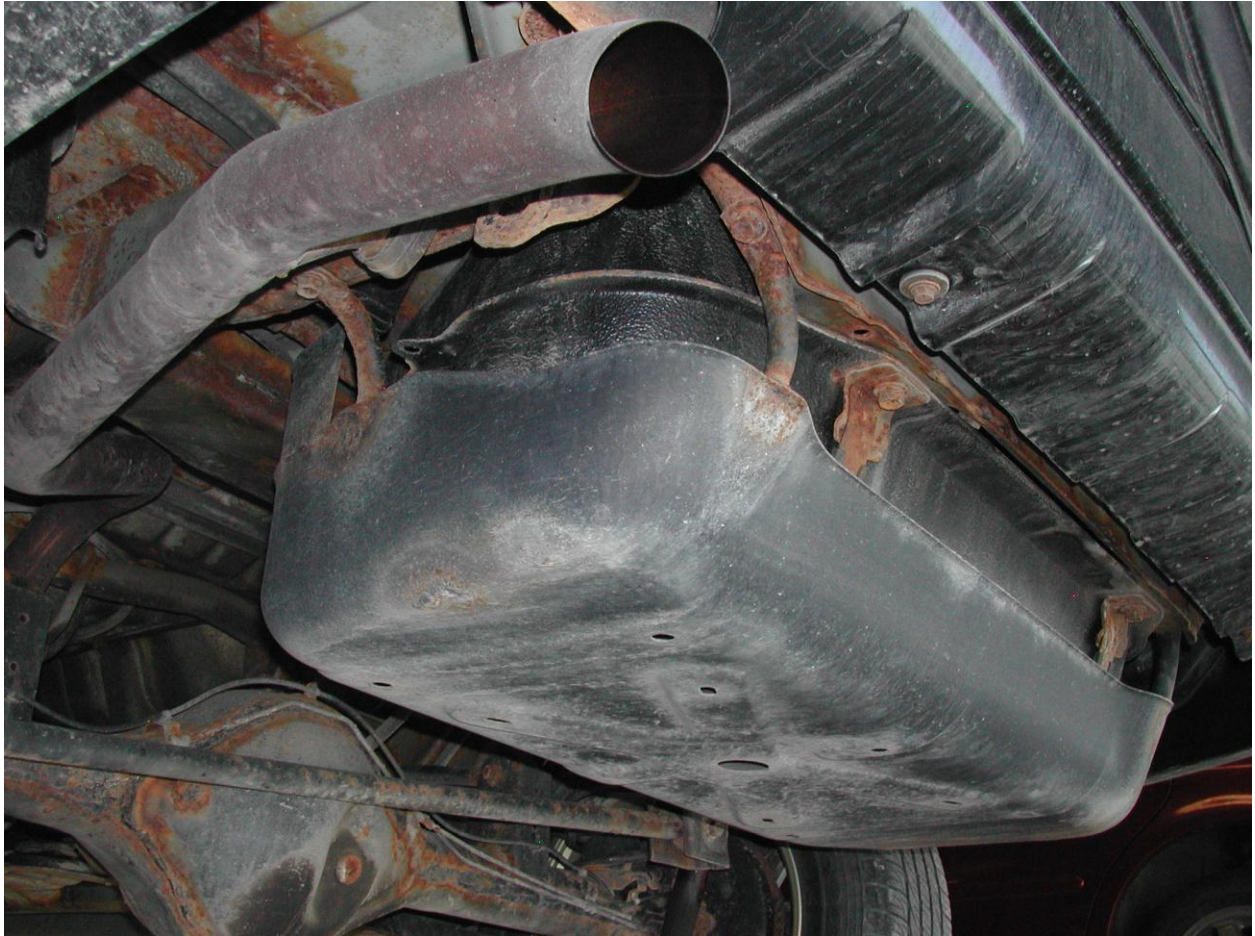
There is no significant production vehicle currently sold in the U.S. with the fuel tank located behind the rear axle. Even at the time the subject Jeeps were sold, only a few vehicle lines had fuel tanks in this location. And ones like the Suzuki XL-7 have a steel structure encapsulating the fuel tank. (Attachment A.)

Exhibit A – Encapsulated Suzuki SL-7 Fuel Tank

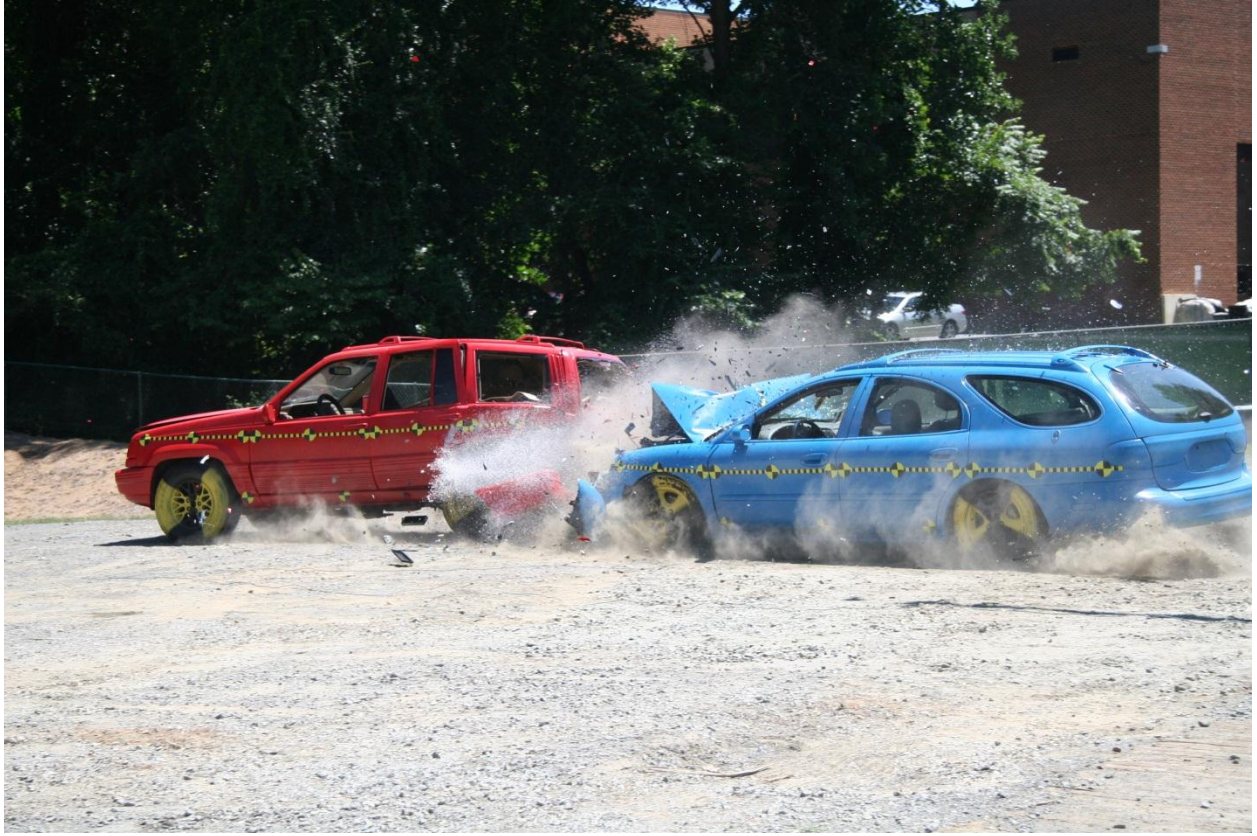
These deficiencies and failure modes were demonstrated in three crash tests in which Ford Taurus passenger cars struck the rear of Jeep Grand Cherokees. In an additional crash test conducted at the Federal Highway Administration's testing ground, a Ford Explorer with its fuel tank located ahead of the rear axle was struck in the rear by a Ford Taurus moving at 75 mph, and sustained no fuel leakage. The Explorer was fitted with an instrumented Hybrid II dummy that showed the driver would have survived this impact. This impact involved an impact energy more than three times that of the lowest speed Jeep Grand Cherokee impact conducted for the Center for Auto Safety in which there was major fuel leakage. Indeed, the energy level of the striking Taurus of 630,500 ft-lbs was higher than 29 of the 40 crashes cited by Chrysler without considering whether Chrysler inflated the speed of the bullet vehicle.

Exhibit B Fuel Spray from FHWA Due to Filler Hose Pulling Loose

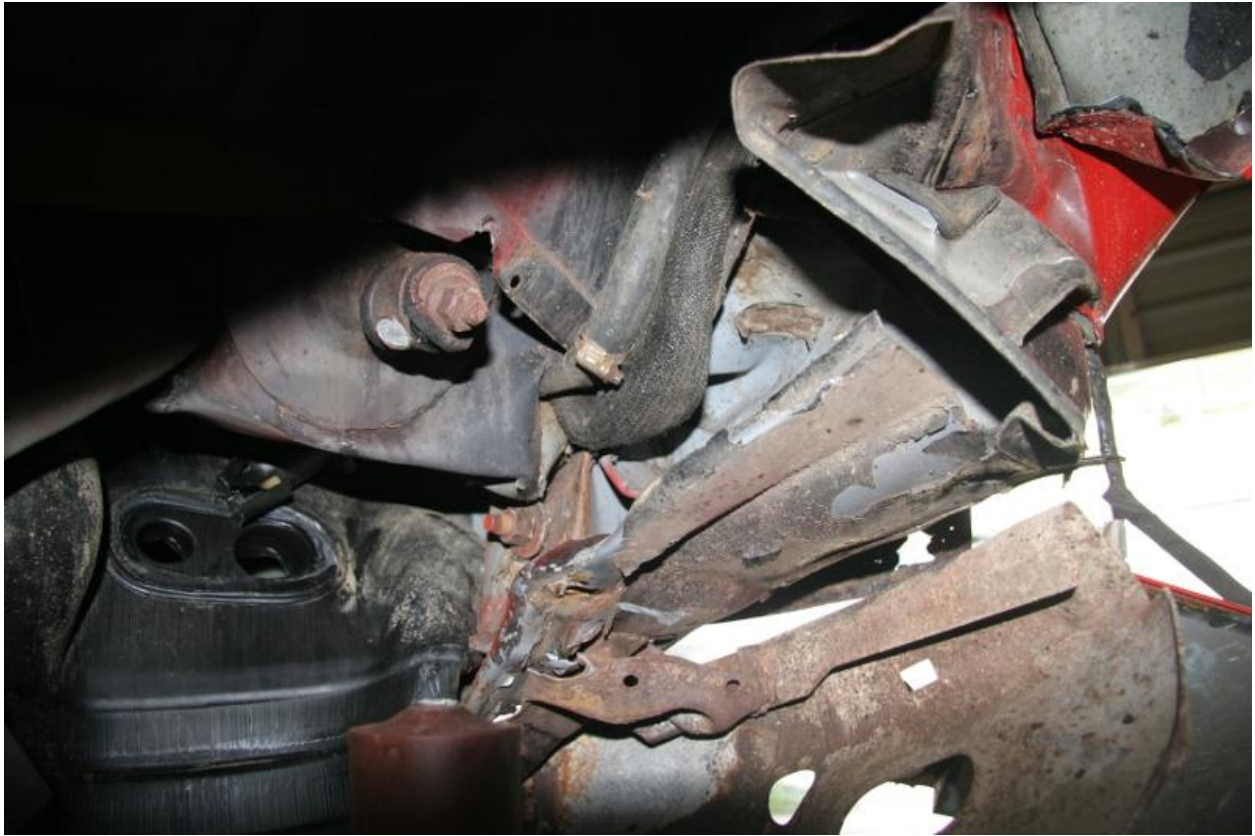
The Jeeps do have a check valve in the tank to preclude back flushing when the gas cap is removed on a hot day. However, this valve lacks a simple spring that would keep it closed under any circumstances where the pressure in the tank is equal to or greater than atmospheric pressure. Such a spring would ensure that the fuel in the tank remained there (assuming that the tank itself is not damaged) even when the filler tube is damaged.

Exhibit C – Fuel Tank Connection Where Filler Tube Pulled Loose
