EA12-005 Reconstruction Testing for KJ Jeep Liberty and ZJ Grand Cherokee

July 2014

U.S Department of Transportation
National Highway Traffic Safety Administration

1. Report No.	2. Government Accession No.	3. Recipient's Catalog No.	
4. Title and Subtitle EA12-005 Reconstruction Testing for KJ Jeep Liberty and ZJ Grand Cherokee		5. Report Date July 2014

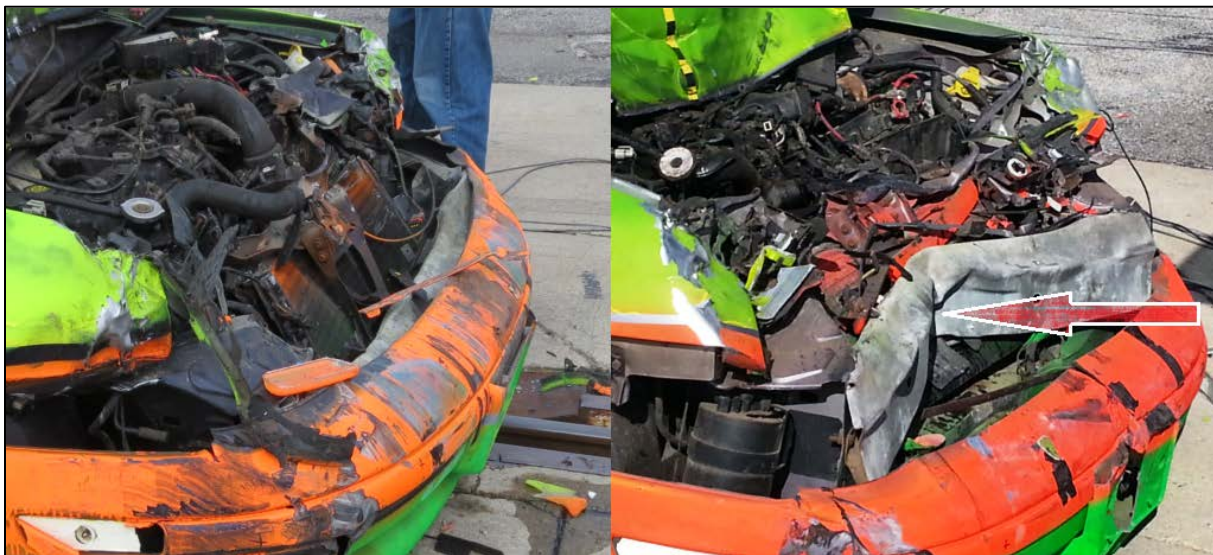
Figure 7 - Neon bumper reinforcement Test 1 vs. Test 2. Arrow at hitch-receiver contact

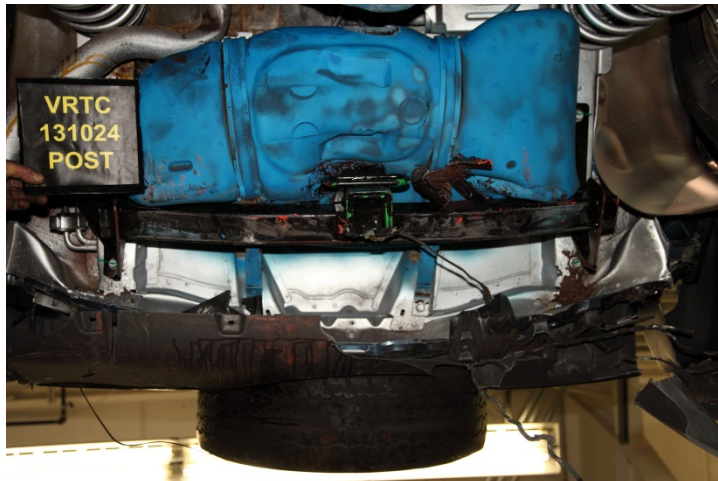
Figure 10 – Test #2 Post-test target vehicle fuel tank close-up view with hitch-receiver

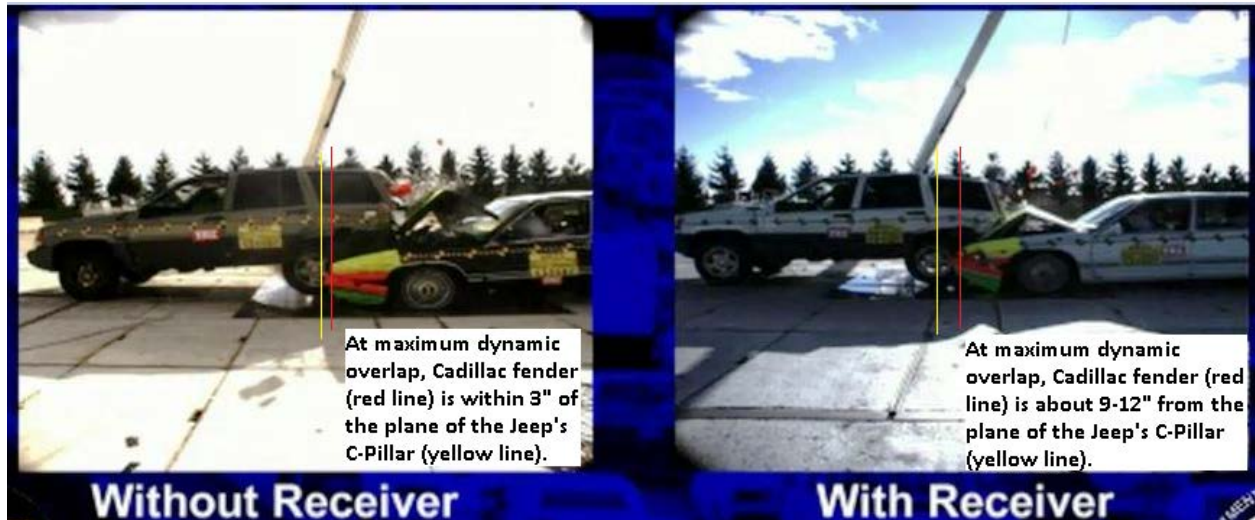
Figure 14- Dynamic overlap between Cadillac and Jeep Grand Cherokee without and with a hitch-receiver

from the high speed video showed the difference in dynamic overlap, where the Cadillac did not encroach as far into the Grand Cherokee when it was equipped with the hitch-receiver (Figure 14).

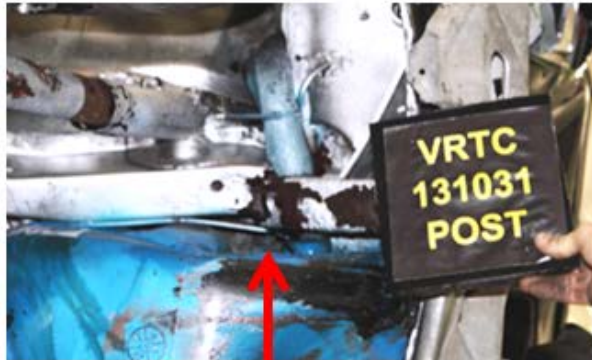
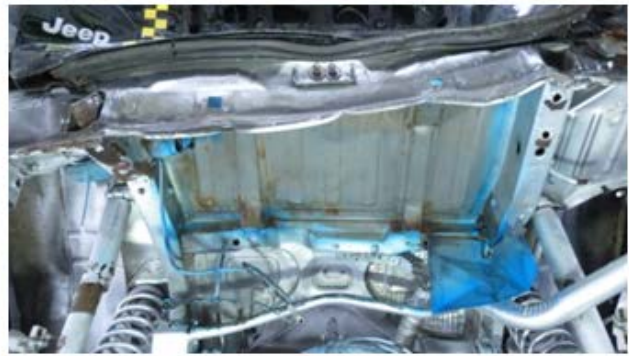
Fuel filler frame pass-through collapsed and pulled away from tank – Known source of leak from testing, Unknown if this occurred in the real-world crash

Significant sliding interaction between tank & bullet vehicle – Known source of leakage from real-world crash
