December 19, 2011

RE: *Kline et al. v. Loman Auto Group*

As requested, Kineticcorp investigated and reconstructed a fatal motor vehicle accident that occurred on February 24, 2007 at approximately 8:53 a.m. The crash occurred on southbound Interstate 287 at milepost 42.8 in Parsippany, New Jersey. A 1998 Subaru Outback, driven by Natalie Rawls, slowed or stopped in the right travel lane of southbound I-287. Susan Morris Kline slowed or stopped her 1996 Jeep Cherokee behind the Subaru. The Jeep was then impacted in the rear by a 2004 Toyota Sienna operated by Victoria Morgan-Alcala. As a result of this initial impact the Jeep was pushed into the rear of the Subaru before coming to rest between the right and center lanes of I-287. During the accident sequence a fire erupted. As a result of the crash, Ms. Kline was killed. In the area of the accident, southbound I-287 is an asphalt roadway with three lanes of travel bordered to the right by a gore area separating the through-travel lanes from the exit lane for Parsippany Road. Figure 1, a photograph taken by police, shows the accident scene. At the time of the accident the weather was clear and the roadway was dry, straight and leve

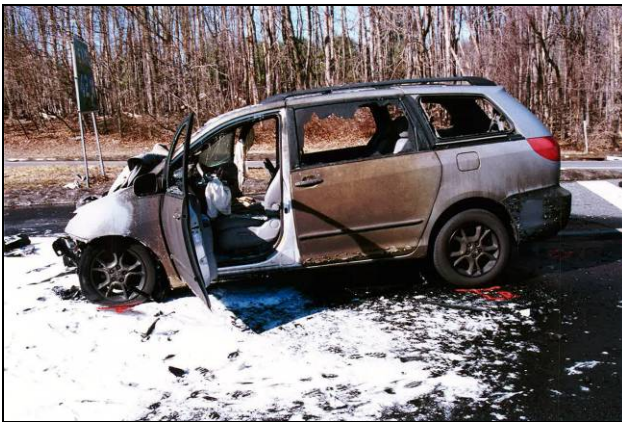
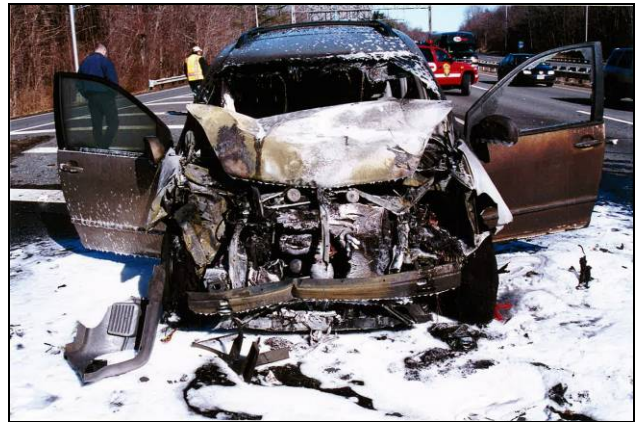
2004 Toyota: The Toyota involved in this crash was a 2004 model year Sienna XLE (VIN - 5TDZA22C34S052135). This vehicle was equipped with a 3.3-liter 6-cylinder gasoline engine and an automatic transmission. Figure 2 shows the Toyota at the accident scene. As can be seen in the figure, the Toyota shows signs of frontal impact and fire damage. The Toyota was not available for Kineticorp’s inspection.

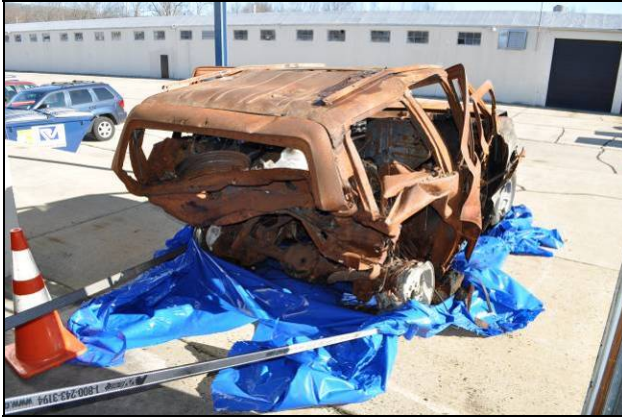
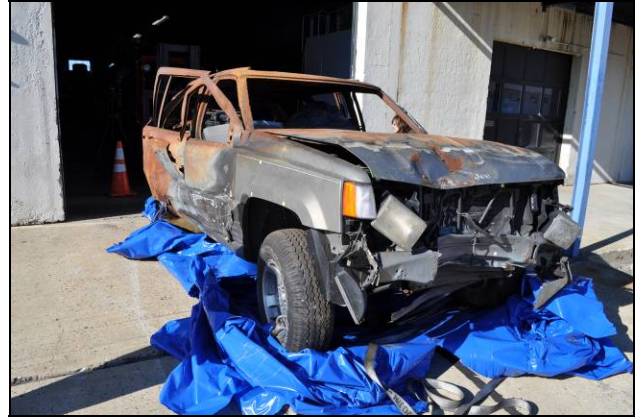
1996 Jeep: The Jeep involved in this crash was a 1996 model year Grand Cherokee Laredo (VIN- 1J4GZ58S9TC401311) equipped with a 4.0-liter 6-cylinder gasoline engine and an automatic transmission. Figure 3 shows the Jeep at the time of our inspection. As can be seen in the figure, the Jeep exhibits signs of impact damage to both the front and rear of the vehicle as well as fire damage.

Kineticorp determined that the maximum static crush to the rear of the Jeep was approximately 37 inches. The forces of the collision caused the rear axle of the Jeep to move forward.

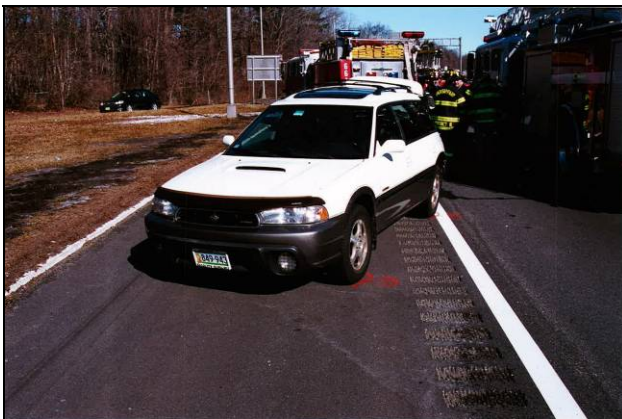
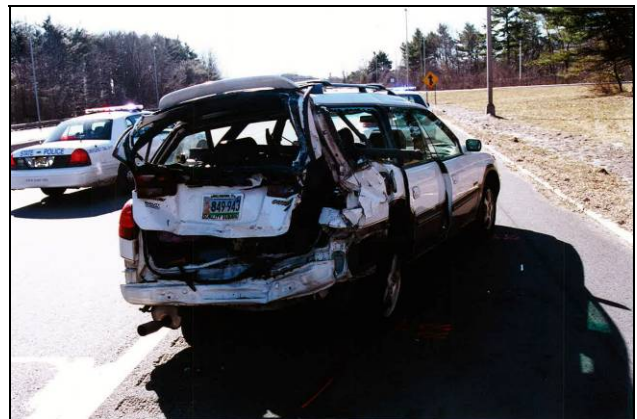
Figure42

1998 Subaru: The Subaru involved in this accident was a 1998 model year Legacy, Outback Edition (VIN - 4S3BG6852W7610862). This 4-door wagon was equipped with a 2.5-liter, 4-cylinder gasoline engine and an automatic transmission. Figure 4 shows the Subaru at the time of the accident. As can be seen in the figure, the Subaru sustained damage to the rear of the vehicle. The Subaru was not available for Kineticorp's inspection.

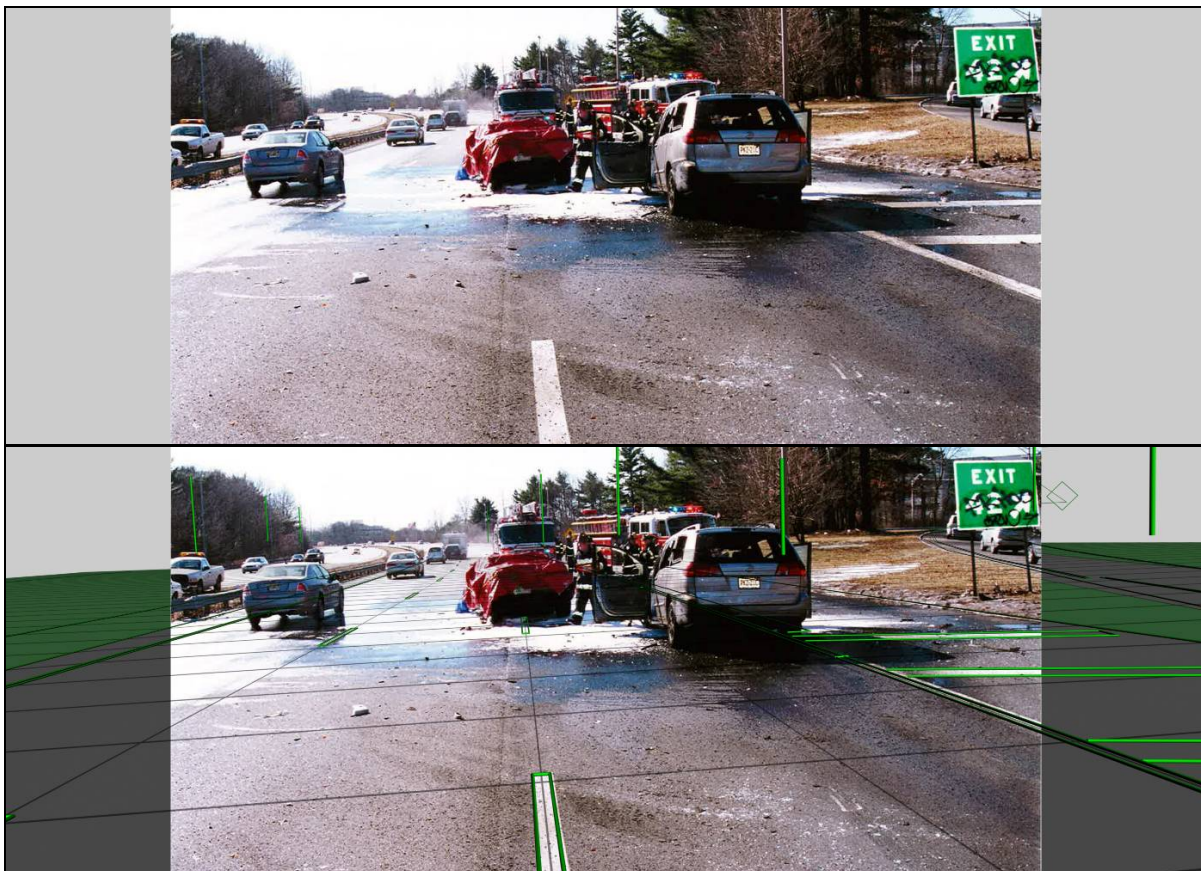
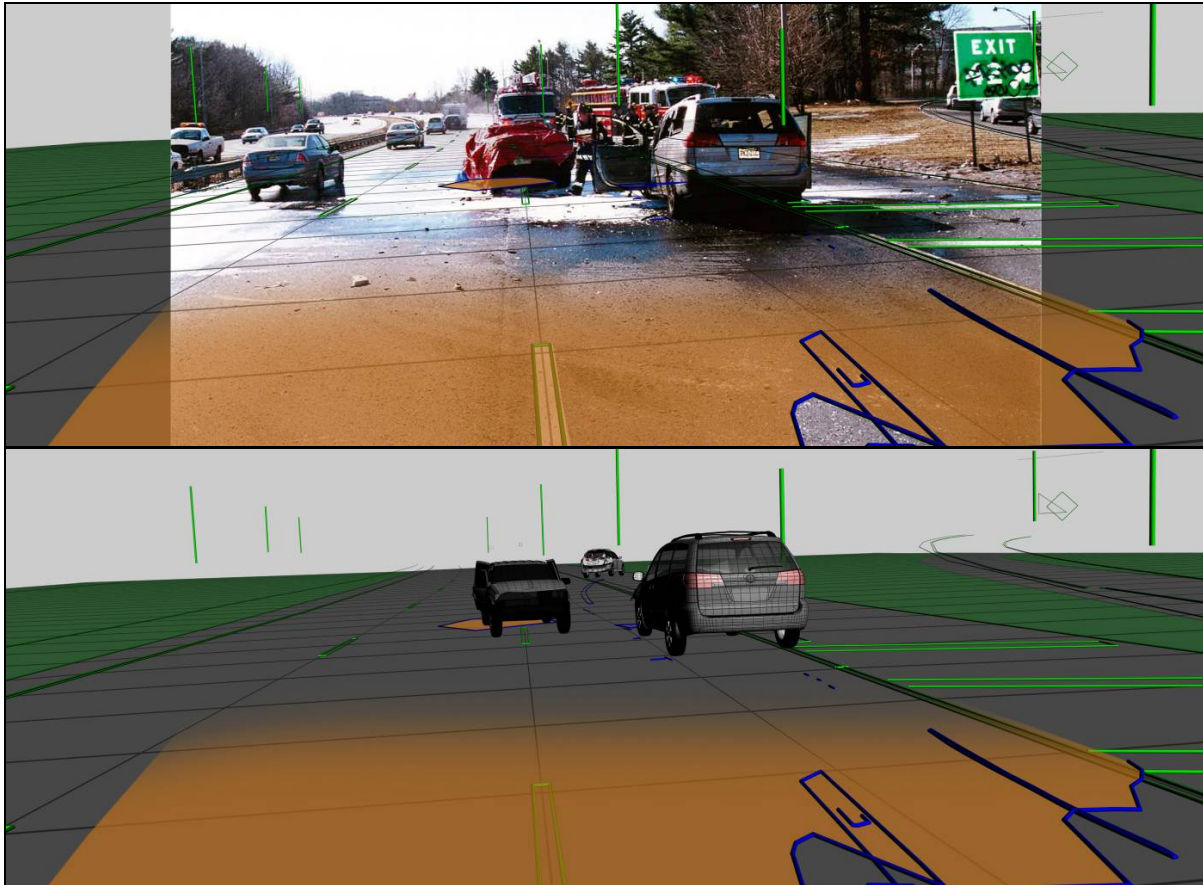
Figure 5 depicts a sampling of our photogrammetry analysis. The first image of the figure is a photograph taken by police. In the second image of the figure, the accident scene photograph has been aligned with the computer model which is visible as an overlay of lines. The third image of Figure 5 ((continued on following page), shows the aligned computer model with the physical evidence traced. Additionally, vehicle models have been positioned to locate the involved vehicles points of rest. In the bottom image of Figure 5-continued, the photograph has been removed leaving the geometry from the computer model.

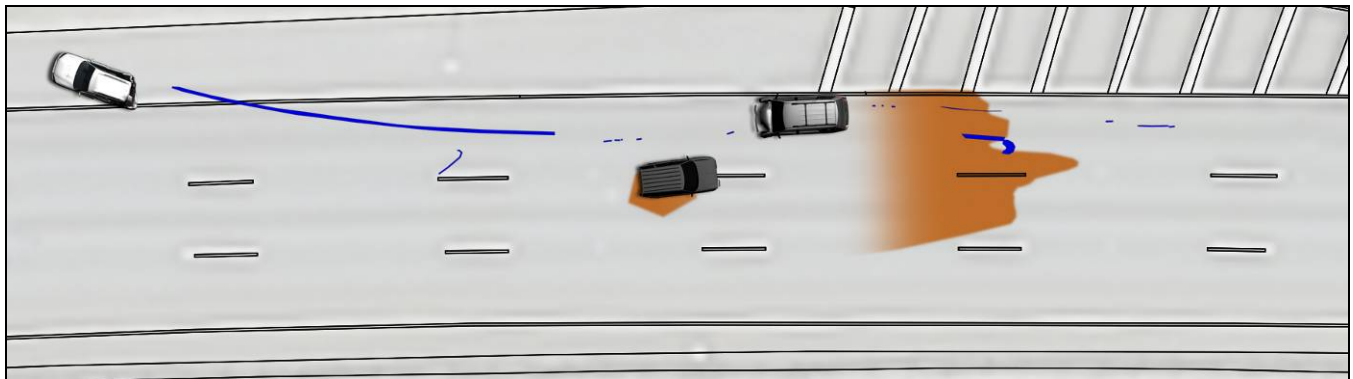
Figure 6 depicts our accident scene diagram, including the rest positions of the vehicles that were located using photogrammetry. Glass, gouge marks and tire marks are indicated in blue. Fluid and burn areas are shown in orange.

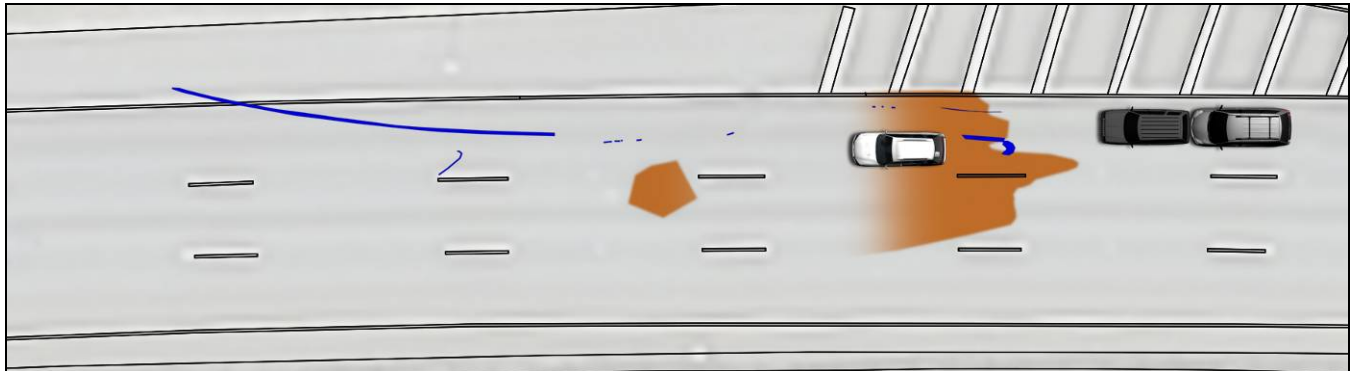
Analysis: Gouge and tire mark evidence were used to locate the points of impact on the roadway. Figure 7 depicts the location of the vehicles at first impact as dictated by the physical evidence.

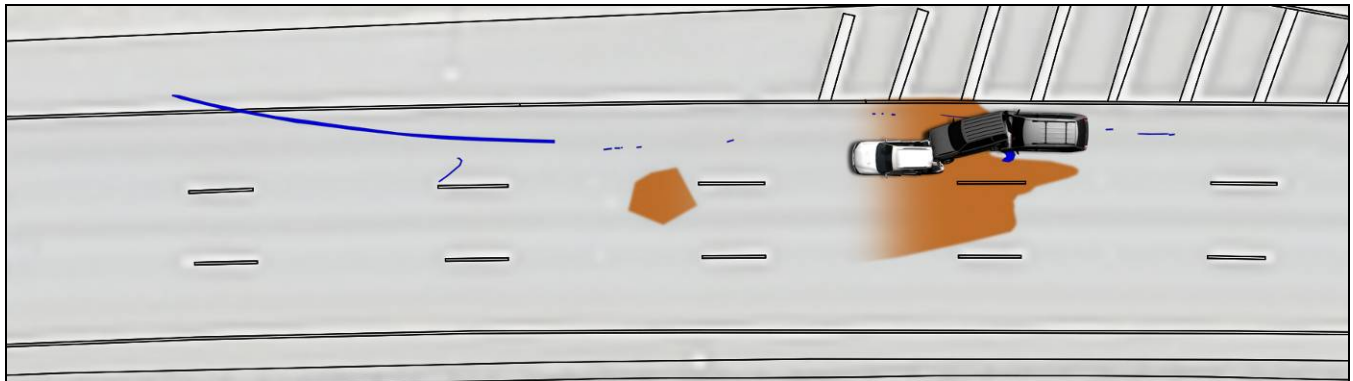
After the initial impact, the Jeep and Toyota traveled approximately 30 feet before impacting the rear of the Subaru. Figure 8 depicts the position of the vehicles at the second impact. As seen in the figure, the Jeep is crushed between the Toyota and Subaru. During impact two, the Jeep and Toyota were both damaged more extensively, as evidenced by the glass deposit at the location of the impact. As the Jeep was crushed, it rolled towards the passenger side and the Toyota under-rode the rear of the Jeep as depicted in Figure 9. The Jeep rolled approximately 25 degrees based on the damage pattern to the rear lift gates of the Jeep and the Subaru. Specifically, the window opening of the Jeep's rear lift gate exhibits more damage to the right side than the left, consistent with the Jeep being rolled to the right as the Toyota penetrated underneath the rear on the Jeep. Also, the rear lift gate of the Subaru exhibits damage consistent with the front of the Jeep being lifted up above the Subaru's rear bumper. Additionally, the right rear wheel of the Jeep gouged the pavement as it rolled to the right.

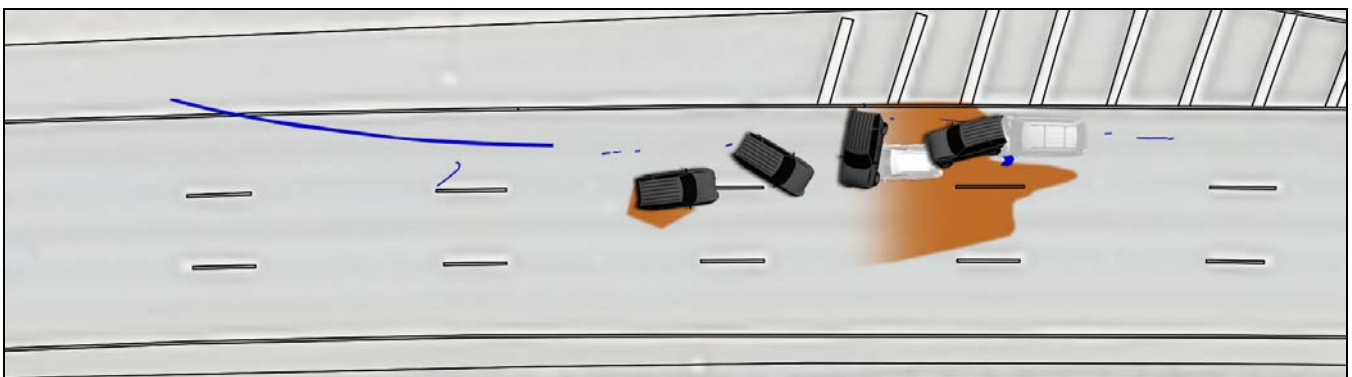
Figure 10

The vehicles then traveled to rest. The collision locked the rear right tire of the Subaru, causing it to leave a dark tire mark that led to its rest position. The Subaru traveled approximately 130 feet after the impact and came to rest on the shoulder. The Toyota traveled approximately 40 feet before coming to rest in the right lane. As the Jeep was crushed between the Subaru and the Toyota, it began to rotate counter-clockwise. The Jeep traveled approximately 50 feet, and rotated approximately 180 degrees before coming to rest straddling the right and middle lanes. The motion of the Jeep as it traveled to rest is depicted in Figure 10.

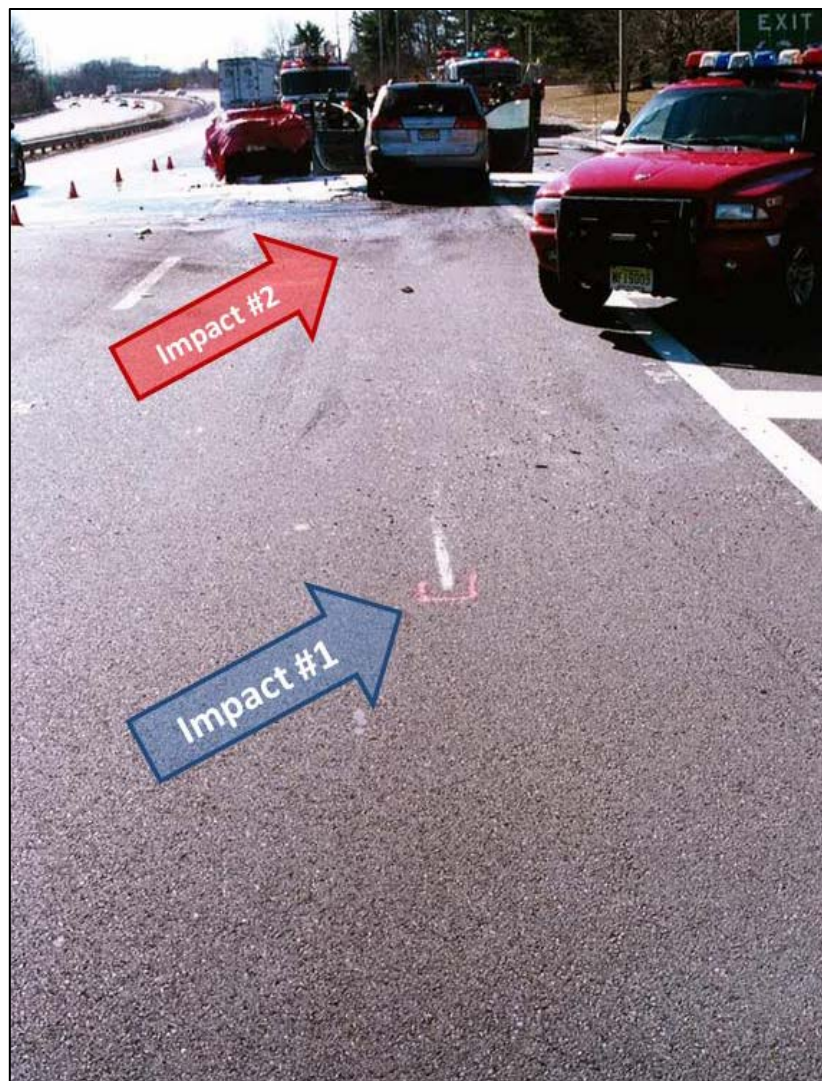
Figure 11 below shows a gouge mark created during impact one when the Toyota first impacted the rear of the Jeep. The gouge mark was likely created when the Jeep's undercarriage made contact with the pavement. Analysis of the vehicle's bumper structures shows that the height of the Toyota's front bumper is in line with the Jeep's rear bumper and that there was good engagement between the bumper structures. As mentioned earlier, the Toyota pushed the Jeep ahead approximately 30 feet into the rear of the Subaru. During this second impact, the Jeep was crushed between the two vehicles and the rear structure of the Jeep, which had already been damaged, was crushed additionally. As seen in Figure 11, the fire pattern on the ground is located in the area of impact two. As depicted in Figure 9, the Toyota penetrated underneath the left side of the Jeep causing it to roll towards its right side. It is during this second impact where there is evidence of a fire pattern on the ground due to the Jeep's fuel system being breached.

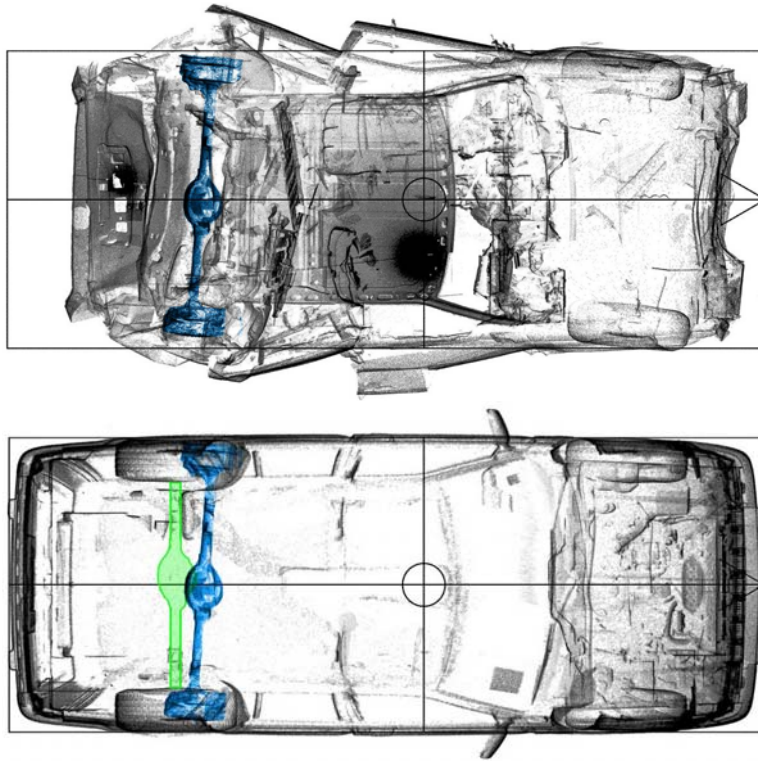
The top image in Figure 12 depicts the damage to the Jeep, as documented with our three-dimensional scan. The rear axle is highlighted in blue in Figure 12. The bottom image of Figure 12 depicts the relative movement of the rear axle compared to its original undamaged position. The axle would have moved further forward dynamically during the crash.

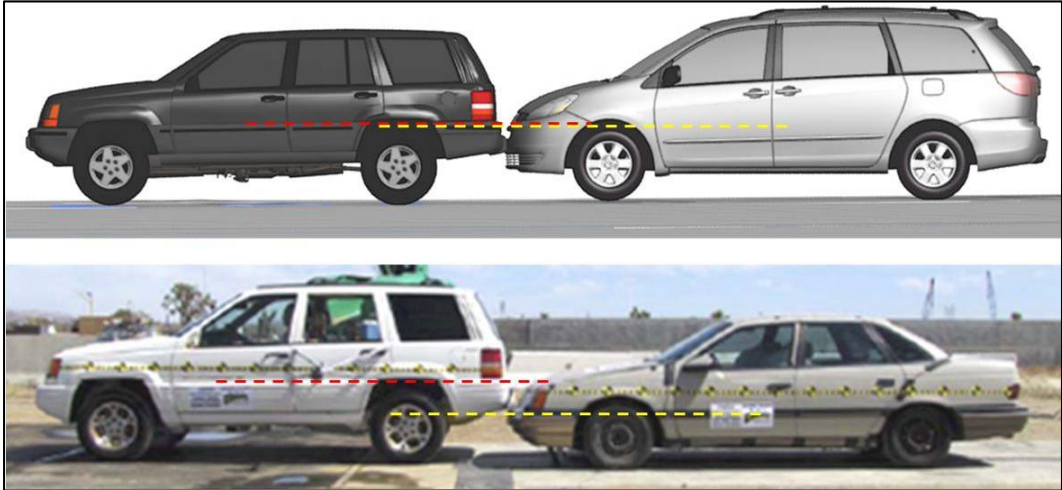
The subject accident was significantly different than the KARCO tests in terms of the lateral and vertical alignment of the vehicles. The top image in Figure 13 depicts the initial impact alignment between the Toyota and the Jeep. The image below shows the alignment between the Taurus and Jeep from test TR-P31070-01-NC. The top of the bumper of each vehicle has been indicated, the Jeep in red and the impacting vehicle in yellow. As depicted, there was good bumper alignment in the subject accident. However, in the KARCO test, the entire bumper of the Taurus was beneath the bumper of the Jeep. The test setup is conducive to vehicle under-ride, the subject accident was not. In both KARCO tests, the tires on the Jeep were significantly larger than the tires on the subject Jeep at the time of the accident. Also, the tires on the test Taurus were significantly smaller than the recommended tire size for that vehicle in test TR-P31070-01-NC. These tire differences make it easier for the Taurus to under-ride the rear of the Jeep in the tests. Further, the test tire pressures were not listed in the test reports and it appears that the tires of the Taurus were underinflated for the test. This would lower front of the Taurus and make it easier for the tires of the Taurus to compress during the impact. Low tire pressure would also make it easier for the Taurus to under-ride the Jeep. The alignment between the test vehicles was drastically different than the alignment during the accident. In terms of under-ride propensity, the vehicle and tire selections in the test are skewed towards a worst case scenario for the Jeep's structural ability to absorb the crash energy. These conditions did not exist in the subject accident.

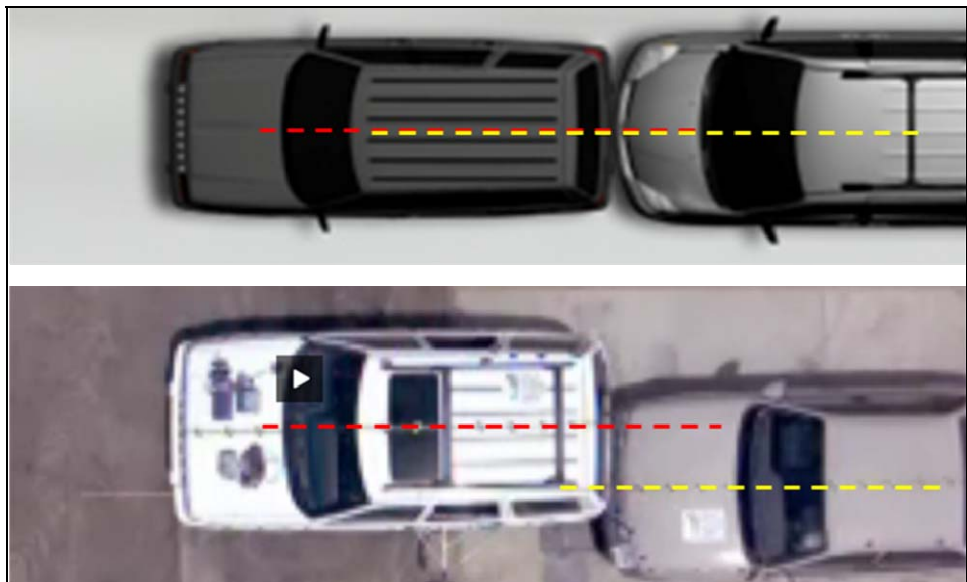
In the subject accident, the Toyota impacted squarely into the entire rear of the Jeep. In the KARC tests, the collision was offset, such that the entire rear of the Jeep was not directly involved in the collision. This offset in the test is significant because less of the vehicle's width is available to absorb the impact energy. In other words, offset collisions are more severe in terms of energy absorption demands placed on the impacted vehicle. Since the subject accident was a full overlap collision, the offset tests are misrepresentative of the subject accident. The top image in Figure 14 depicts the lateral alignment of the vehicles in the subject accident. The red line indicates the center of the Jeep, the yellow line indicates the center of the Toyota. The KARC test is depicted below.<sup>2</sup> In the KARC test, the Taurus is offset significantly to the left at impact. Due the lateral and vertical alignment differences, no meaningful comparisons can be made between the subject accident and the KARC test results. It should also be noted that components in the test Jeeps were removed, such as the spare tire, door panels and the rear side windows. At this time Kineticcorp has not made a determination as to the effect of removing these items in the tests.
