Massachusetts State Police

Collision Reconstruction Report

CASE #	2013-CAR-000404
Related Case#	2013-0B3-006595

RT 91 North, Mile Marker 2.2, LONGMEADOW, MA

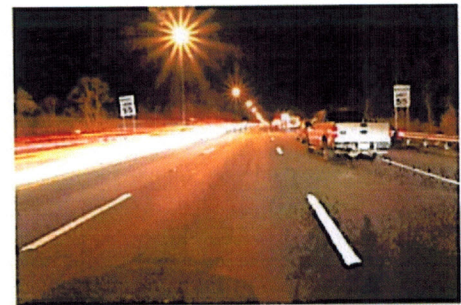
Photograph One

The posted speed limit for Interstate Route 91 northbound approaching the crash scene is 65 miles per hour, decreasing to 55 miles per hour at the crash scene with signs posted within the scene. This scene is fairly and accurately depicted in ***Exhibit One, Image One,*** and ***Photograph One.*** Interstate Route 91 in Longmeadow, Massachusetts is designated a public way by Massachusetts General Law C. 90 § 1. It is maintained by the Massachusetts Department of Transportation. It is patrolled by the primary agency of jurisdiction, the Massachusetts State Police – Springfield substation.

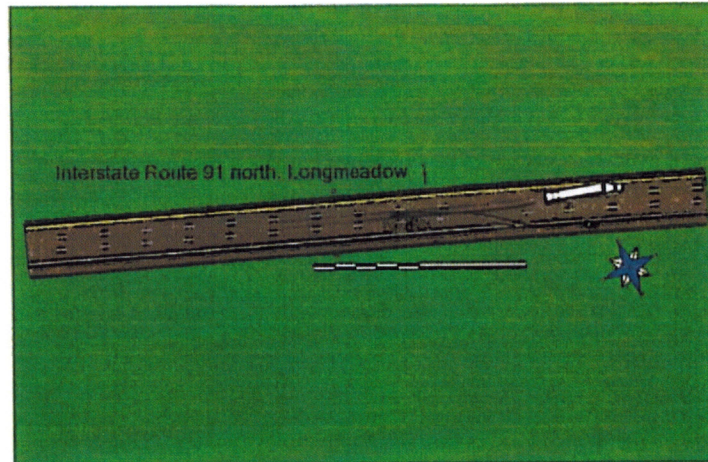
Exhibit Two

5. A preliminary joint investigation was begun with the investigating officer. As part of this preliminary investigation physical evidence about the roadway was recorded. Trooper Christopher Kennedy of the Massachusetts State Police Collision Analysis Reconstruction Section assisted me in conducting a forensic survey of the collision location. Infrared technology via a TopCon transit and FC-100 Data acquisition system was utilized. Employing polar coordinates, the physical evidence was located and recorded. Physical evidence was noted as depicted in *Exhibit Two* and documented as follows:

Post impact: Vehicle #1 left skidmarks beyond the area of impact and scraping from the area of impact toward its position of final rest. Vehicle #2 left scrapes from its left rear damage, a scuff mark with striations from its left front tire in the right lane, and scraping along the guardrail. Both vehicles remained at their positions of uncontrolled final rest. Operator #2 was found in the breakdown lane outside of his vehicle.

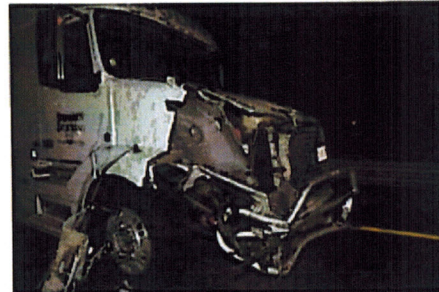
Photograph Two

7. Vehicle # 1 received the following damage, as depicted in *Photograph Two*, during the crash:

INDUCED DAMAGE

- Radiator
- Hood

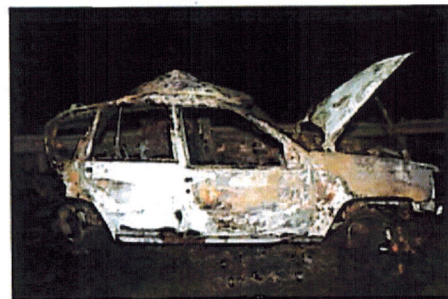
Photograph Three

Vehicle # 2 received the following damage, as depicted in *Photograph Three*, during the crash:

CONTACT DAMAGE

INDUCED DAMAGE

- Left front door
- Roof
- Left rear door
- Left quarter panel
- Right quarter panel
- Left and right C pillars
- Right rear door
- Right front door
- Rear floor
- Rear seats
- Driver's seat

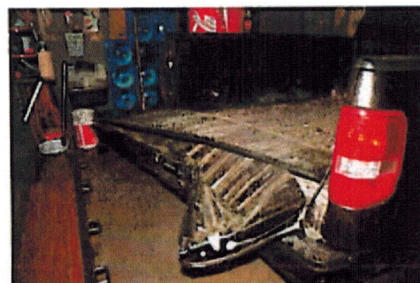
Photograph Five

Vehicle # 3 received the following damage, as depicted in *Photograph Five*, during the crash:

CONTACT DAMAGE

- Rear tailgate
