Subject: Chrysler Group, LLC Failure-to-Warn/Comply under 49 CFR § 573.6, et al.

Reference 2: EA12-005 File Update (Chrysler Jeep Fuel Tank System Safety Defect)

Chrysler Jeep Fuel System Defect Investigation EA12-005

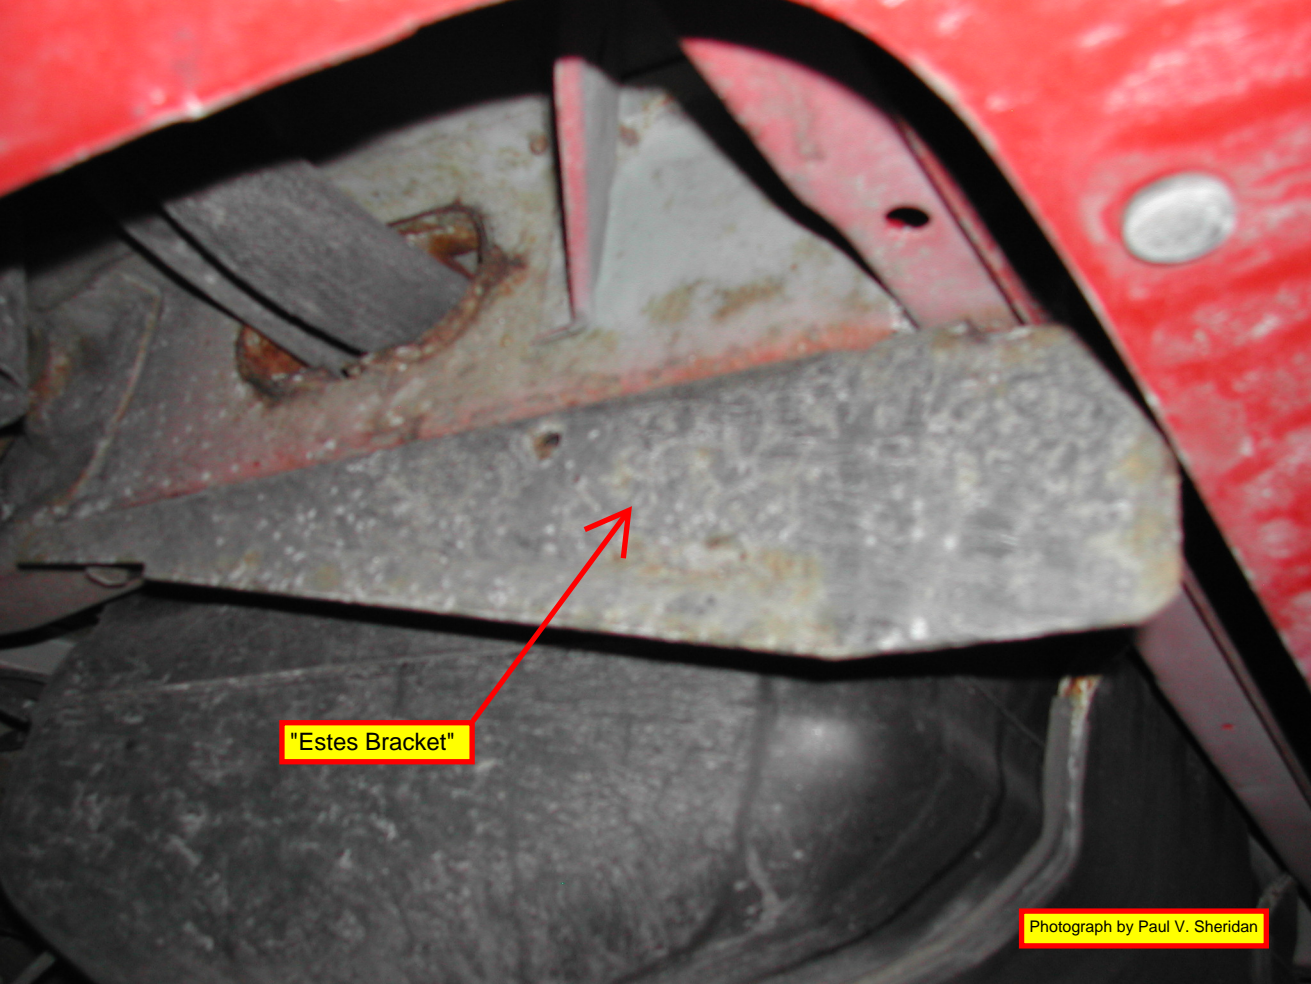
"Estes Bracket"

Photographs of last-minute release of preposterous, make-shift reinforcement to the rear frame rail, nicknamed the “Estes bracket” for the 1997 Jeep Grand Cherokee.

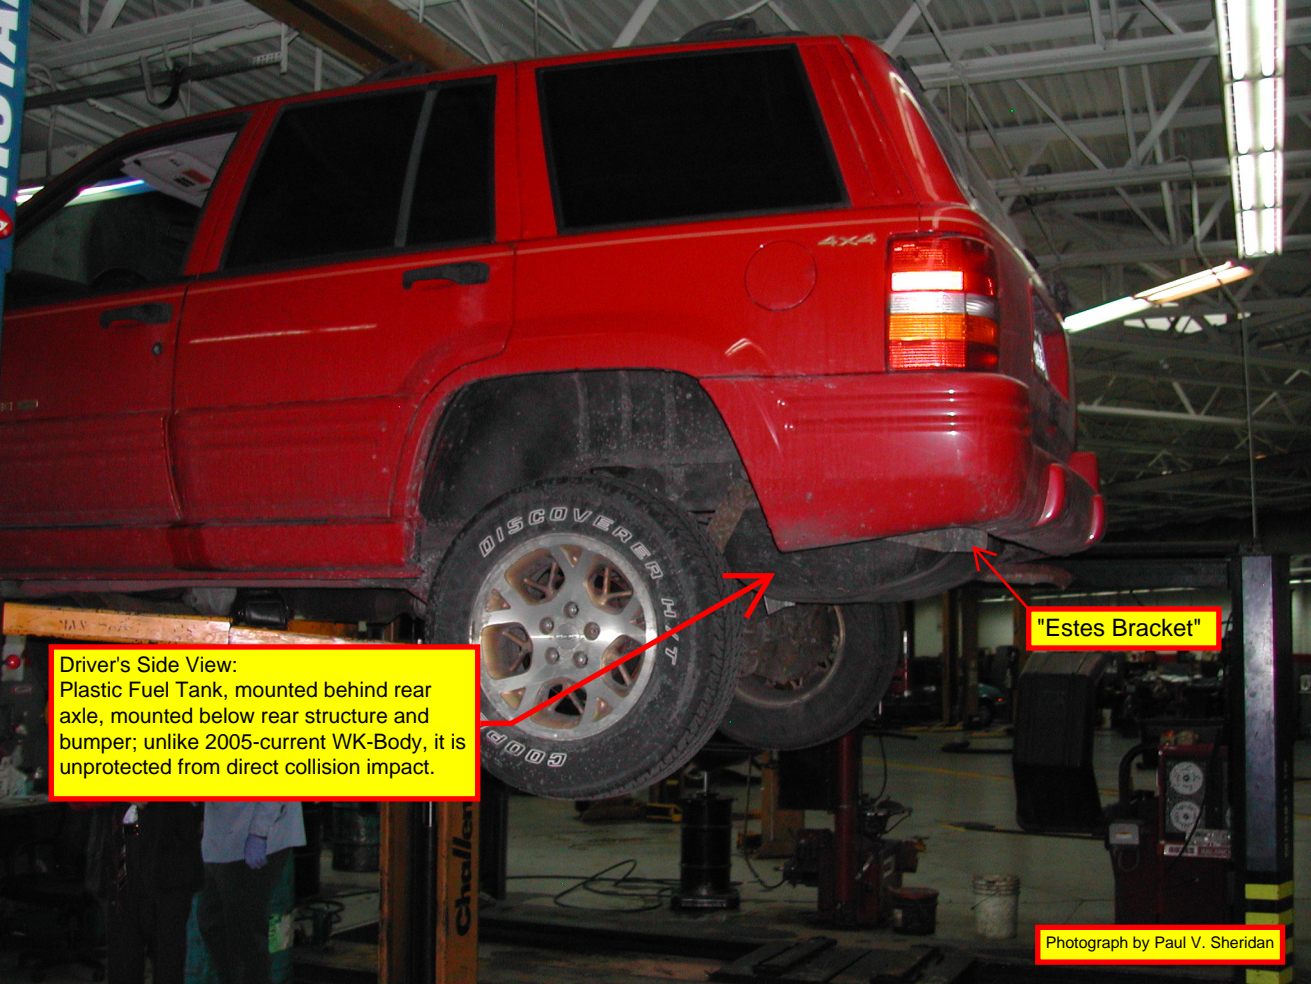
Driver's Side View:

Plastic Fuel Tank, mounted behind rear axle, mounted below rear structure and bumper; unlike 2005-current WK-Body, it is unprotected from direct collision impact.

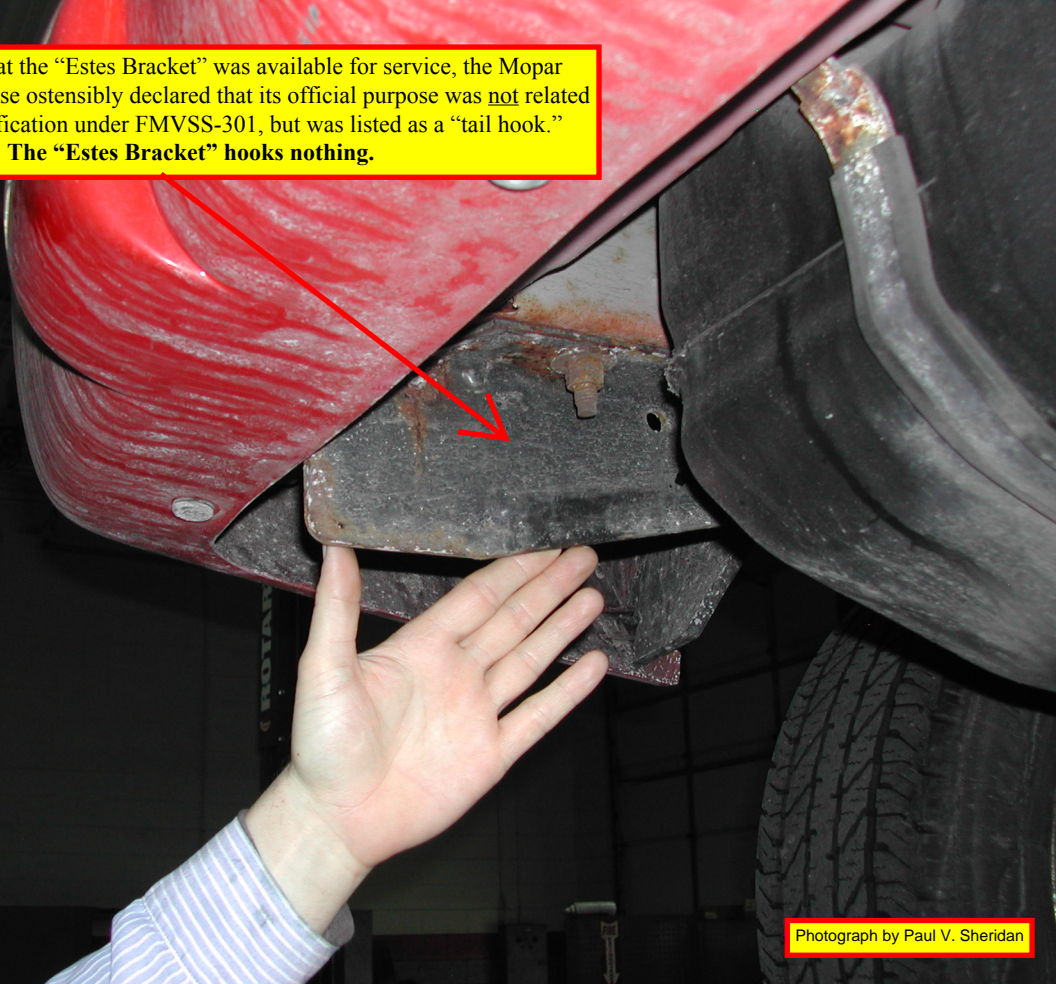
During the time that the “Estes Bracket” was available for service, the Mopar DirectConnect database ostensibly declared that its official purpose was not related to ZJ-Body recertification under FMVSS-301, but was listed as a “tail hook.”

The “Estes Bracket” hooks nothing.

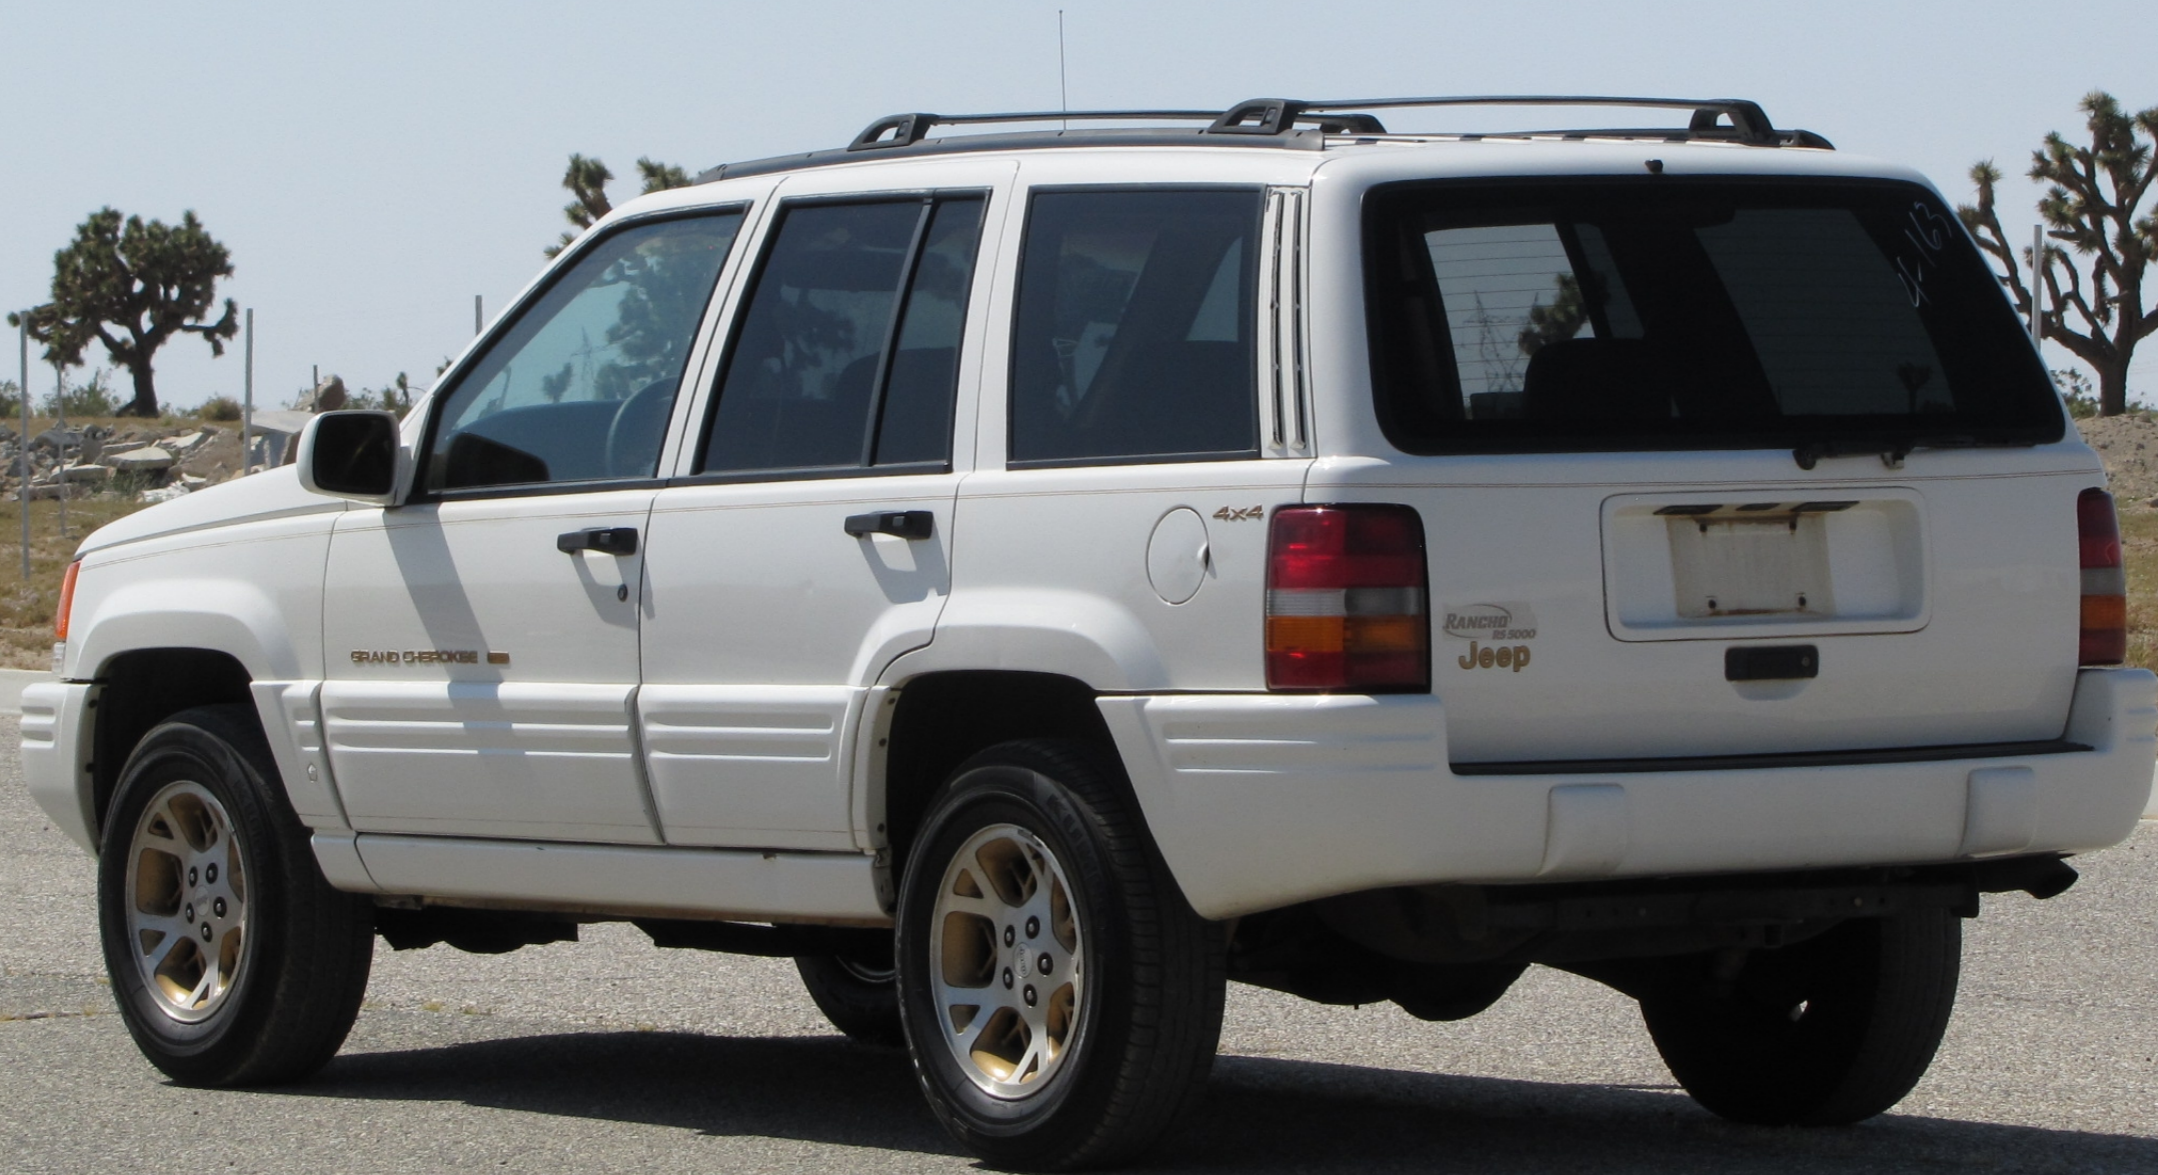
**ZJ-Body Jeep Grand Cherokee:
Typical Customer View (of Fuel Tank)**

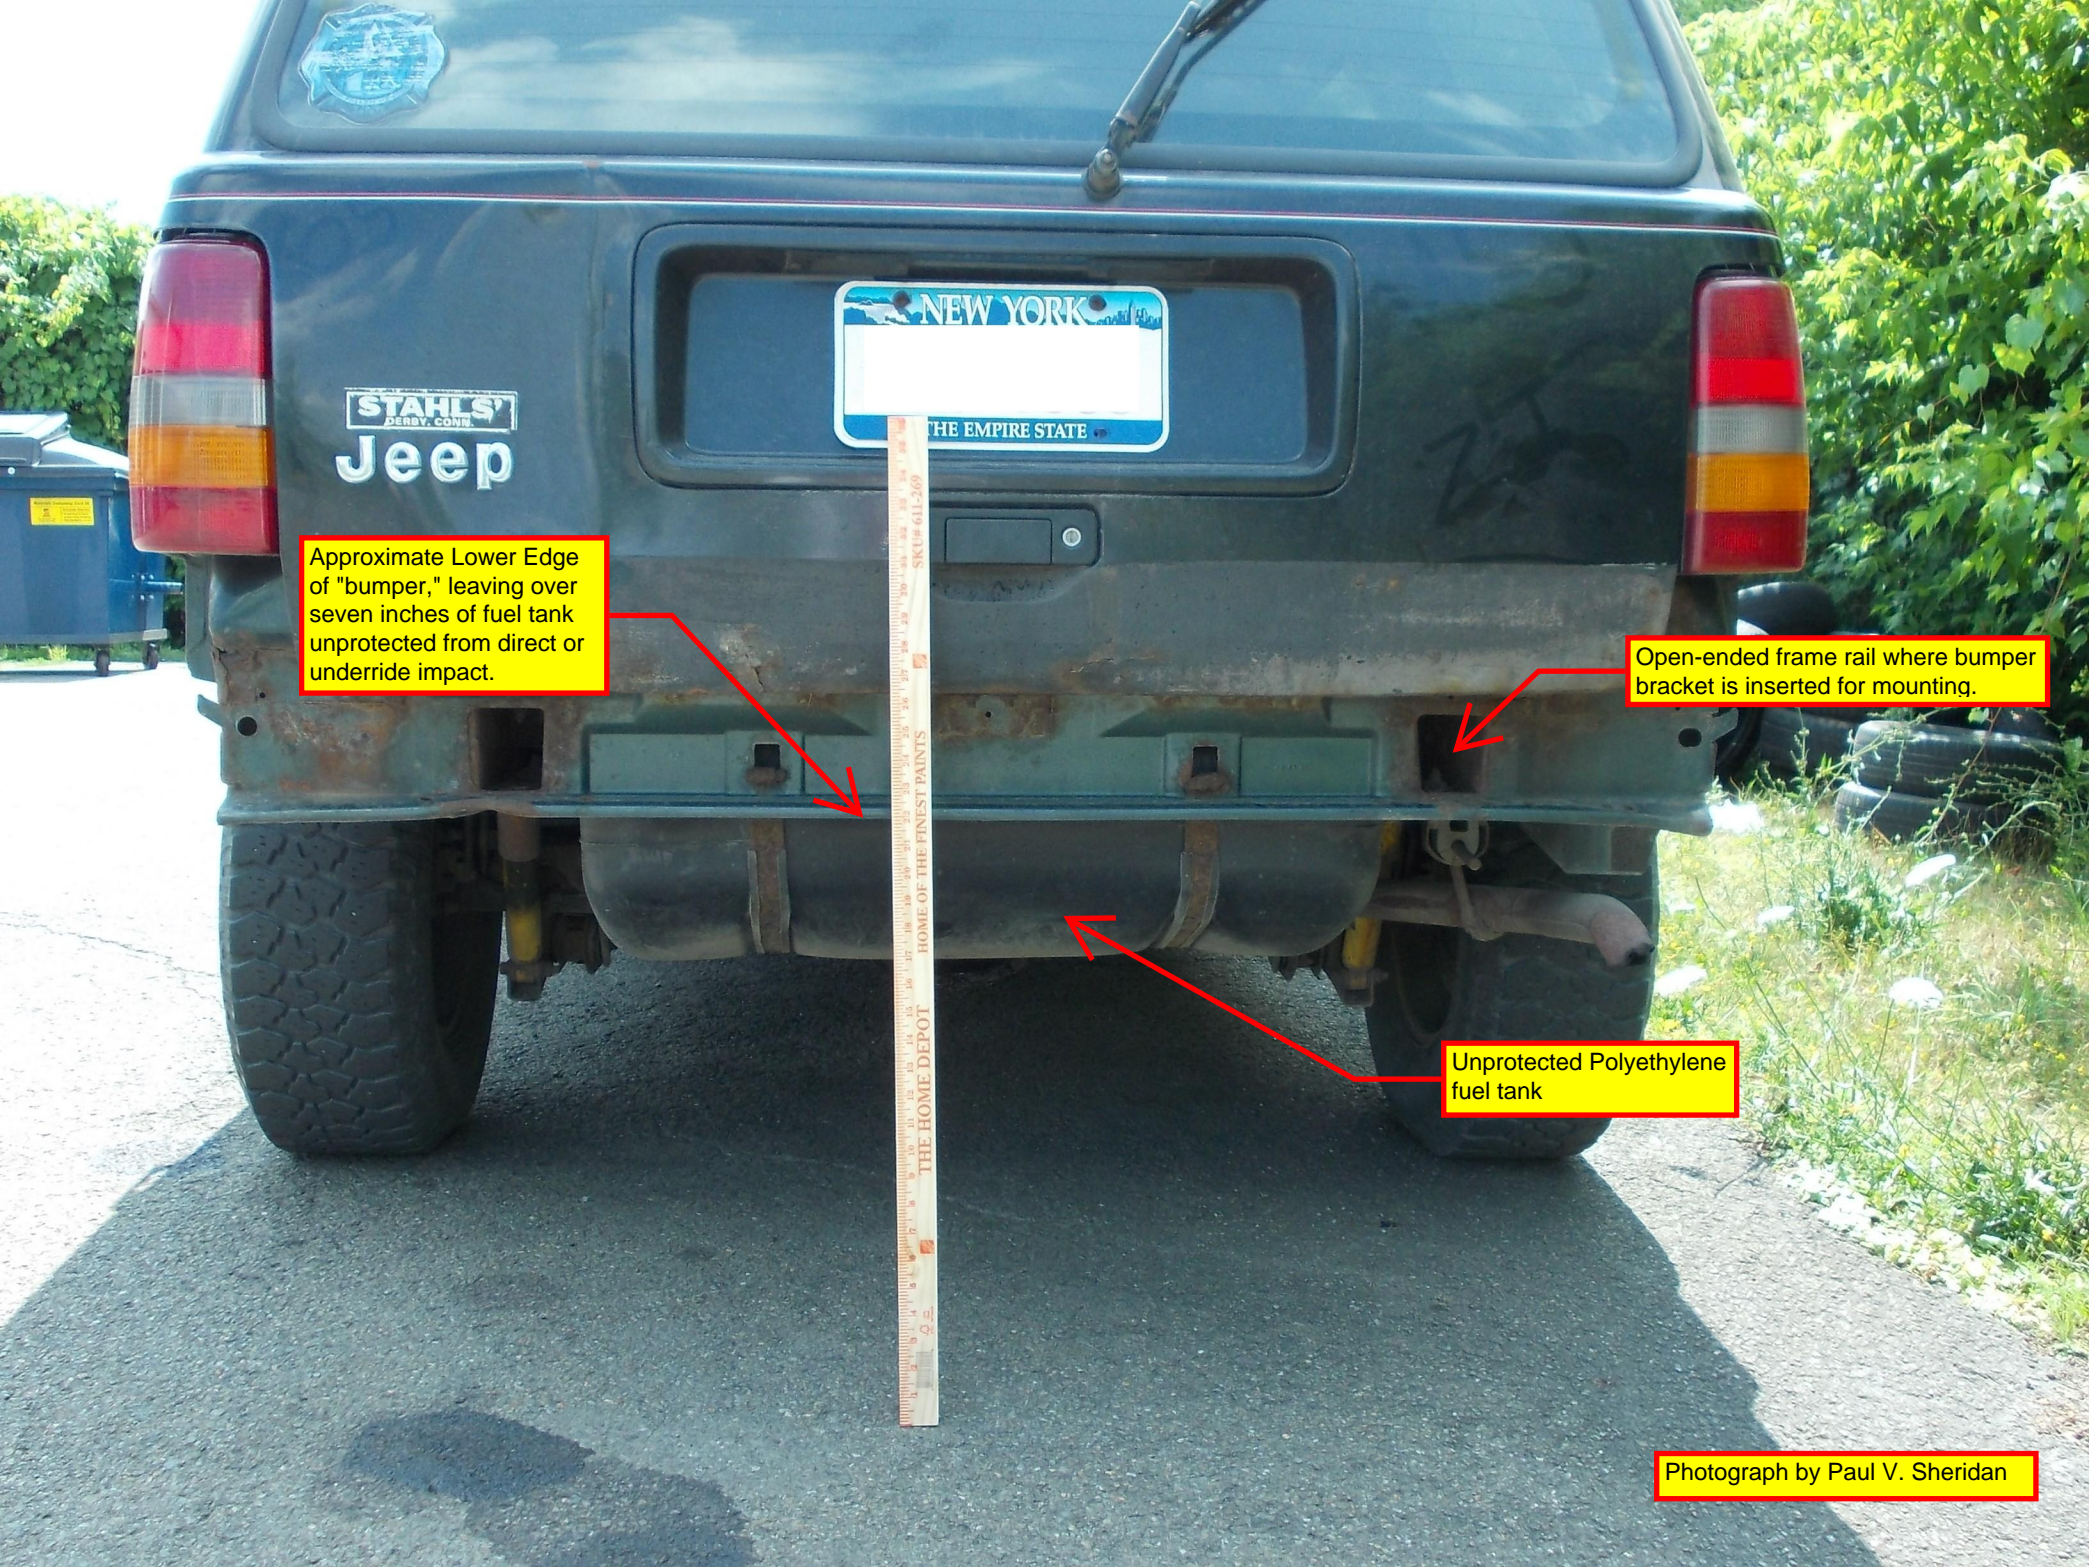
Approximate Lower Edge of "bumper," leaving over seven inches of fuel tank unprotected from direct or underride impact.

Open-ended frame rail where bumper bracket is inserted for mounting.

Unprotected Polyethylene fuel tank

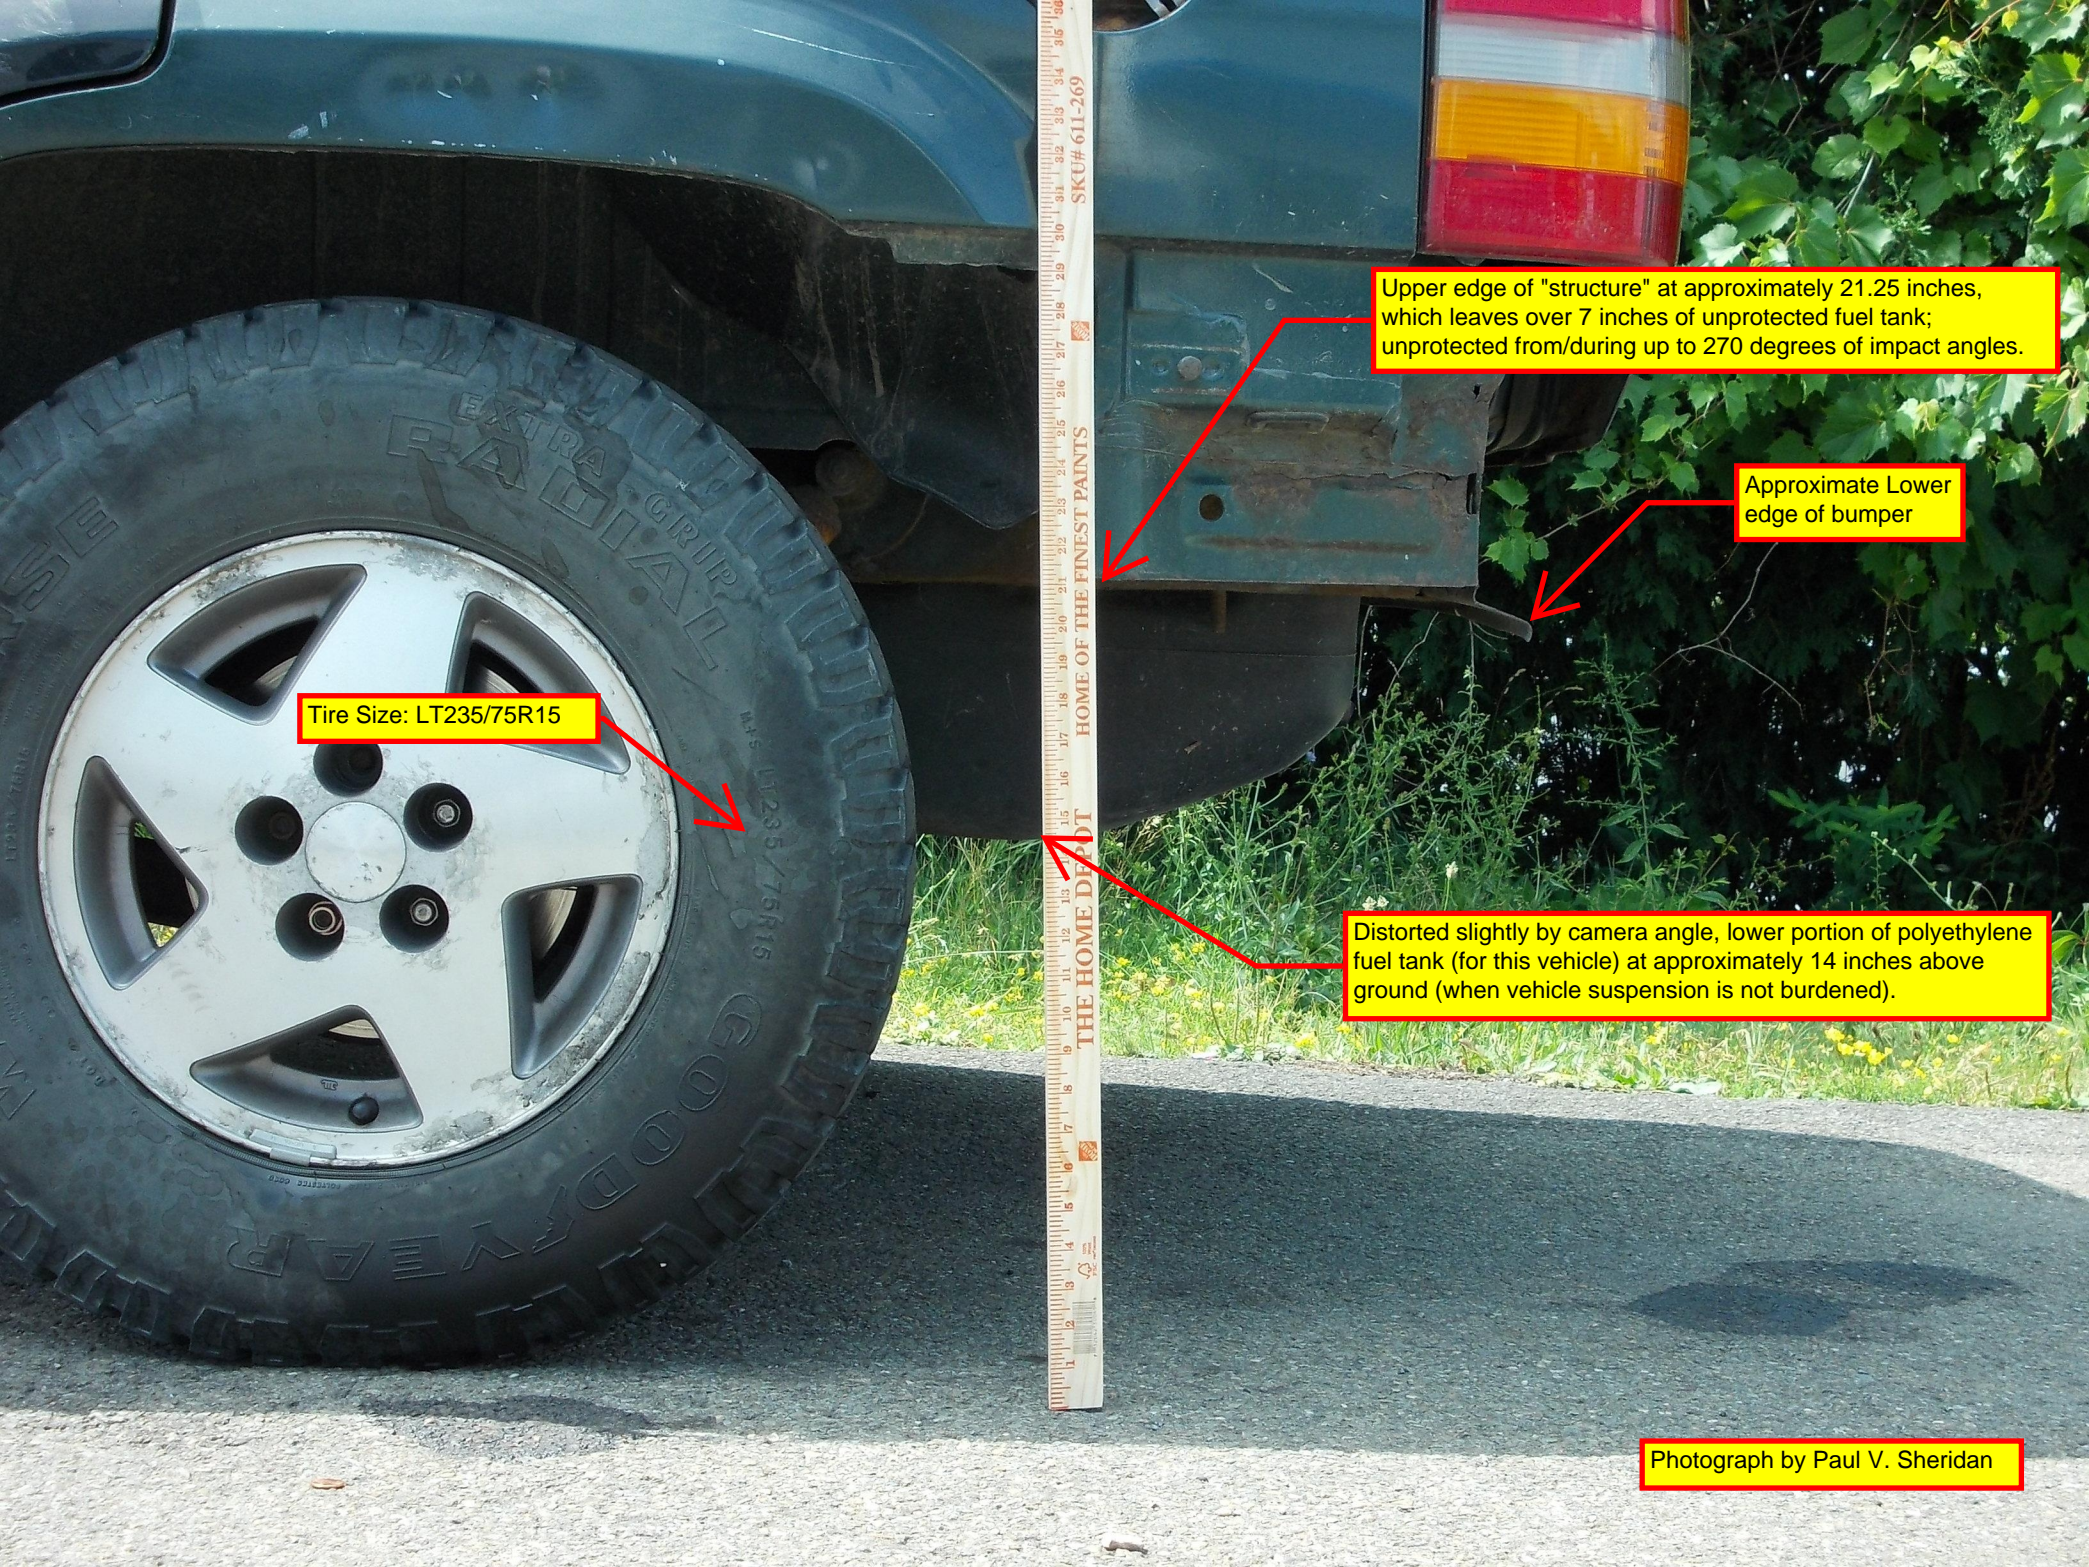
Tire Size: LT235/75R15

Upper edge of "structure" at approximately 21.25 inches, which leaves over 7 inches of unprotected fuel tank; unprotected from/during up to 270 degrees of impact angles.

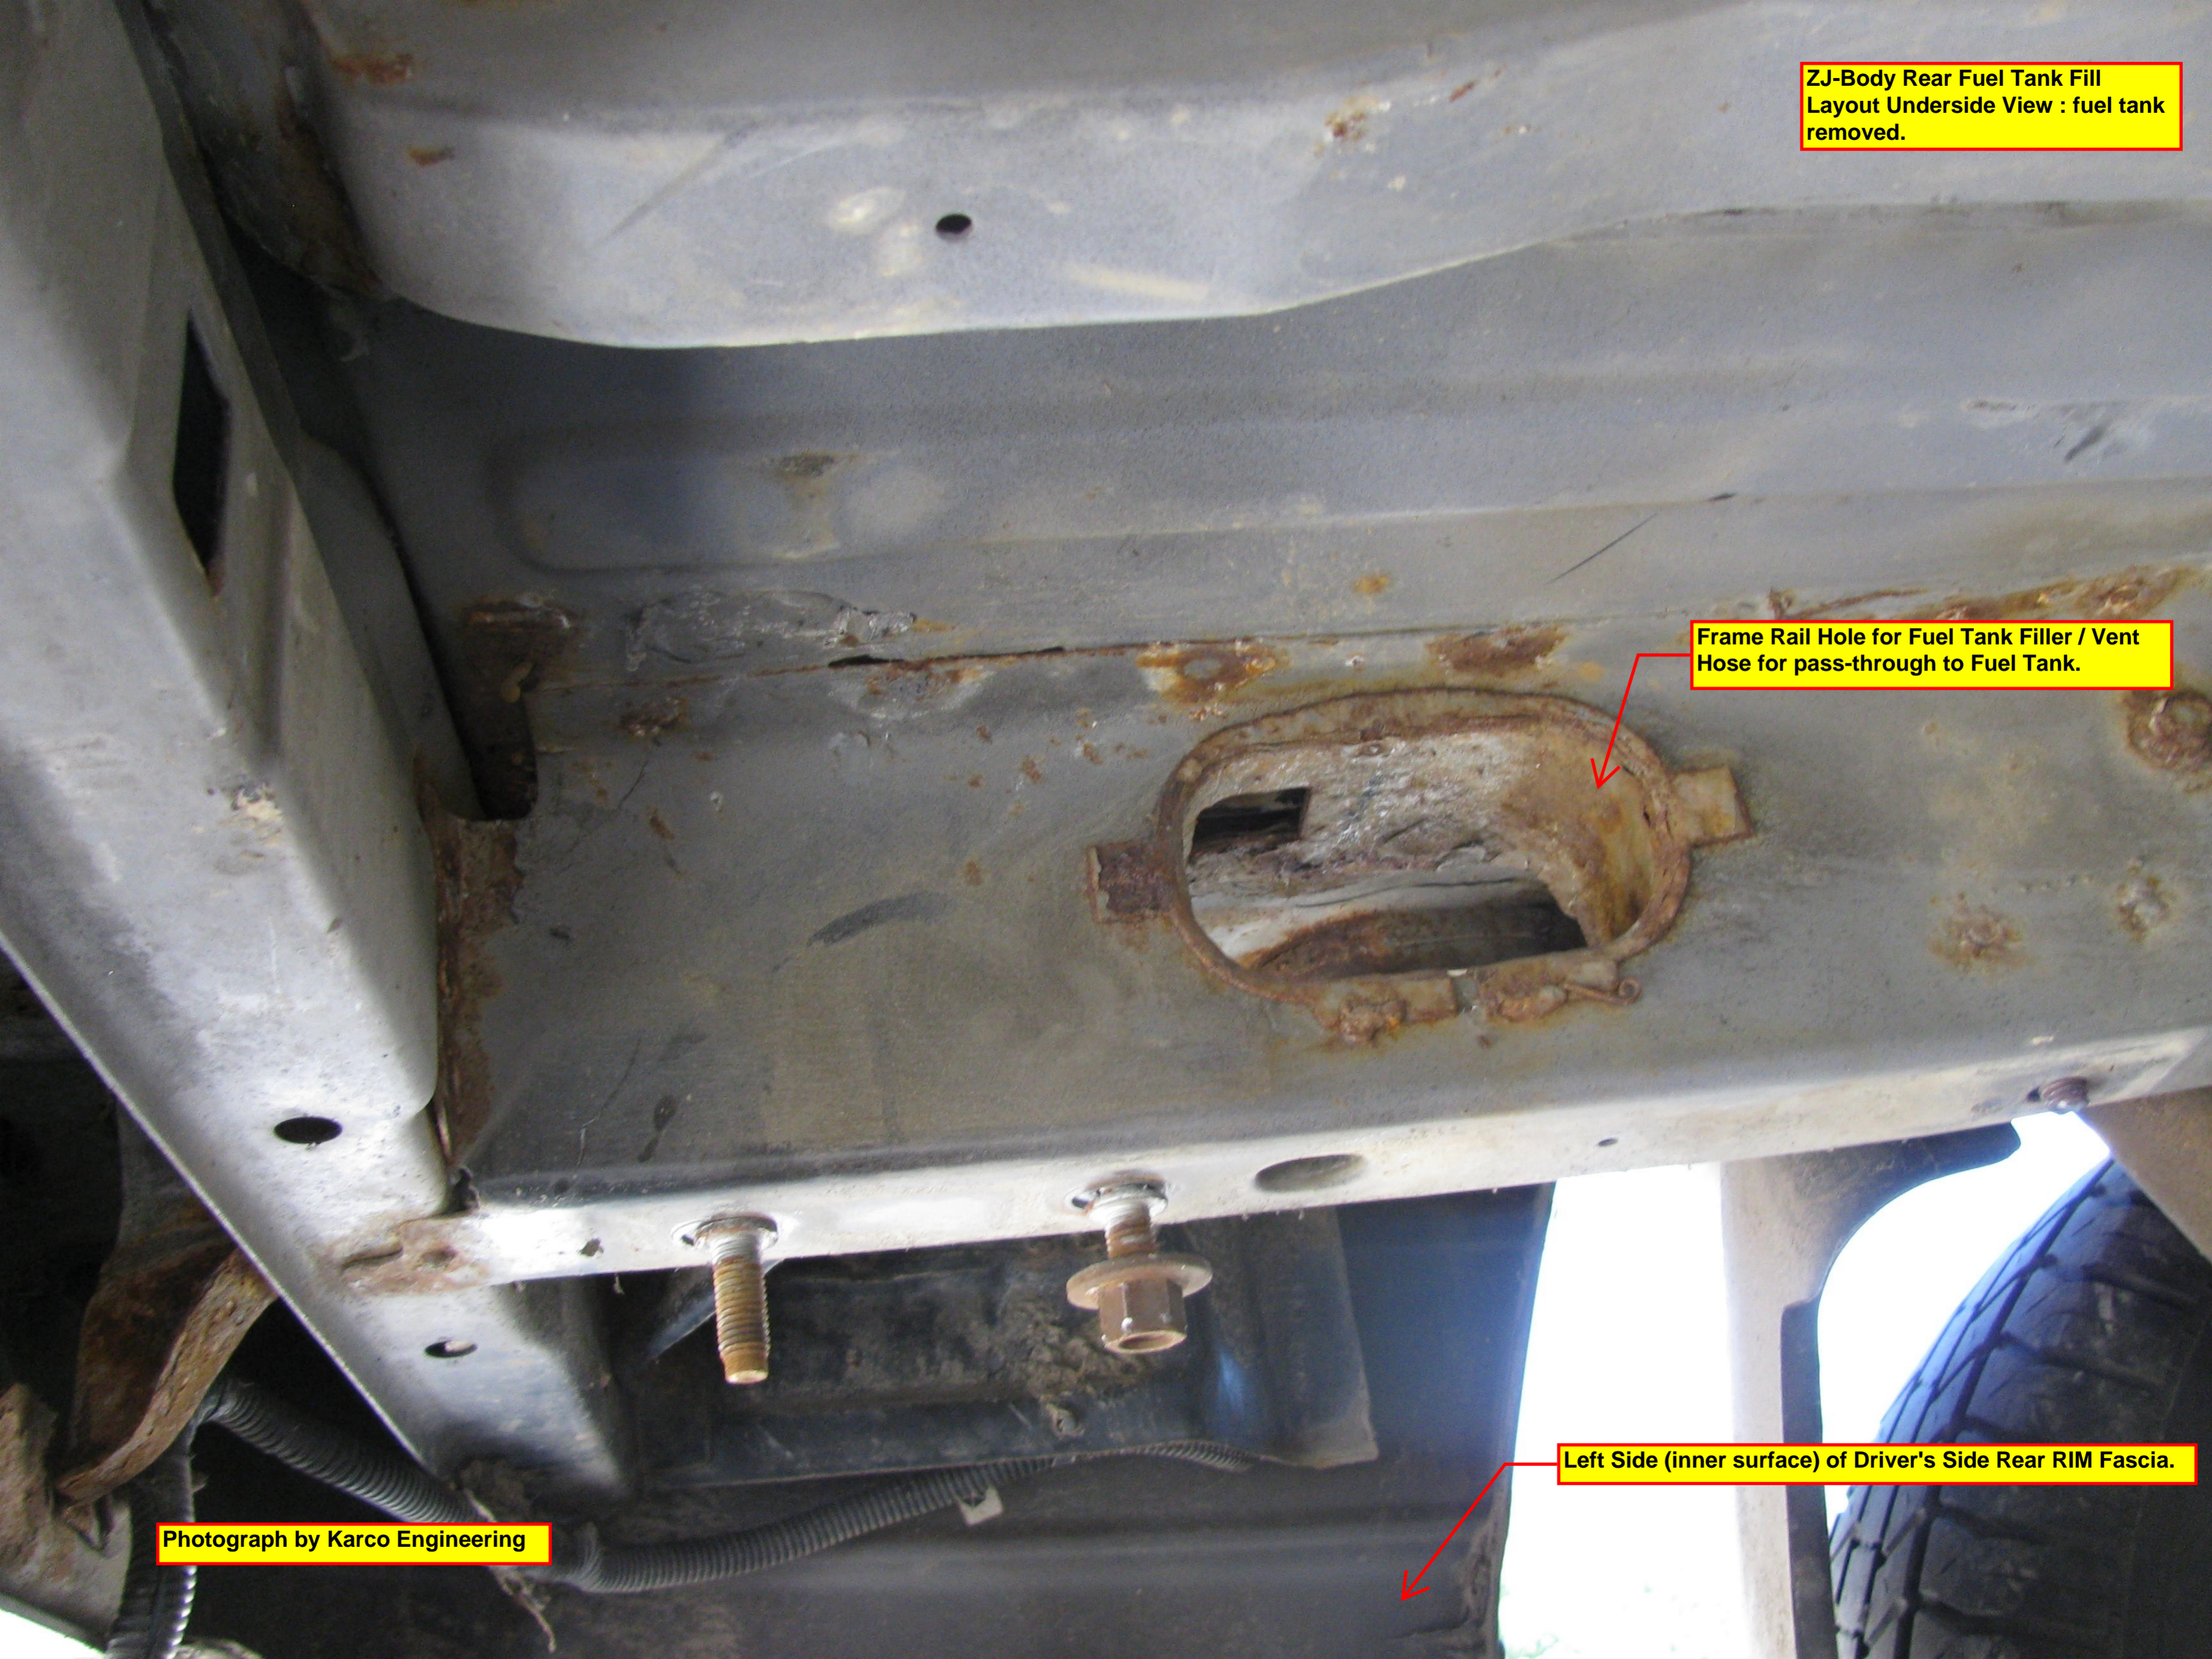
ZJ-Body Rear
Bumper / RIM
Fascia System

Rear RIM Fascia:
Zero protection to
angular impacts.

Rear Bumper: Not IIHS Certified
to Minimal 2.5 MPH (?);
Note lightening holes.

Bumper Bracket: Non-EAU inserted
into Open Frame Rail for Mounting

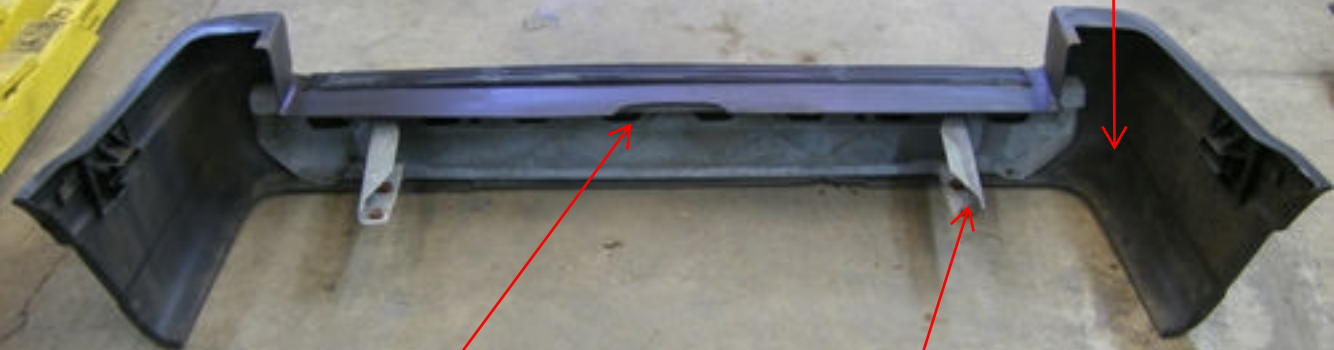
**ZJ-Body Rear "Structure" / Bumper
Fuel Tank Protection Performance
Post Real World 40mph Impact.**

Rear Bumper with lightening holes. High location of lower edge does not provide any direct impact protection for lower 7+ inches of polyethylene fuel tank. RIM Fascia covering exacerbates false impression of crash protection.
