Reference EA12-005

Subject: Chrysler Group LLC Assertions - Karco ZJ-Body Impact Test of 16 May 2011
Reference: EA12-005 File Update (Chrysler Jeep Fuel Tank System Defect)

In April 2011 my expertise was solicited by Mr. Clarence Ditlow, Director for the Washington D.C. based Center for Auto Safety (CAS), regarding a planned real world crash test of a 1996 ZJ-Body Jeep Grand Cherokee fuel system. My role as representative for CAS also included confirmation of test vehicle (Jeep Grand Cherokee) condition as competent, representative and authentic for the stated test purpose(s).

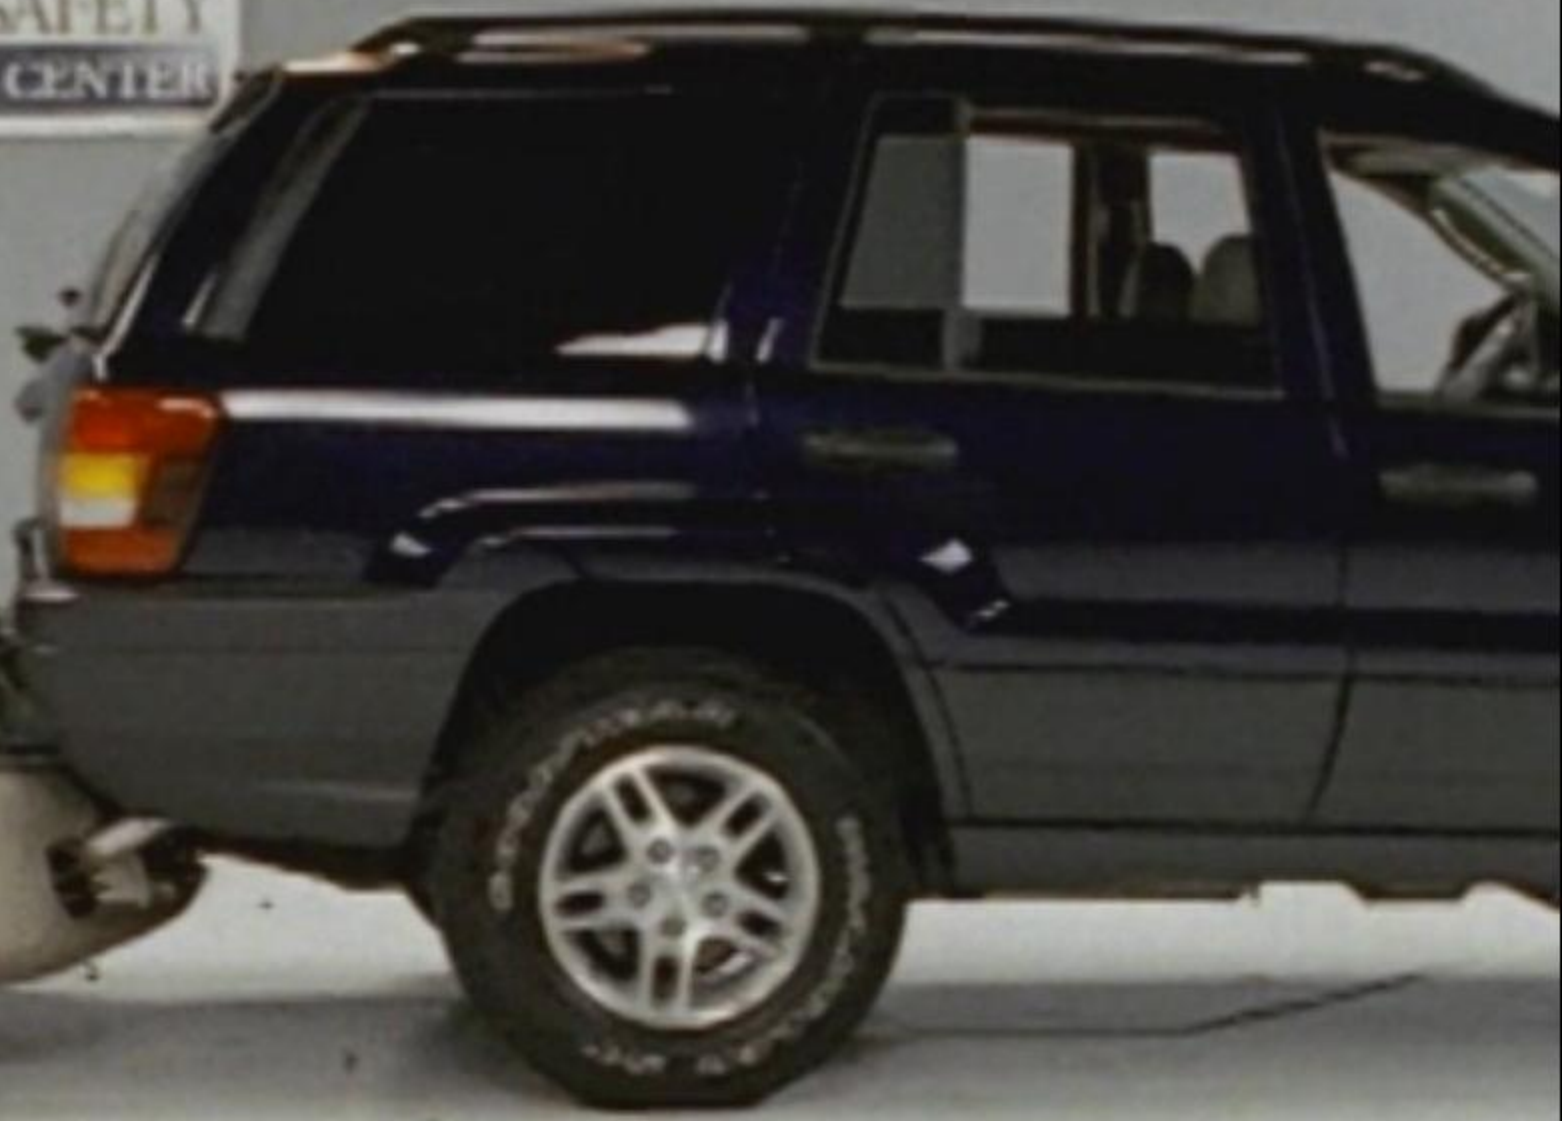
**Underride Mode Caused by
10 mph Bumper Test:
Dodge Stratus into rear of Jeep
Grand Cherokee**

**WJ-Body "Brush Guard"
Damaged, had to be Replaced**

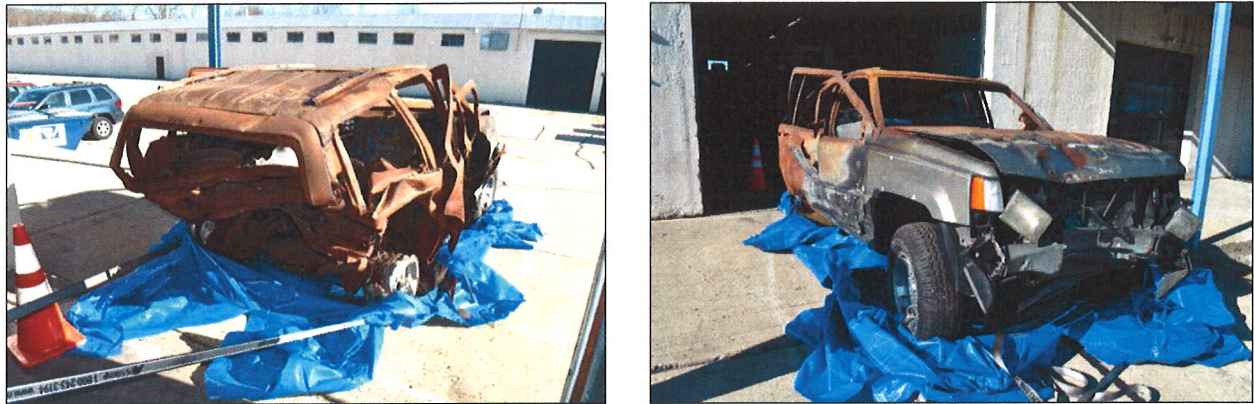
1996 Jeep: The Jeep involved in this crash was a 1996 model year Grand Cherokee Laredo (VIN- 1J4GZ58S9TC401311) equipped with a 4.0-liter 6-cylinder gasoline engine and an automatic transmission. Figure 3 shows the Jeep at the time of our inspection. As can be seen in the figure, the Jeep exhibits signs of impact damage to both the front and rear of the vehicle as well as fire damage.

Kineticcorp determined that the maximum static crush to the rear of the Jeep was approximately 37 inches. The forces of the collision caused the rear axle of the Jeep to move forward.
