Date: 3 September 2012

VIA FEDEX AIRBILL 8007 – 9341 - 5860

**Subject: Chrysler Group LLC Assertions - Karco ZJ-Body Impact Test of 16 May 2011**  
**Reference: EA12-005 File Update (Chrysler Jeep Fuel Tank System Defect)**

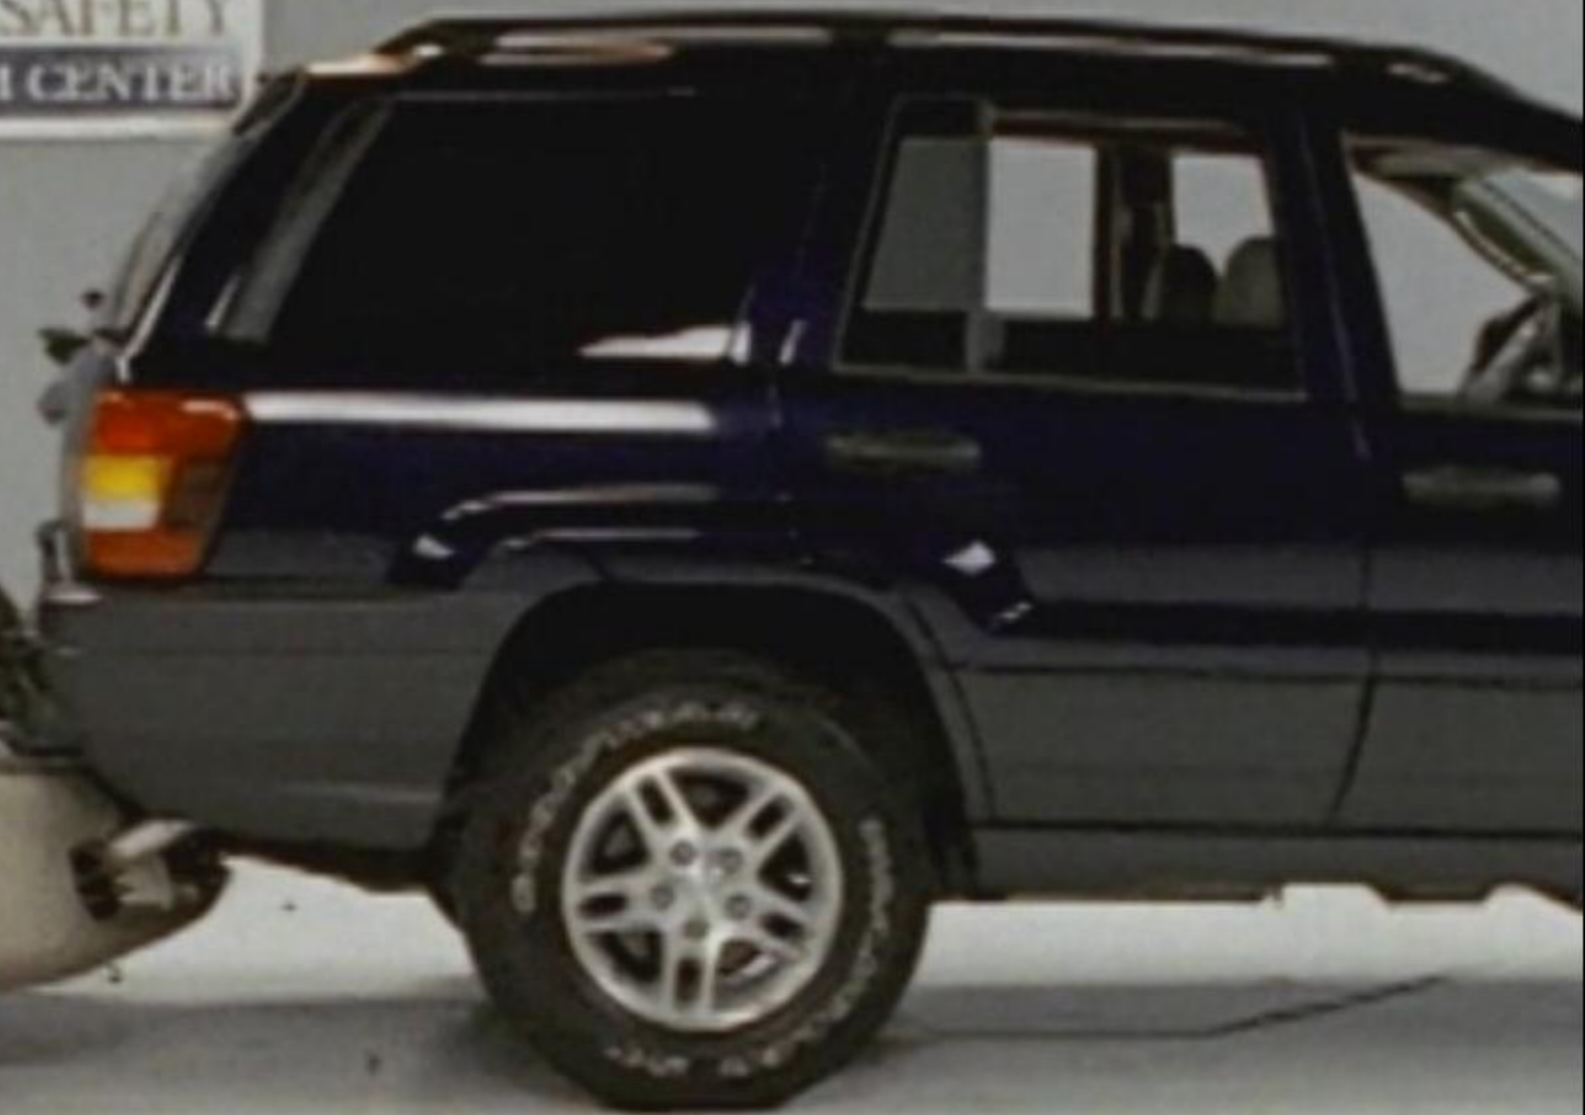
**Underride Mode Caused by  
10 mph Bumper Test:  
Dodge Stratus into rear of Jeep  
Grand Cherokee**

**WJ-Body "Brush Guard"  
Damaged, had to be Replaced**

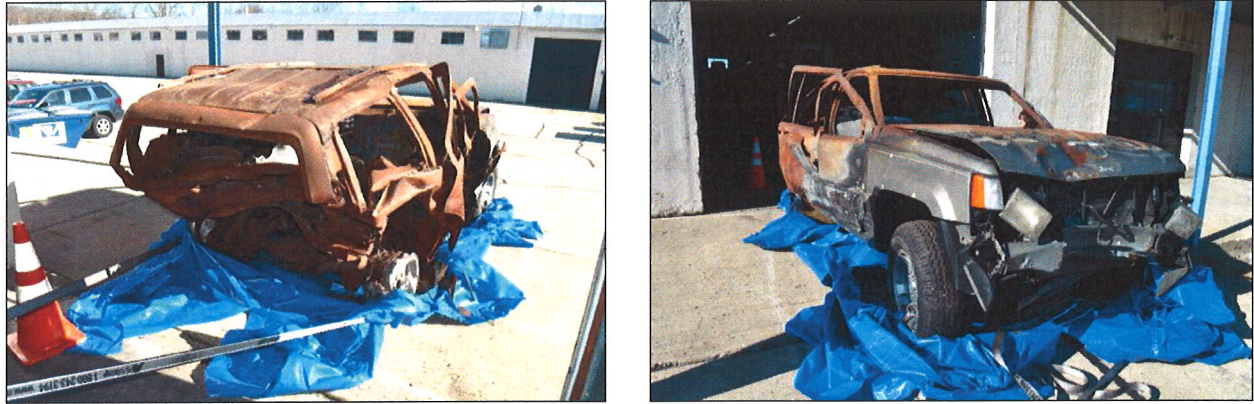
1996 Jeep: The Jeep involved in this crash was a 1996 model year Grand Cherokee Laredo (VIN- 1J4GZ58S9TC401311) equipped with a 4.0-liter 6-cylinder gasoline engine and an automatic transmission. Figure 3 shows the Jeep at the time of our inspection. As can be seen in the figure, the Jeep exhibits signs of impact damage to both the front and rear of the vehicle as well as fire damage.

Kineticcorp determined that the maximum static crush to the rear of the Jeep was approximately 37 inches. The forces of the collision caused the rear axle of the Jeep to move forward.

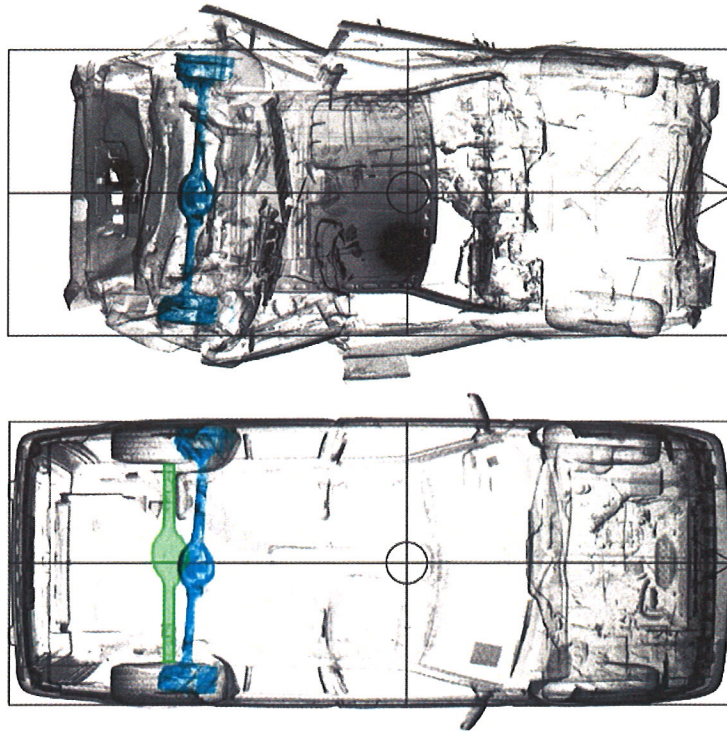
The top image in Figure 12 depicts the damage to the Jeep, as documented with our three-dimensional scan. The rear axle is highlighted in blue in Figure 12. The bottom image of Figure 12 depicts the relative movement of the rear axle compared to its original undamaged position. The axle would have moved further forward dynamically during the crash.

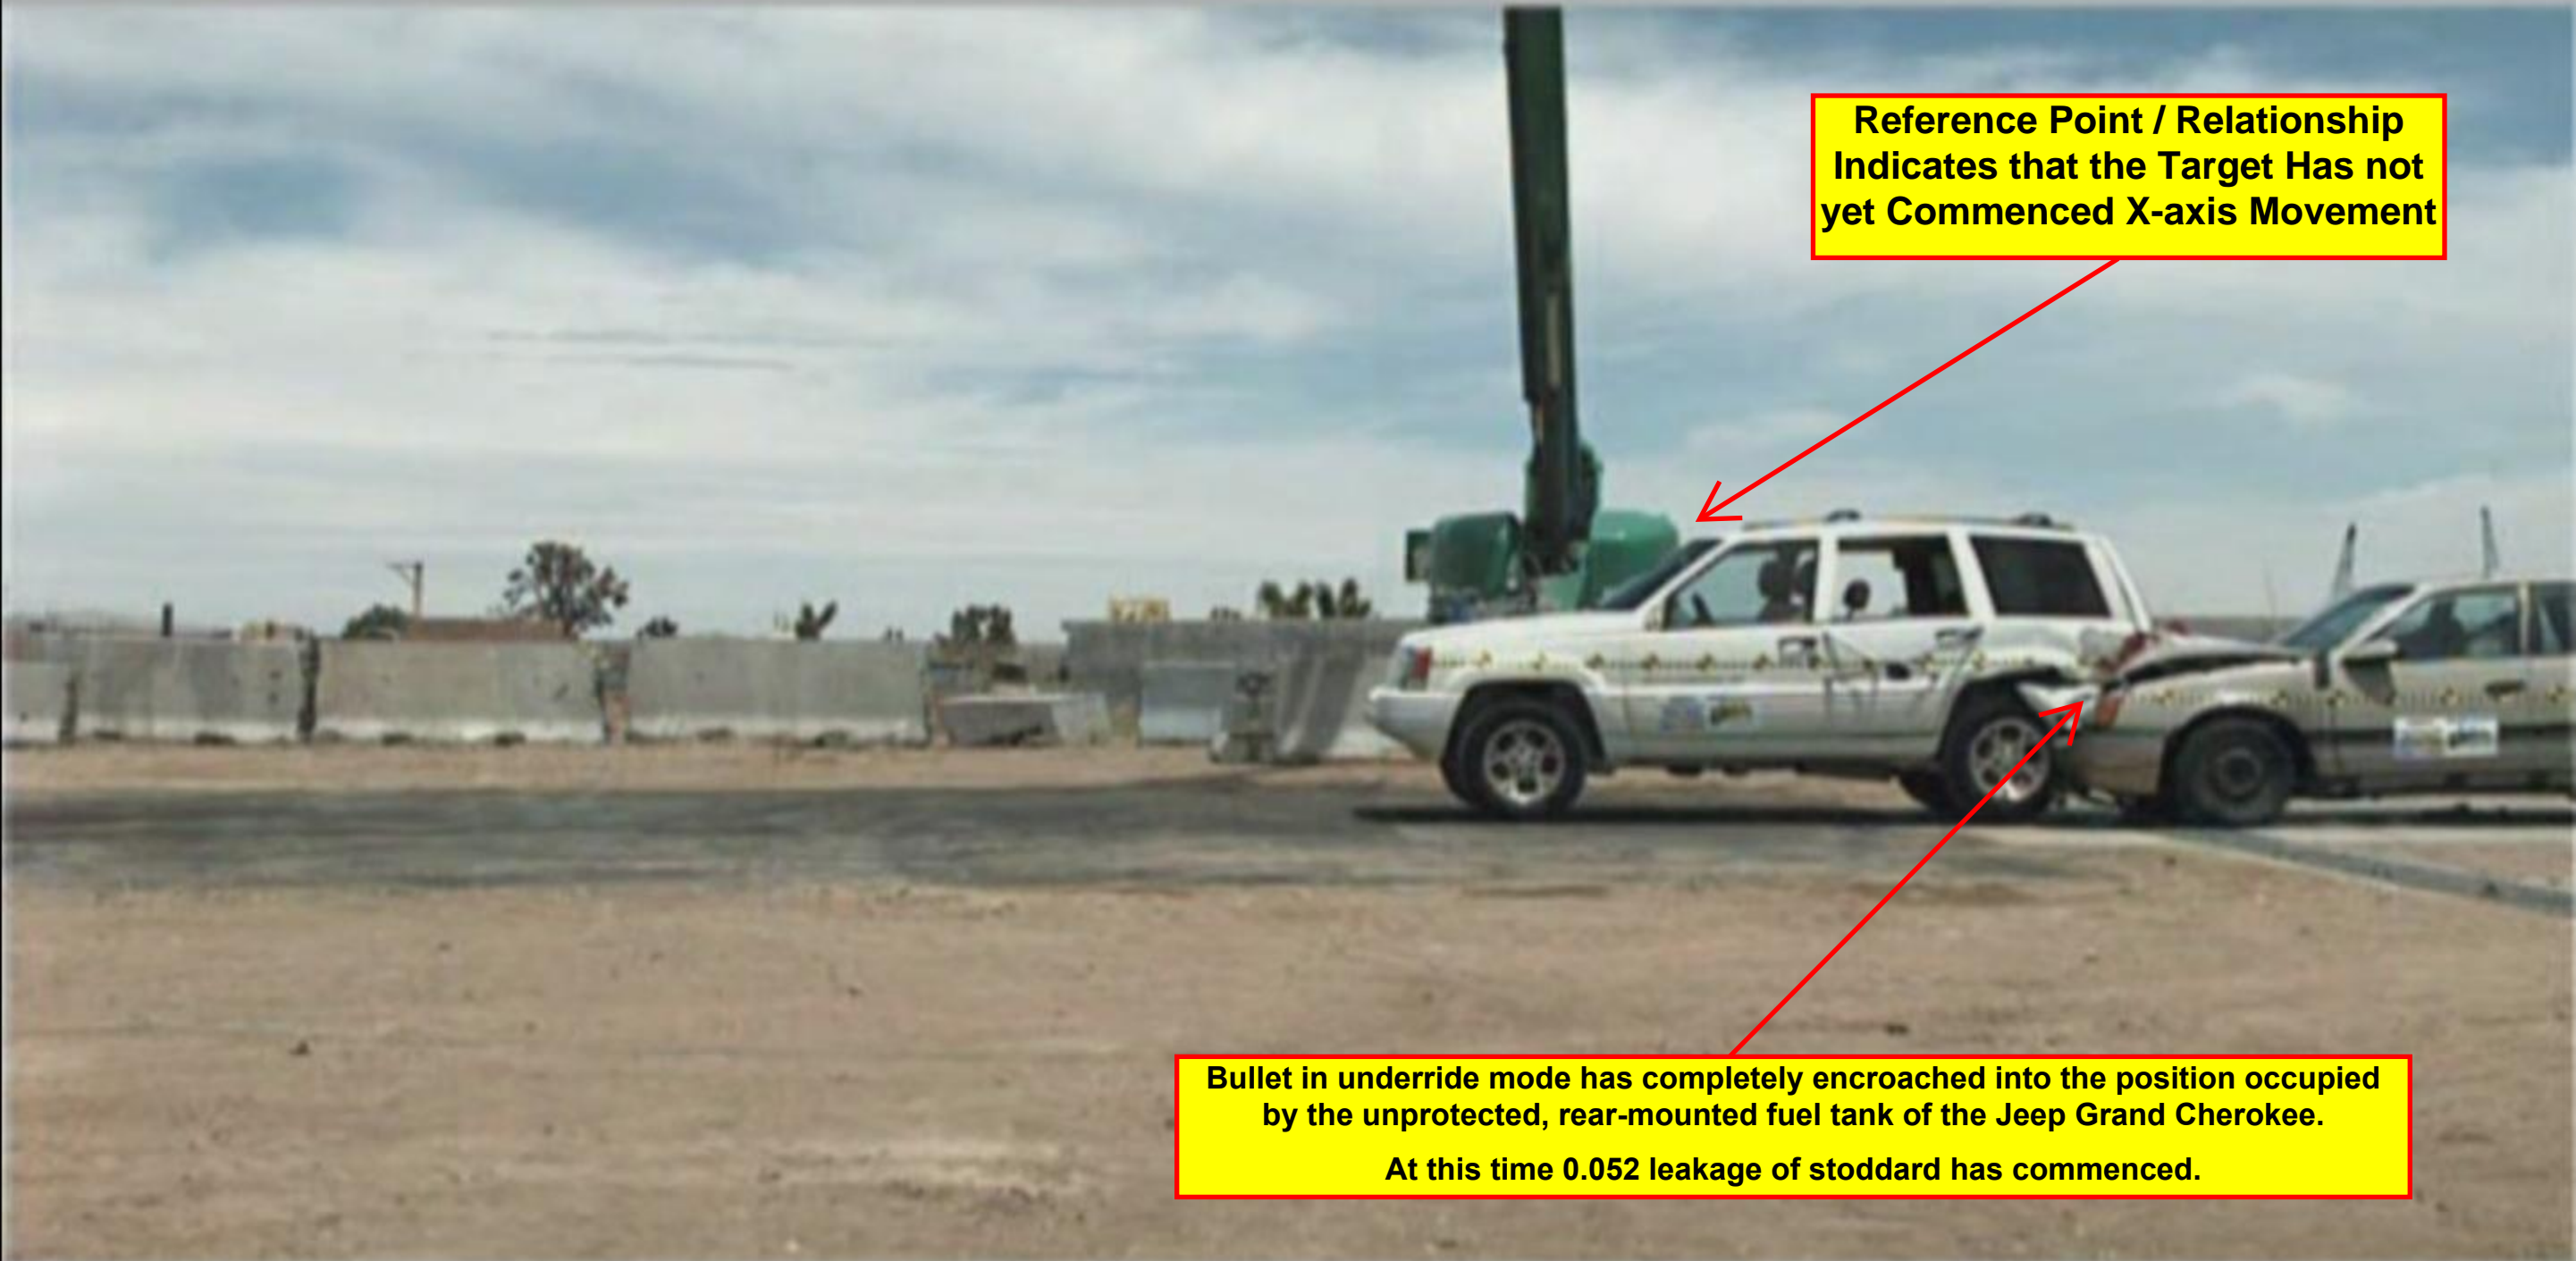
# Camera View-01

**Bullet in underride mode has completely encroached into the position occupied  
by the unprotected, rear-mounted fuel tank of the Jeep Grand Cherokee.  
At this time 0.052 leakage of stoddard has commenced.**

Stoddard Leakage Due to Fuel  
Tank Breach Not Yet Visible

T = 0.052 Represents Maximum Deceleration and Acceleration of Bullet and Target Vehicles Respectively. However, Target Vehicle Movement in X-axis direction has not yet commenced.

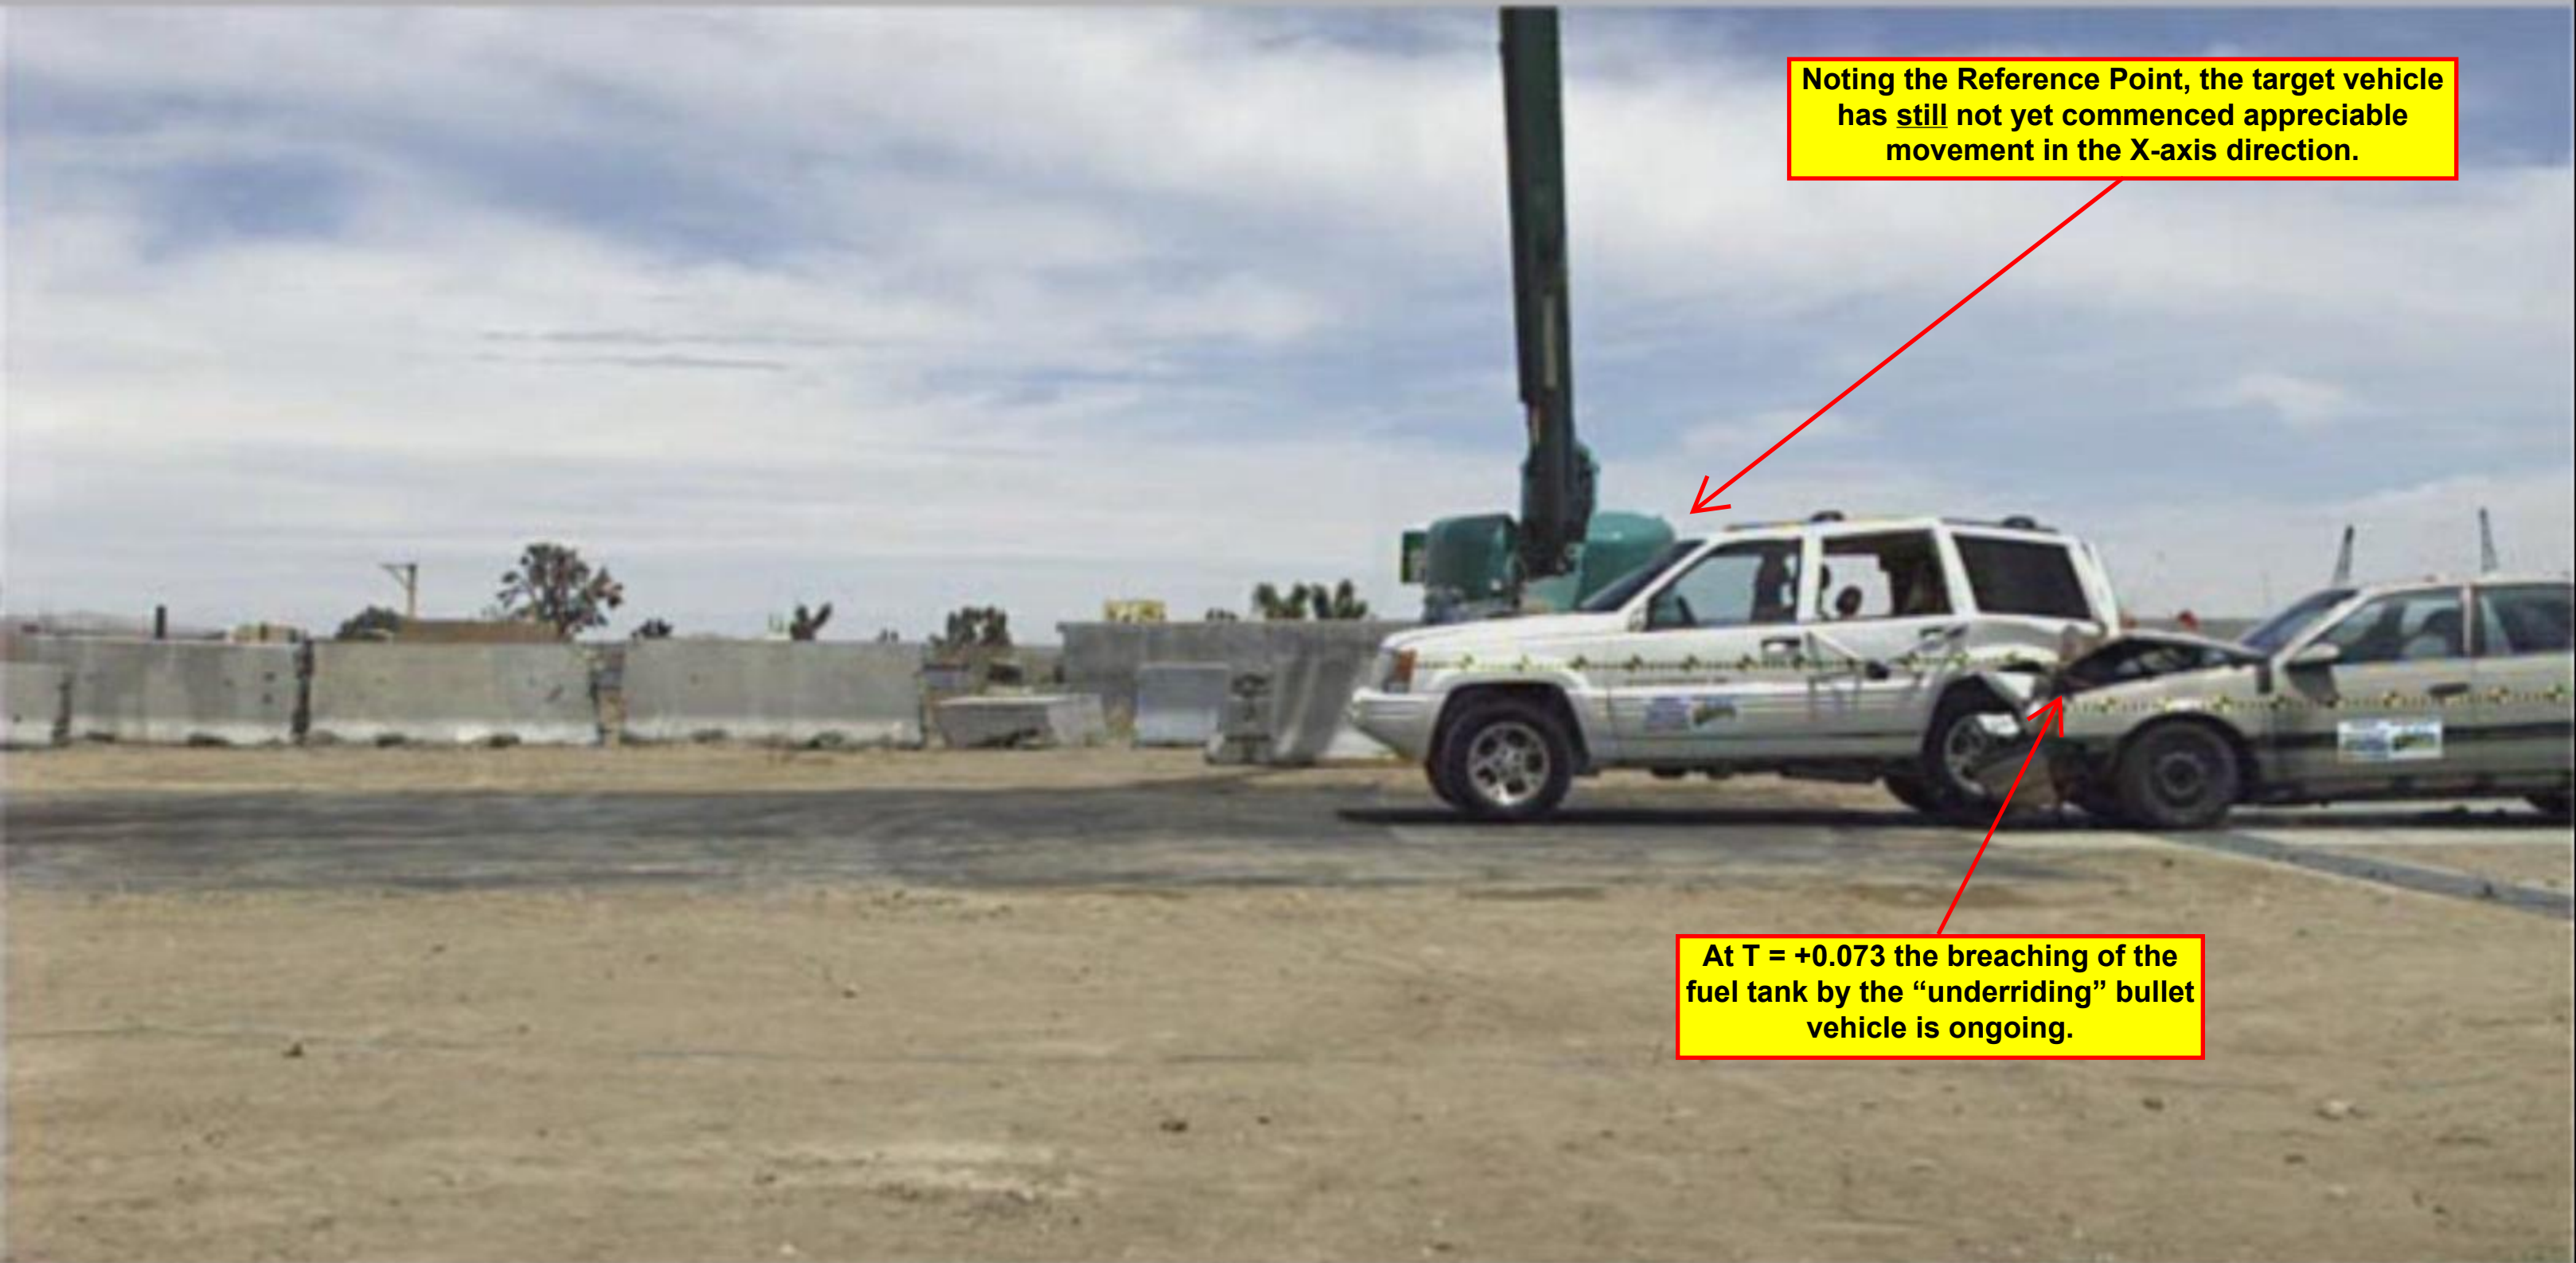
# Camera View-01

At  $T = +0.073$  the breaching of the fuel tank by the “underriding” bullet vehicle is ongoing.

At T = +0.073 Bodyside and Door Frame Deformation has Occurred.  
All four ZJ-Body Doors are Jammed,  
Occupant Egress is Near Impossible.

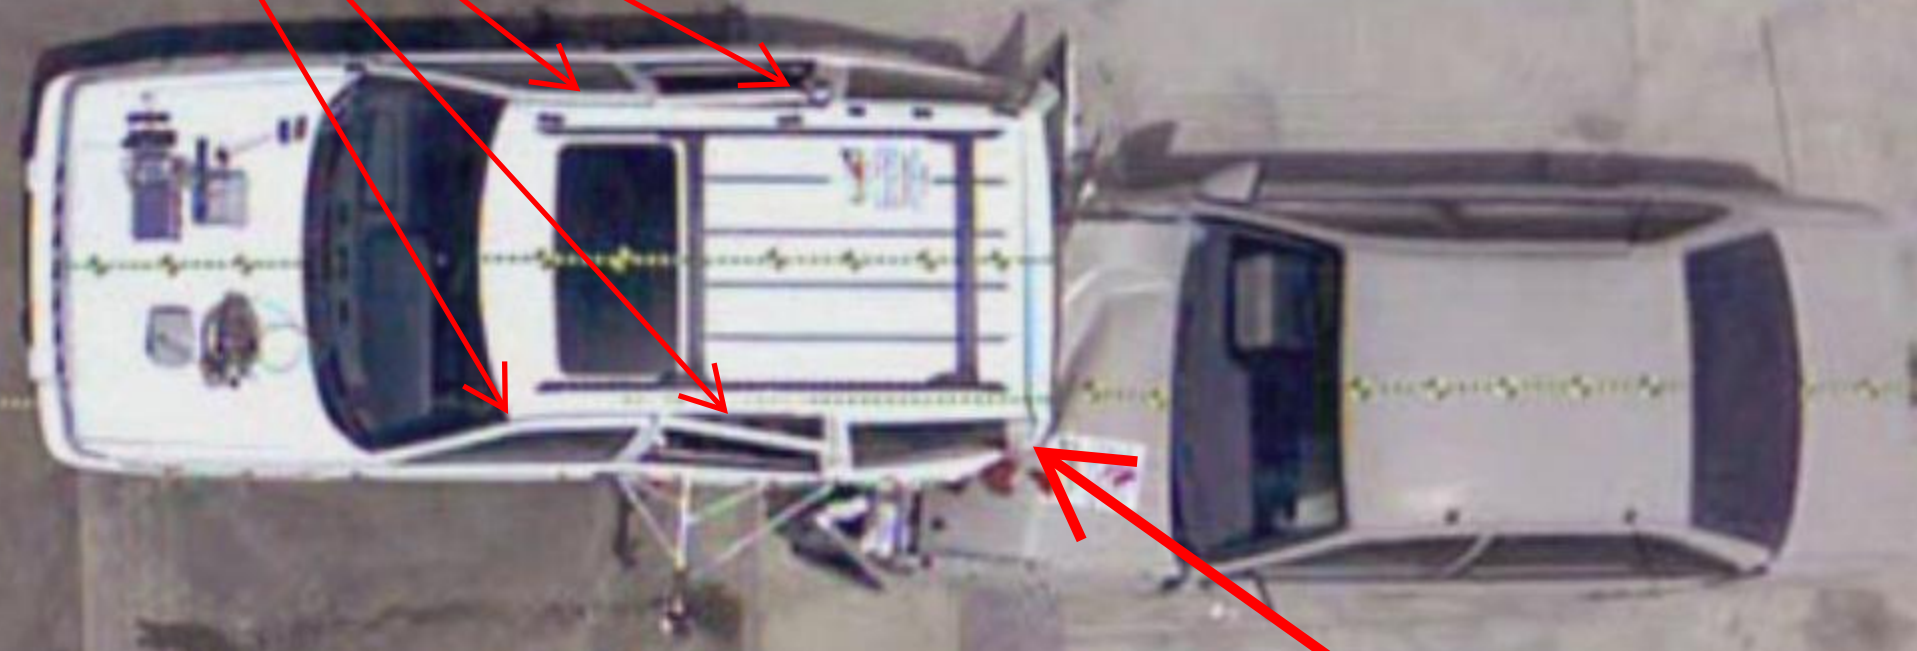
Ongoing Underride of Bullet Vehicle into Jeep Grand Cherokee has produced catastrophic Breaching of the Unprotected Fuel Tank

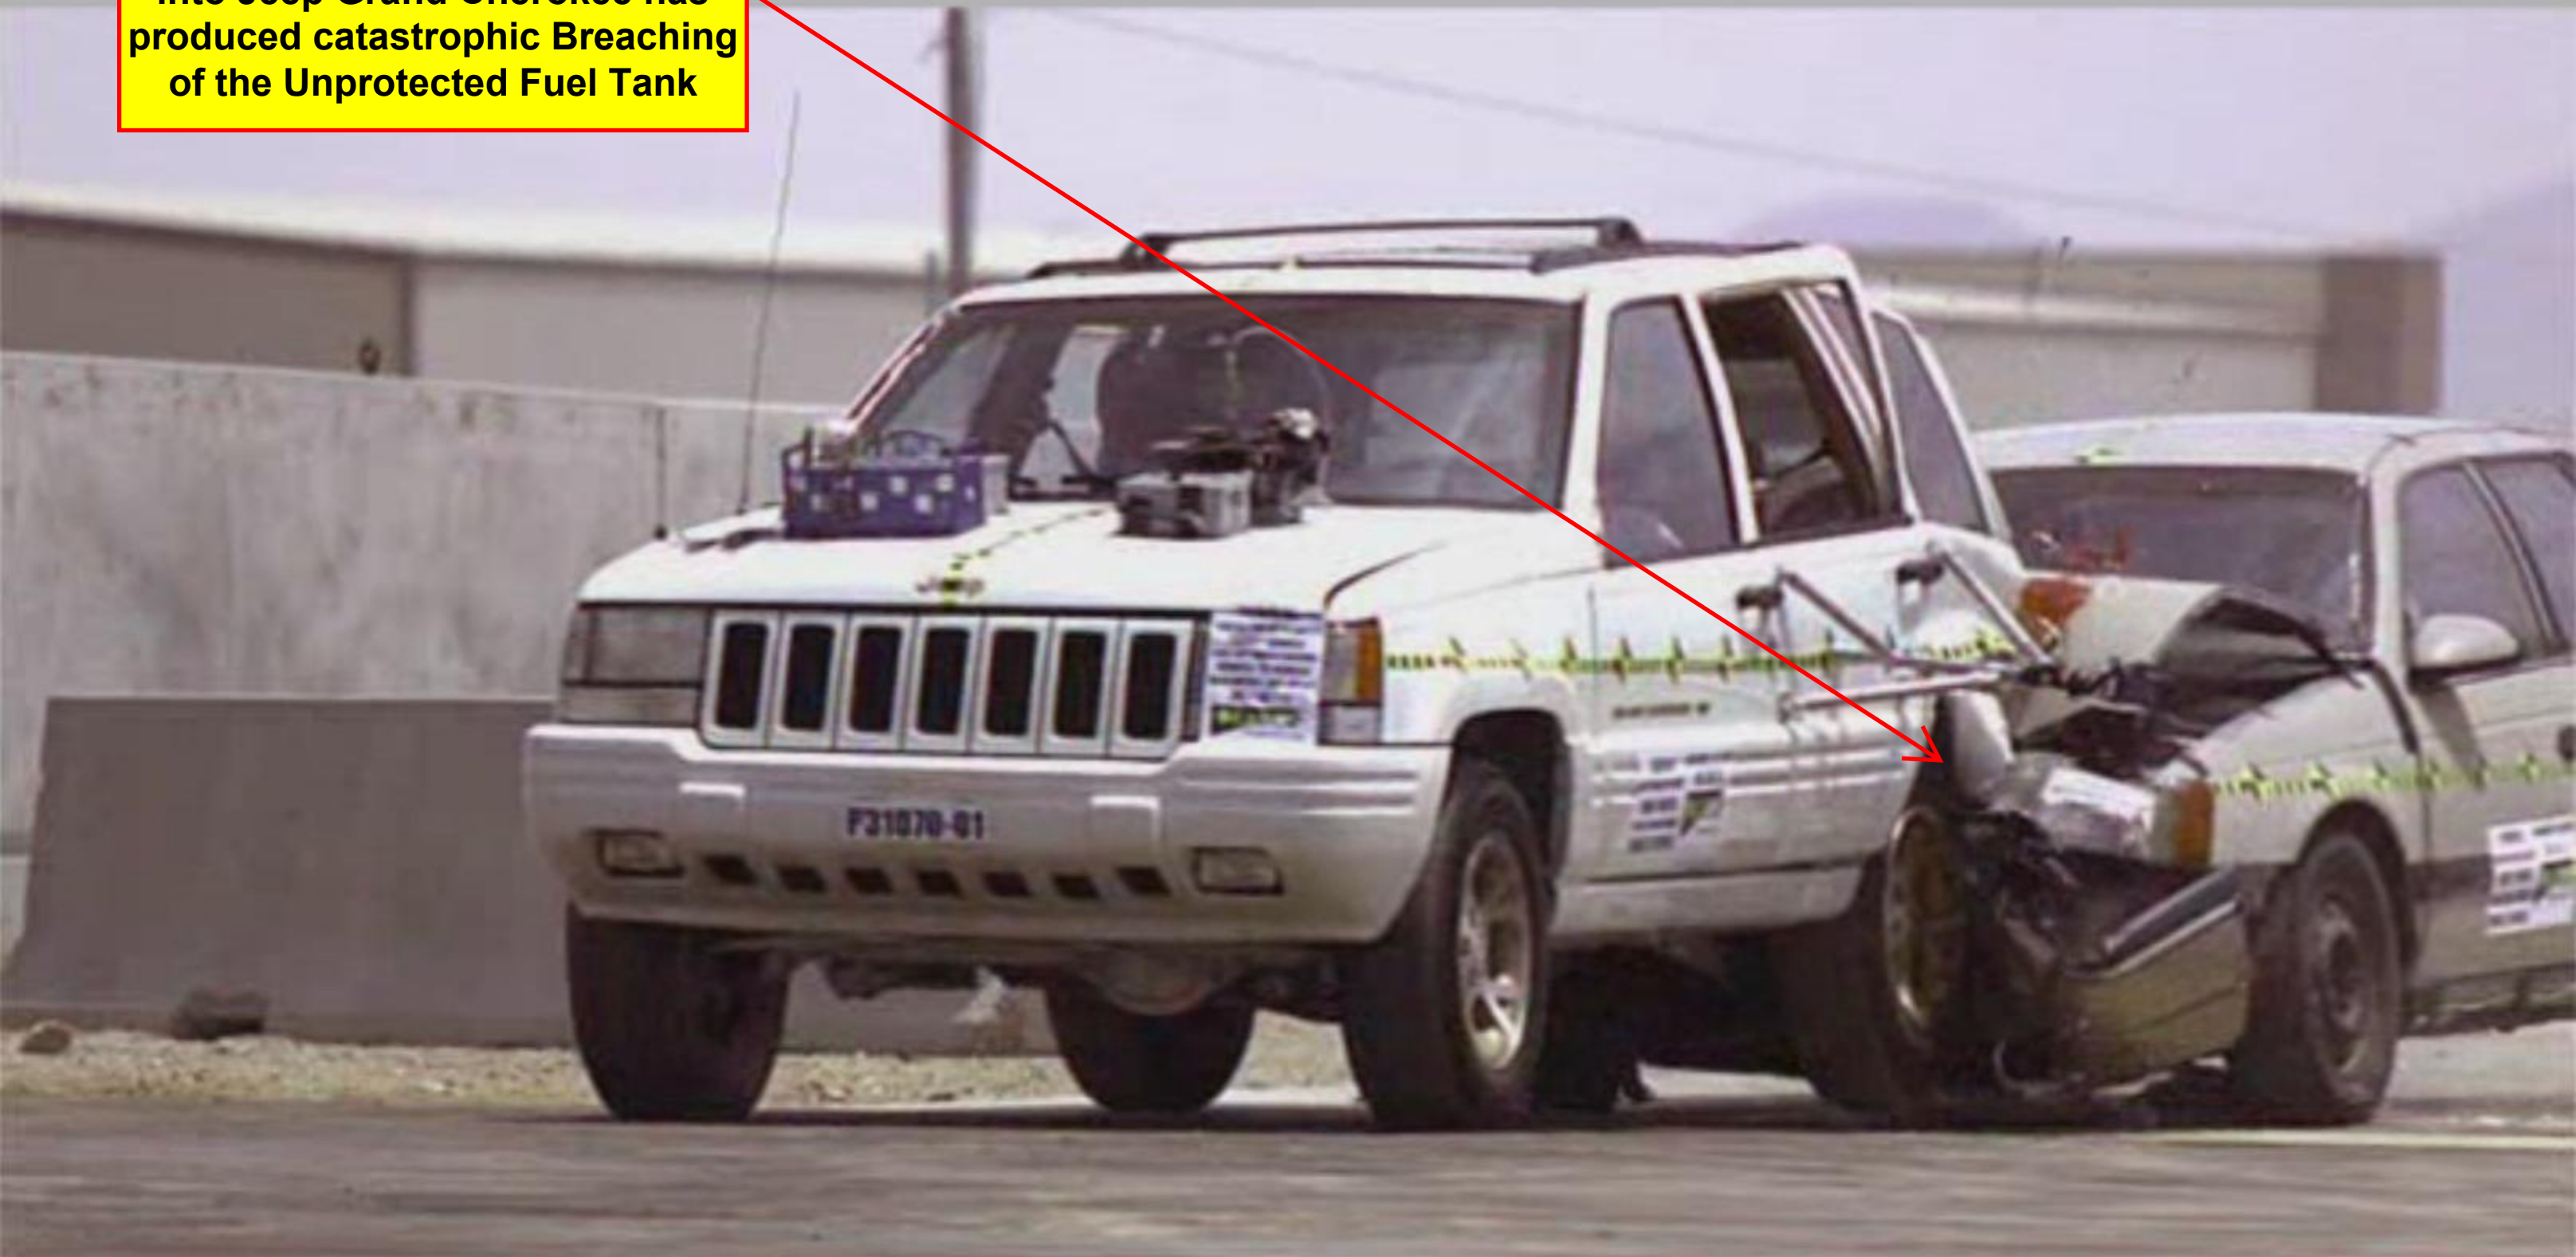
Even in this Low Speed Impact Test, Underride of Bullet Vehicle into Jeep Grand Cherokee has produced catastrophic Breaching of the Unprotected Fuel Tank

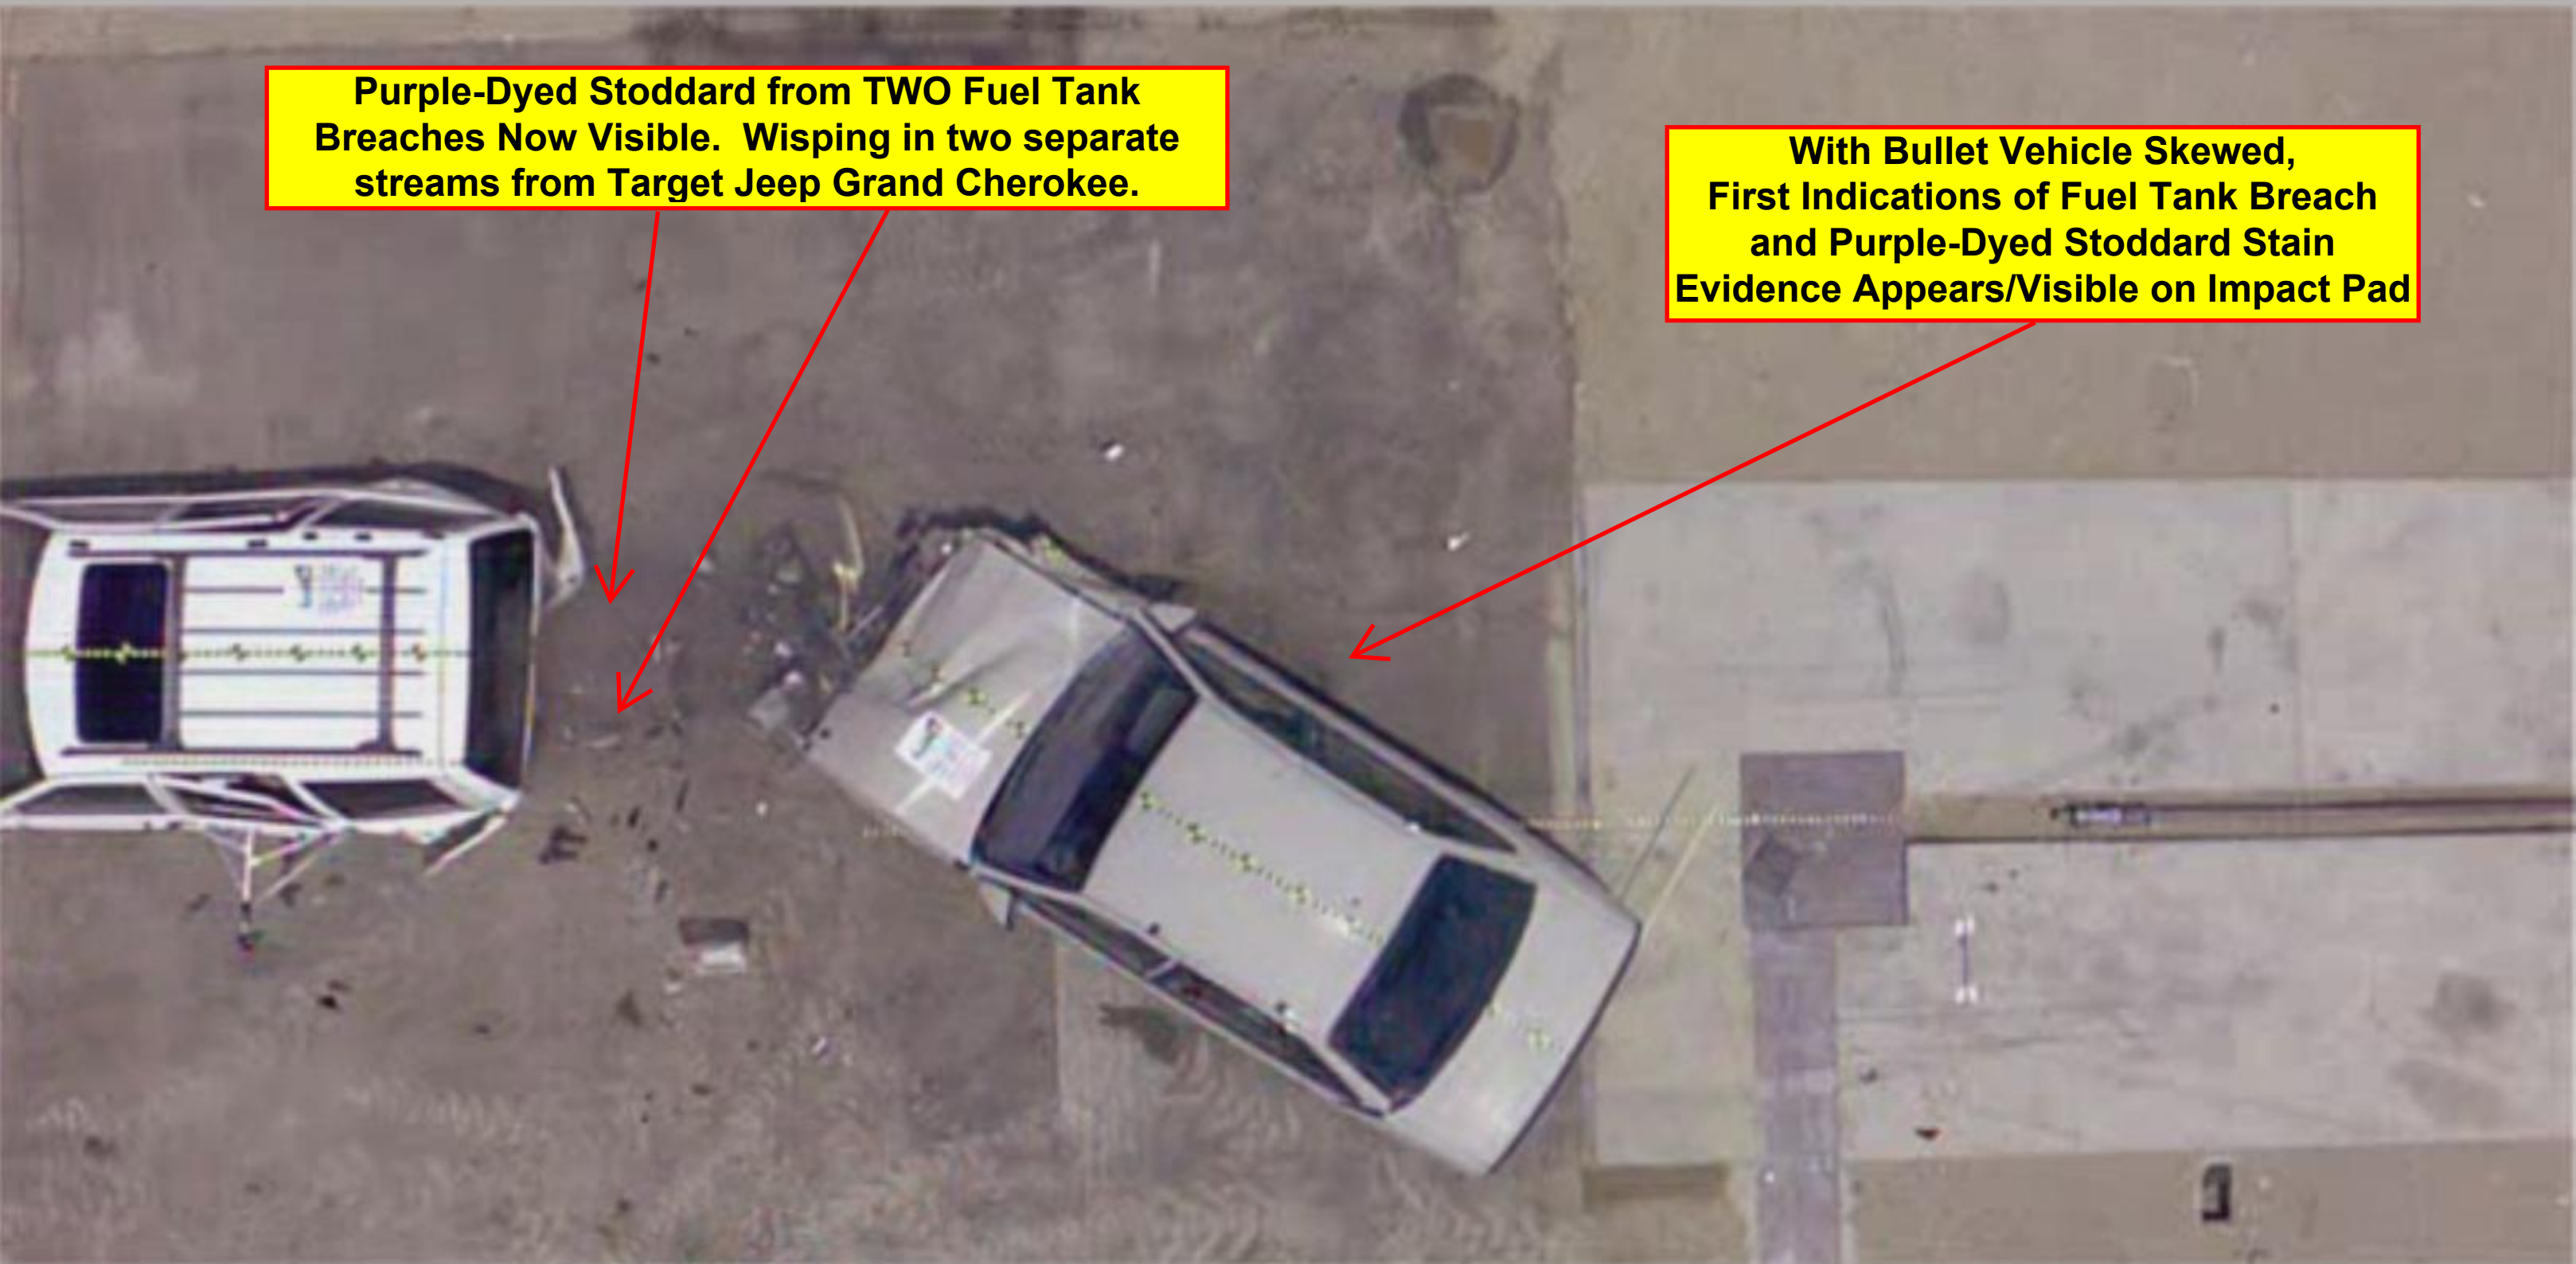
With Bullet Vehicle Skewed, First Indications of Fuel Tank Breach and Purple-Dyed Stoddard Stain Evidence Appears/Visible on Impact Pad

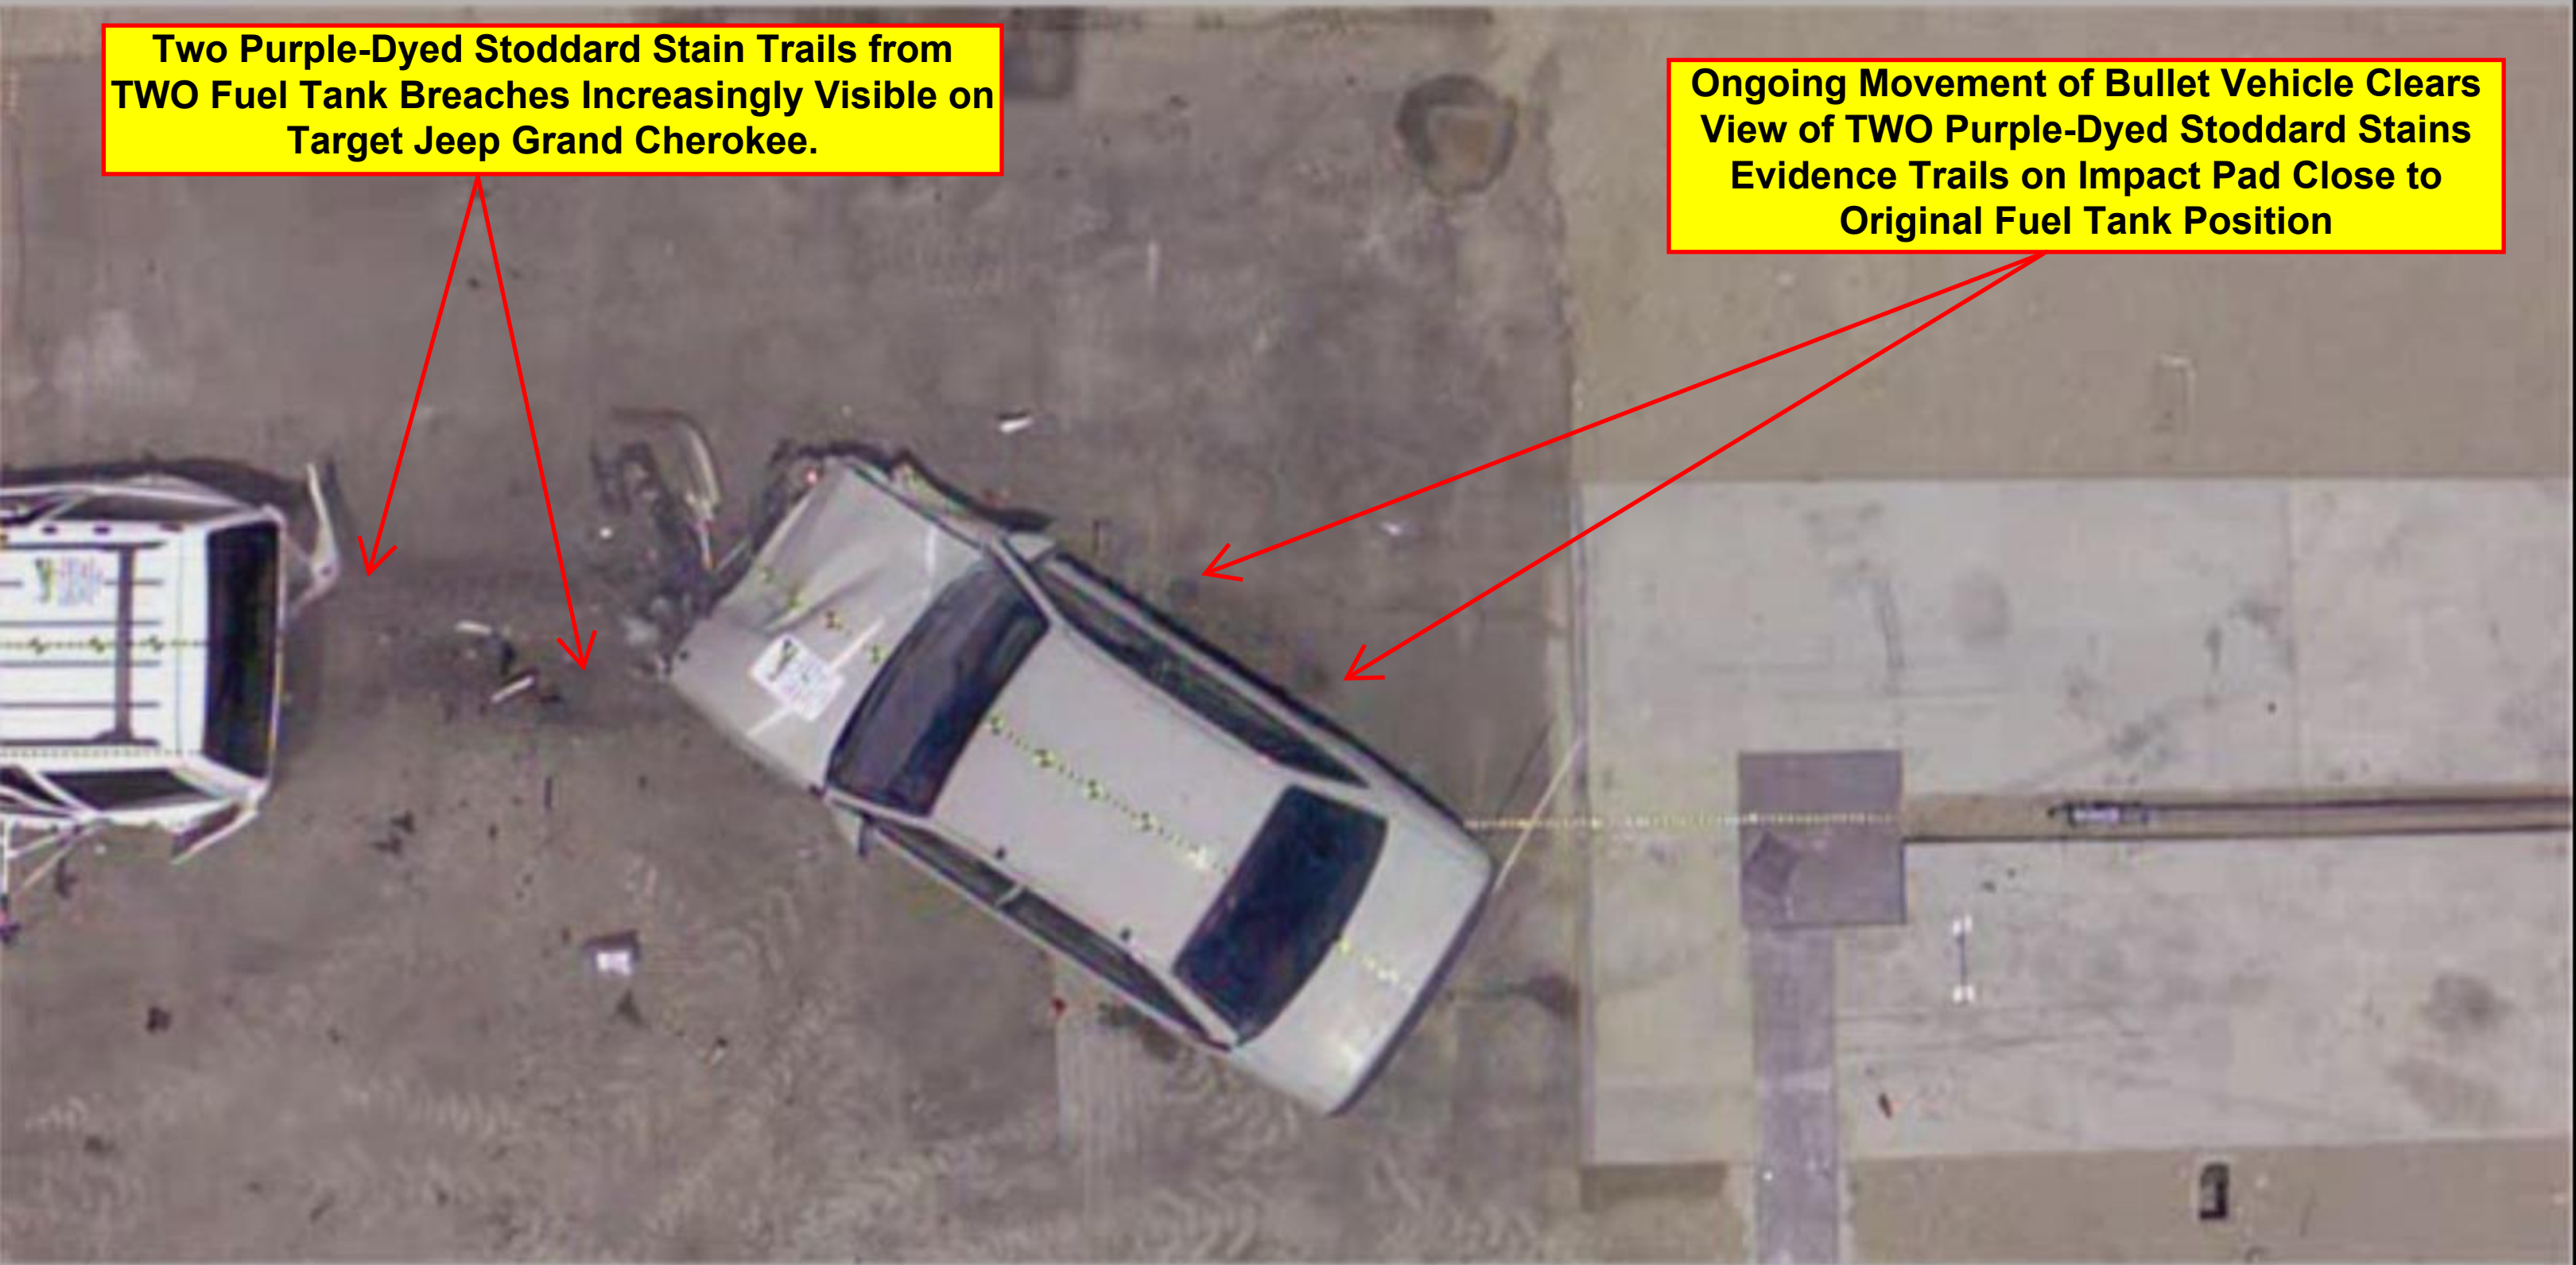
- At T = +1.000 (one second after impact) not one, but TWO fuel tank breaches are evidenced by the purple-dye staining of the impact pad and asphalt run-off areas.

Ongoing Movement of Bullet Vehicle Clears View of TWO Purple-Dyed Stoddard Stains Evidence Trails on Impact Pad Close to Original Fuel Tank Position
