Date: 3 September 2012

VIA FEDEX AIRBILL 8007 – 9341 - 5860

**Subject: Chrysler Group LLC Assertions - Karco ZJ-Body Impact Test of 16 May 2011**  
**Reference: EA12-005 File Update (Chrysler Jeep Fuel Tank System Defect)**

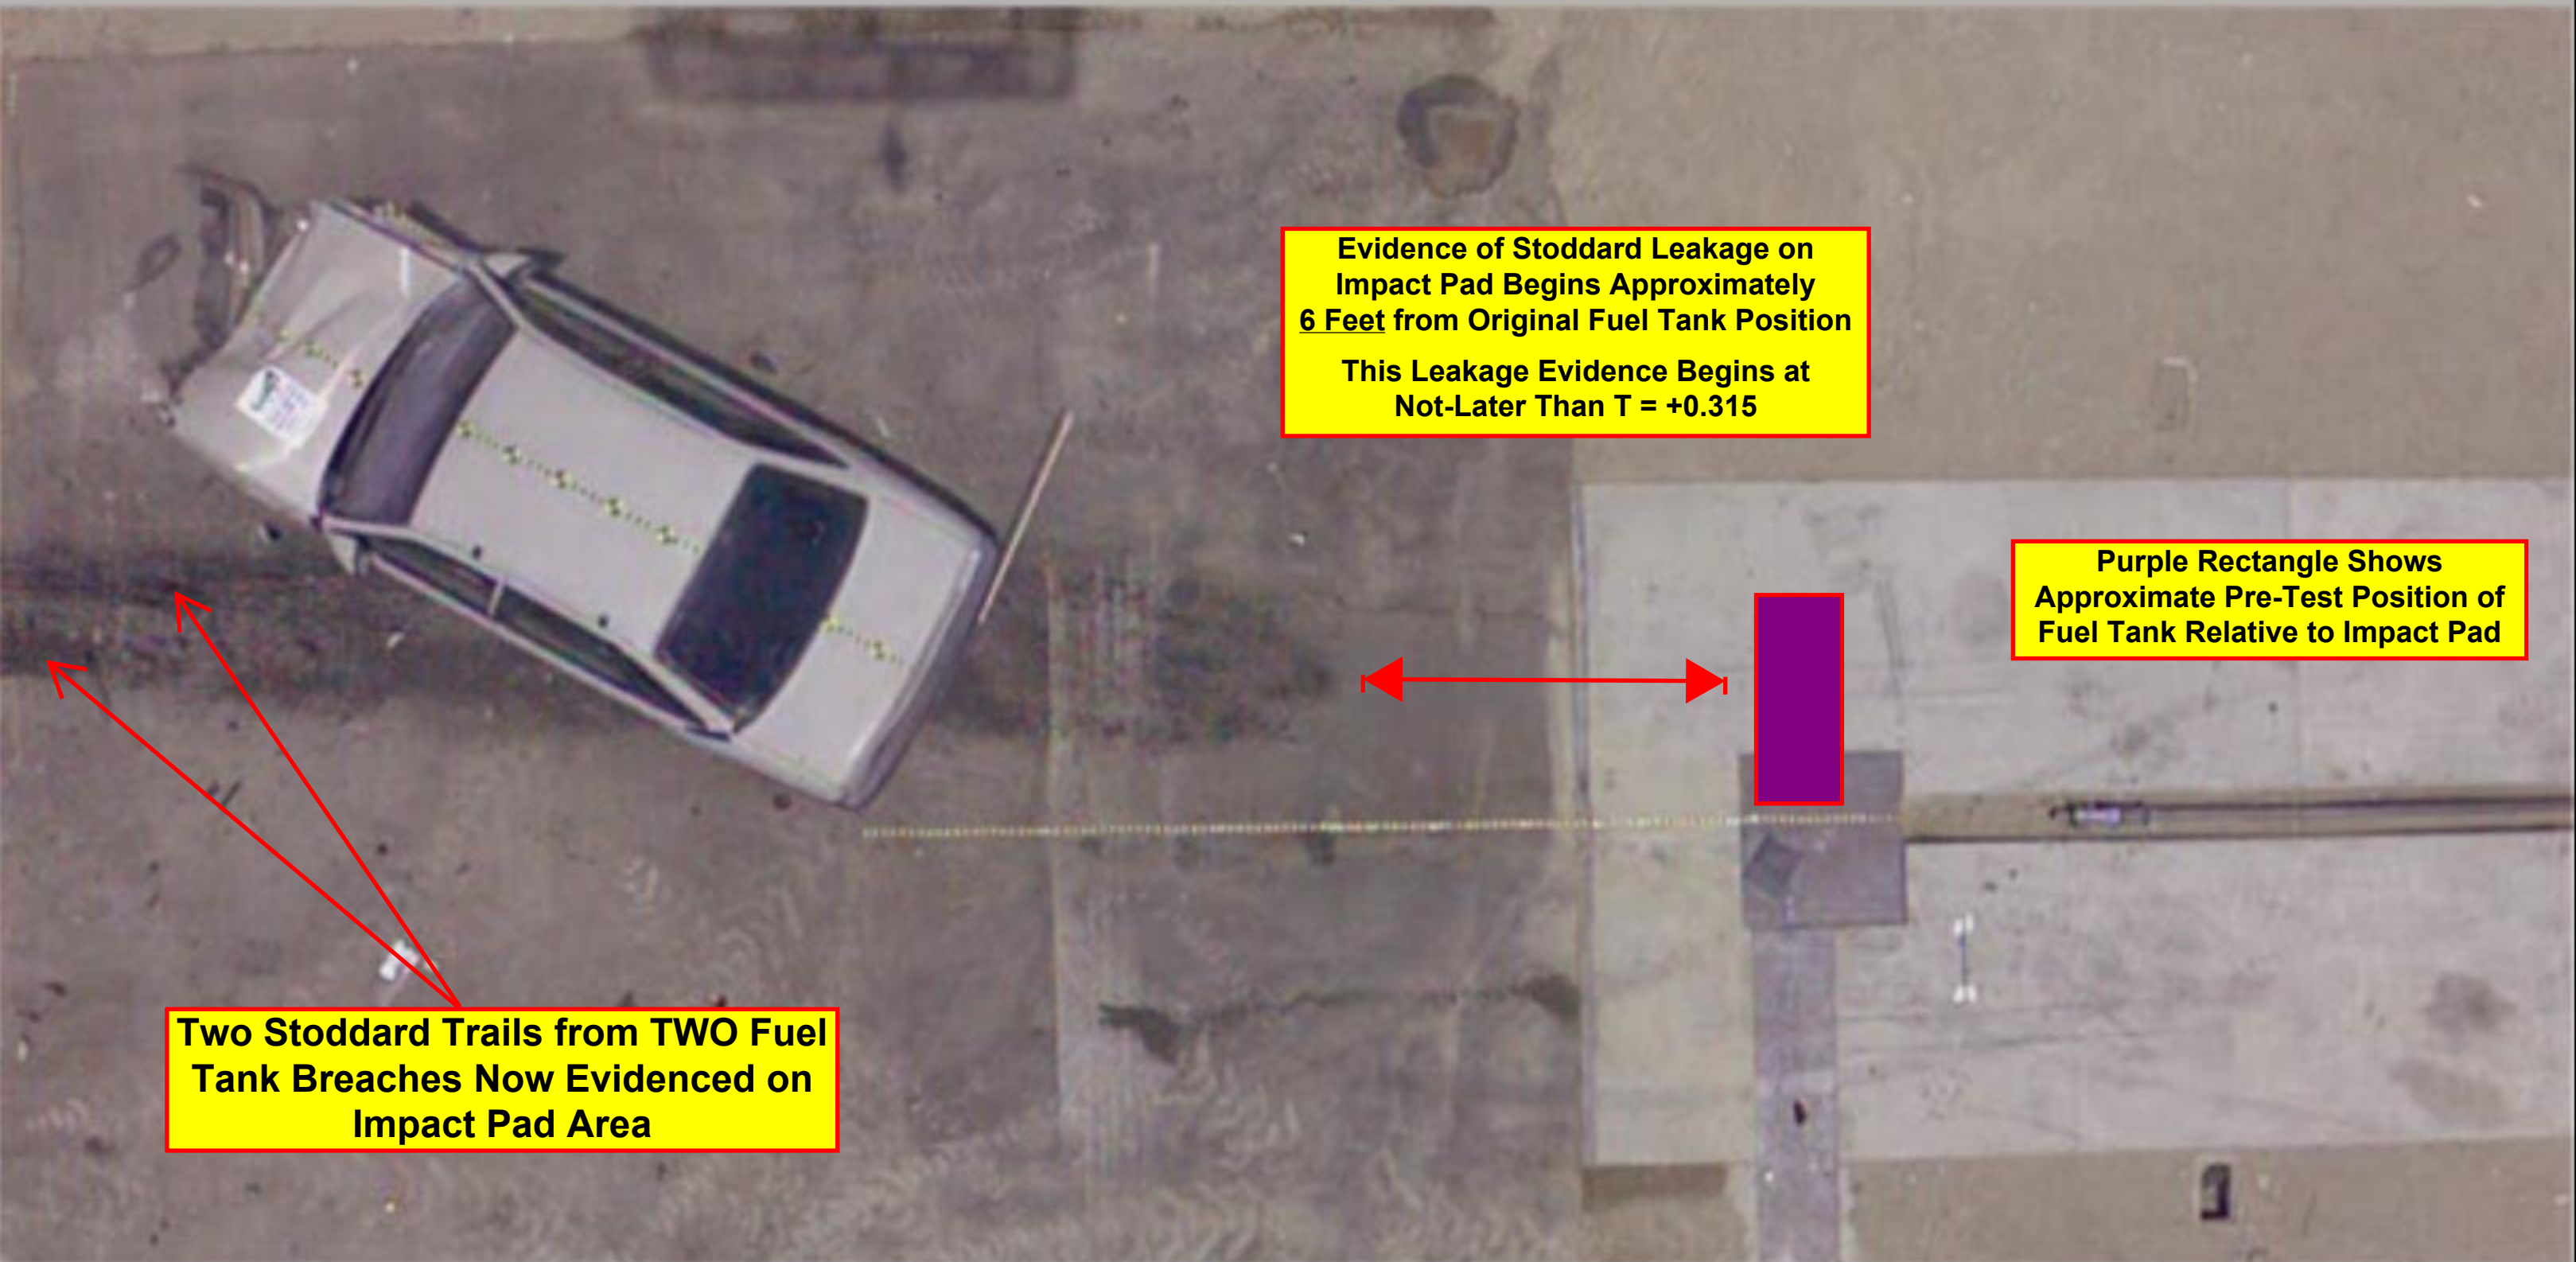
# Camera View-02

Evidence of Stoddard Leakage on Impact Pad Begins Approximately 6 Feet from Original Fuel Tank Position  
This Leakage Evidence Begins at Not-Later Than  $T = +0.315$

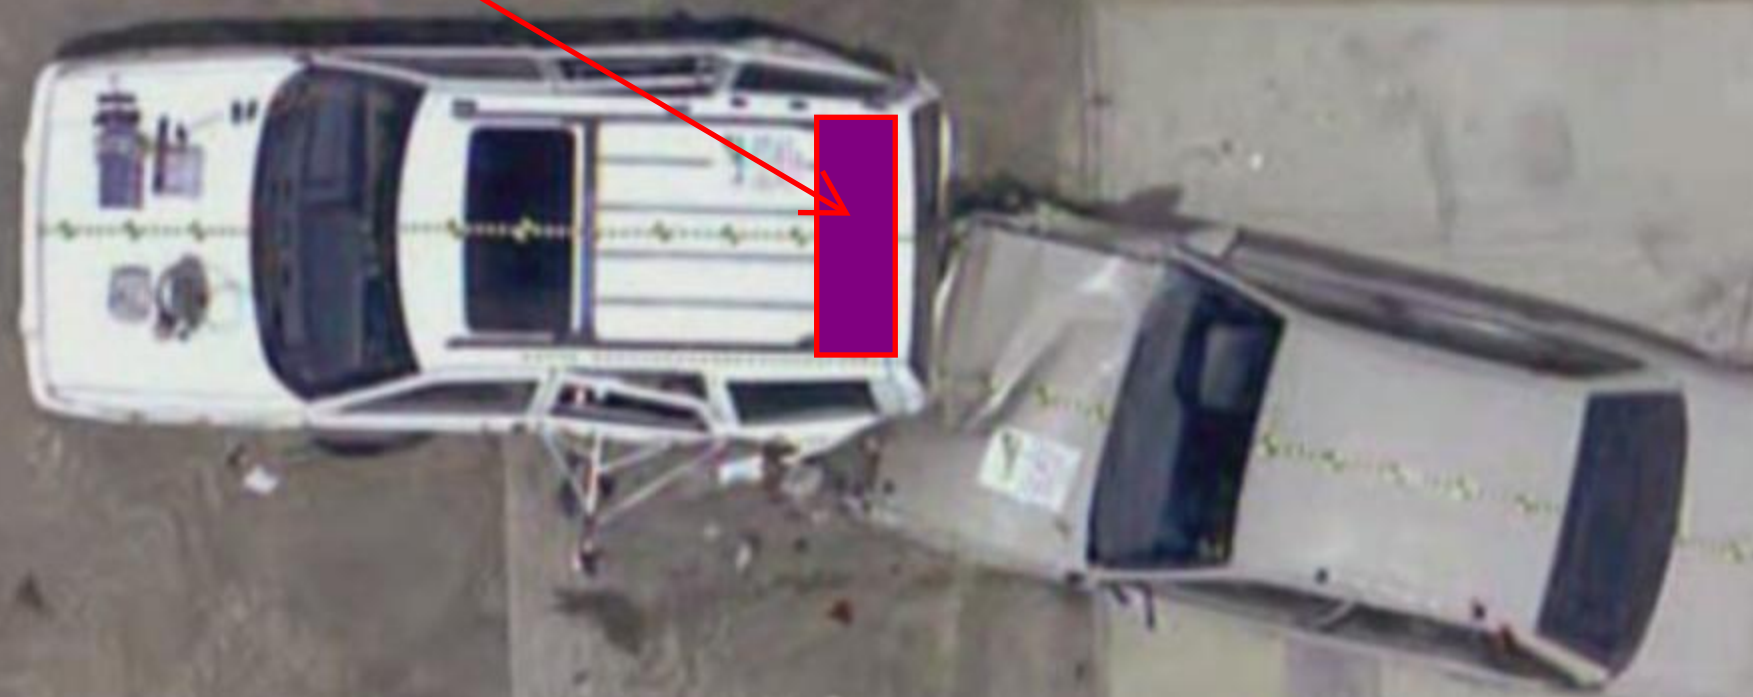
T = +1.598 represents the end of Camera 2 video recorded data. Note that the stoddard staining of the impact pad is near-instantaneous, occurring at a mere 6 feet from the pre-impact location of target vehicle fuel tank.

Position of Target Vehicle Fuel Tank Relative  
to Impact Pad Where Initial Evidence of  
Stoddard Staining of Pad Occurs  
Target Vehicle and Its Fuel Tank Reach this  
Specific Pad Location at  $T = +0.315$

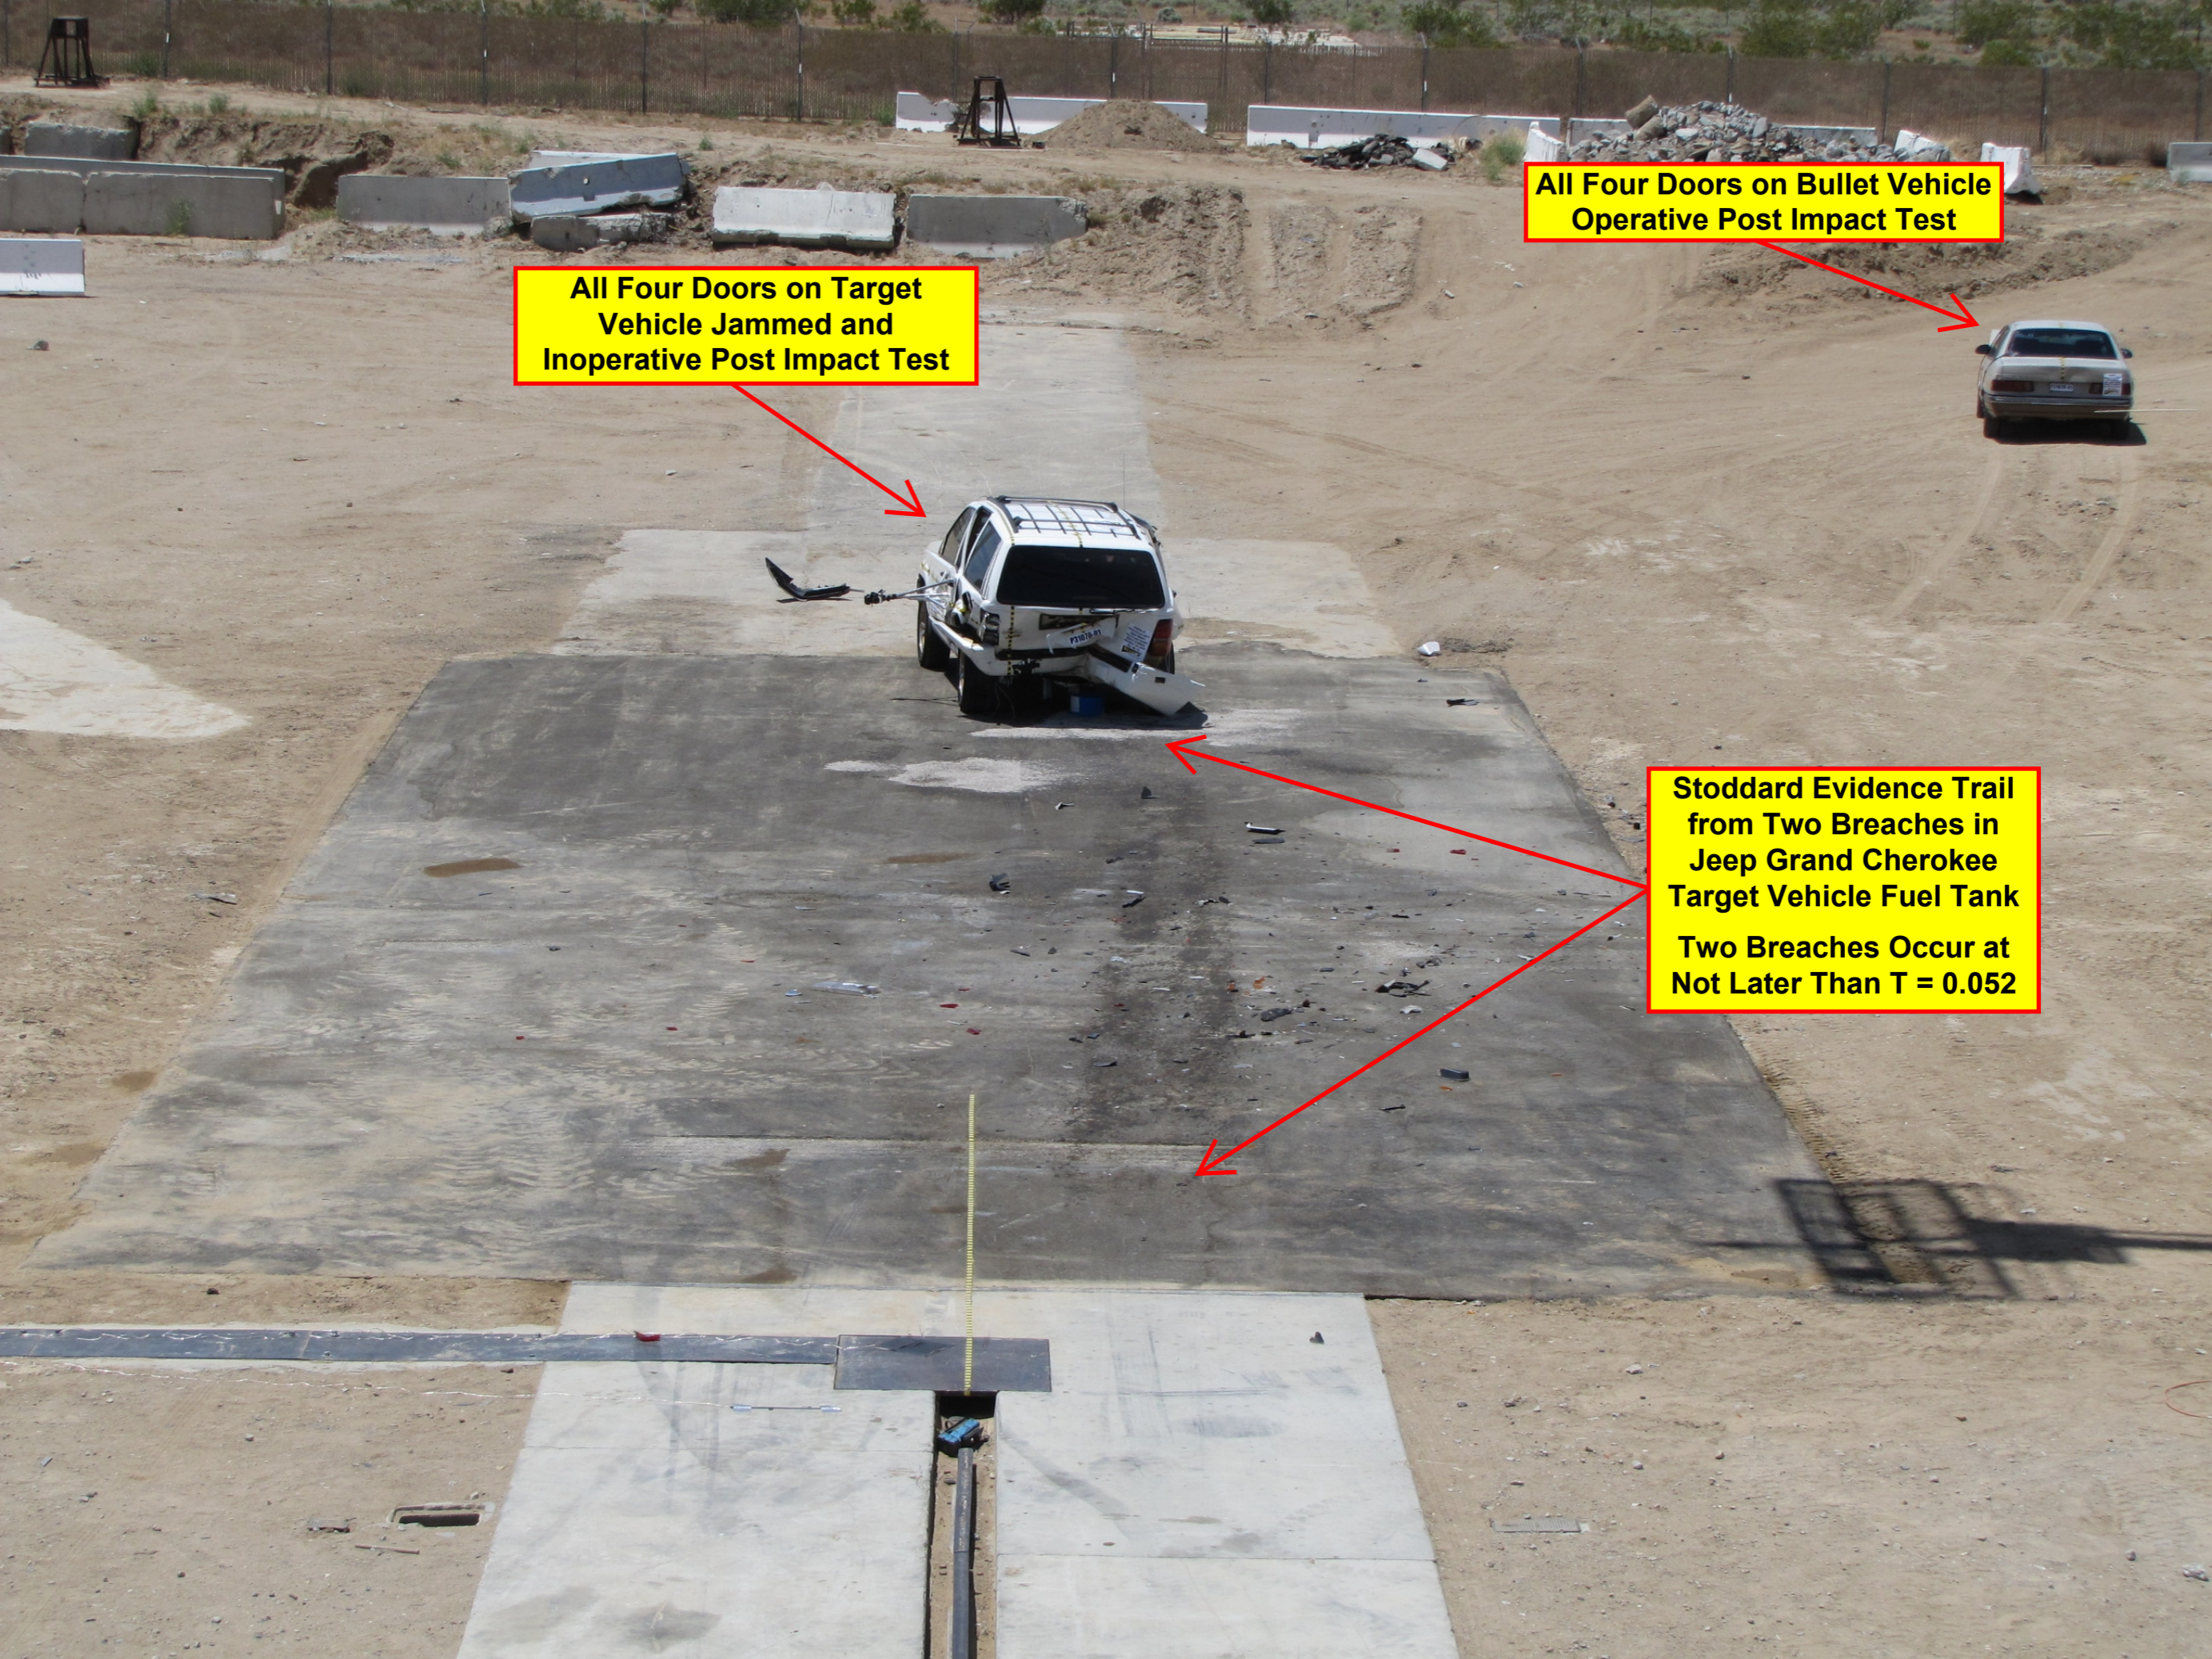
**Stoddard Evidence Trail  
from Two Breaches in  
Jeep Grand Cherokee  
Target Vehicle Fuel Tank  
Two Breaches Occur at  
Not Later Than  $T = 0.052$**
