Subject: Expert Report - White / Campbell versus FCA, et al

This report presents the results of a vehicle to vehicle rear impact test conducted with a 2002 Cadillac Seville SLS V-8 FWD automatic (Bullet Vehicle) and a 2003 Jeep Liberty 4WD V-6 automatic (Target Vehicle) which was equipped with a Fuel Tank Encapsulation Prototype (FTEP). The objective of this test was to evaluate the fuel tank crashworthiness integrity of a 2003 Jeep Liberty equipped with a Fuel Tank Encapsulation Prototype when subjected to the impact conditions described in this report. This test was conducted at Applus IDIADA KARCO Engineering's test facility in Adelanto, California on December 3, 2018.

Applus IDIADA KARCO Engineering, LLC – Test Report Number : TR-P38306-01-NC

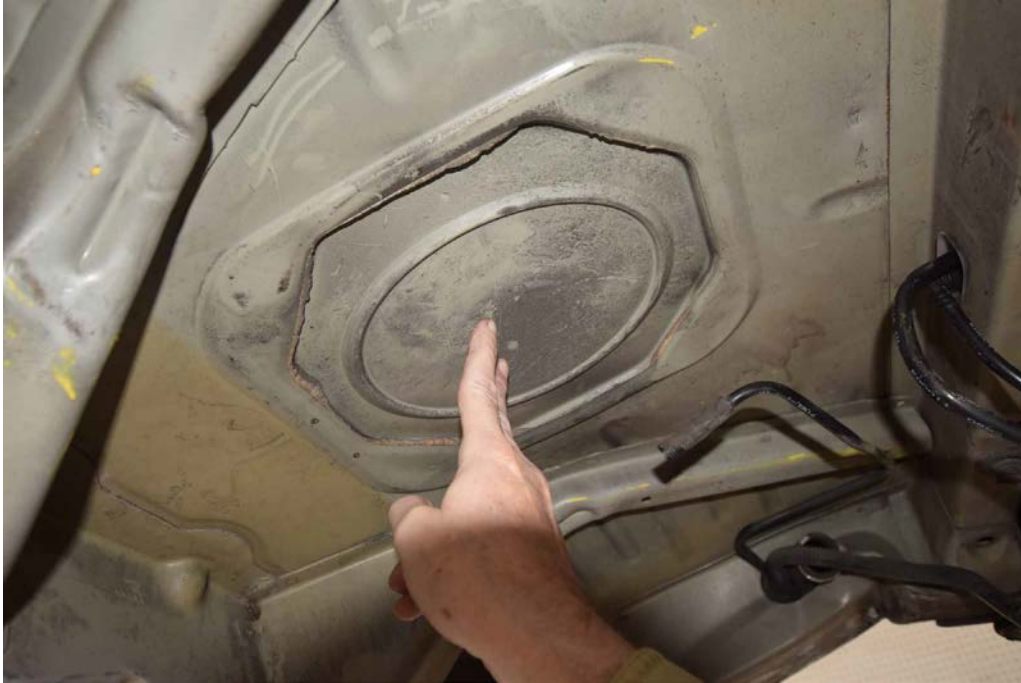
Page 3 – Comment 4 above, fuel pump access panel:

Page 3 Comment 2	Undersigned agrees with, “. . . the odor of Stoddard solvent was present.”
Page 3 Comment 3	Undersigned agrees with, “The amount of solvent observed was immeasurable..”
Page 3 Comment 4	<p>Page 3 paragraph 2, the undersigned was present throughout the post-test inspection, conducted on December 21, 2018.</p> <p>Report verbiage, “Upon removal of the FTEP and the fuel tank from the vehicle, a plastic output nipple on the top of the fuel tank was found cracked.”</p> <p>Two possibilities for this condition were proposed/reviewed:</p> <p>(1) Minor crack occurred during the crash test, provoking attention to an additional Jeep Liberty KJ issue.</p> <p>(2) Initial inspection of the fuel tank and pump assembly confirmed that these 16 year old components had never been removed/serviced.</p> <p>During a two-fold Karco removal/re-install of the fuel tank, the fuel pump access panel was not utilized. Karco technicians later admitted strain/difficulty with fuel pump liquid/electrical lines. It is possible that minor stress crack in the plastic fuel outlet nipple occurred during this difficulty. Crack is shown in report photos #131, #132, #133, #134, #135, #136, #137, and #138, which were taken at the post-crash inspection. It is possible that the crack did not occur during the crash test. Competitive use of steel fuel pump assembly, including steel nipples, such as used by Ford on vehicles such as the Crown Victoria, would have eliminated this additional KJ issue..</p> <p>The minor fumes that were present post-test appeared to originate from top of tank, where no crash ignition sources are present. No other tank surface had Stoddard staining. Photographs of Fuel Pump Assembly Access Panel and minor top of tank Stoddard trace-staining attached below.</p>

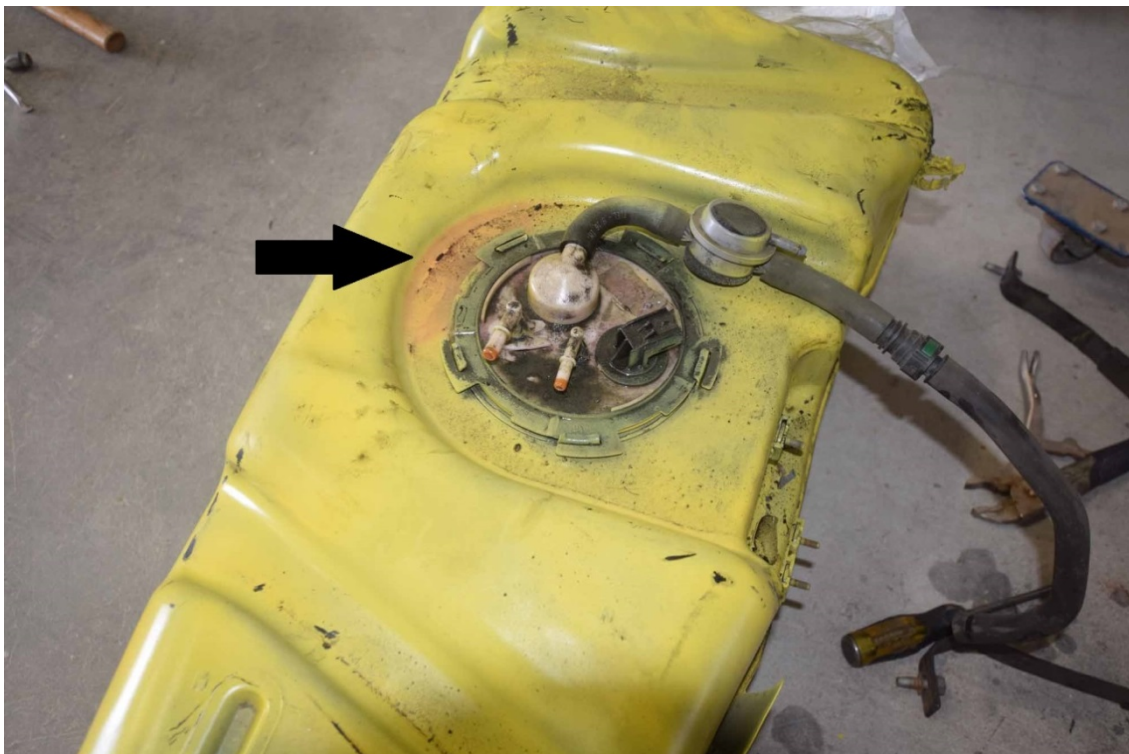
Page 3 – Comment 4 above, Stoddard trace-staining restricted to top-of-tank only, post crash test inspection confirmed that no other tank surface location had staining and were completely dry/intact:
