# EXHIBIT 2

**Subject: Expert Report - White / Campbell versus FCA, et al**

This report presents the results of a vehicle to vehicle rear impact test conducted with a 2002 Cadillac Seville SLS V-8 FWD automatic (Bullet Vehicle) and a 2003 Jeep Liberty 4WD V-6 automatic (Target Vehicle) which was equipped with a Fuel Tank Encapsulation Prototype (FTEP). The objective of this test was to evaluate the fuel tank crashworthiness integrity of a 2003 Jeep Liberty equipped with a Fuel Tank Encapsulation Prototype when subjected to the impact conditions described in this report. This test was conducted at Applus IDIADA KARCO Engineering's test facility in Adelanto, California on December 3, 2018.

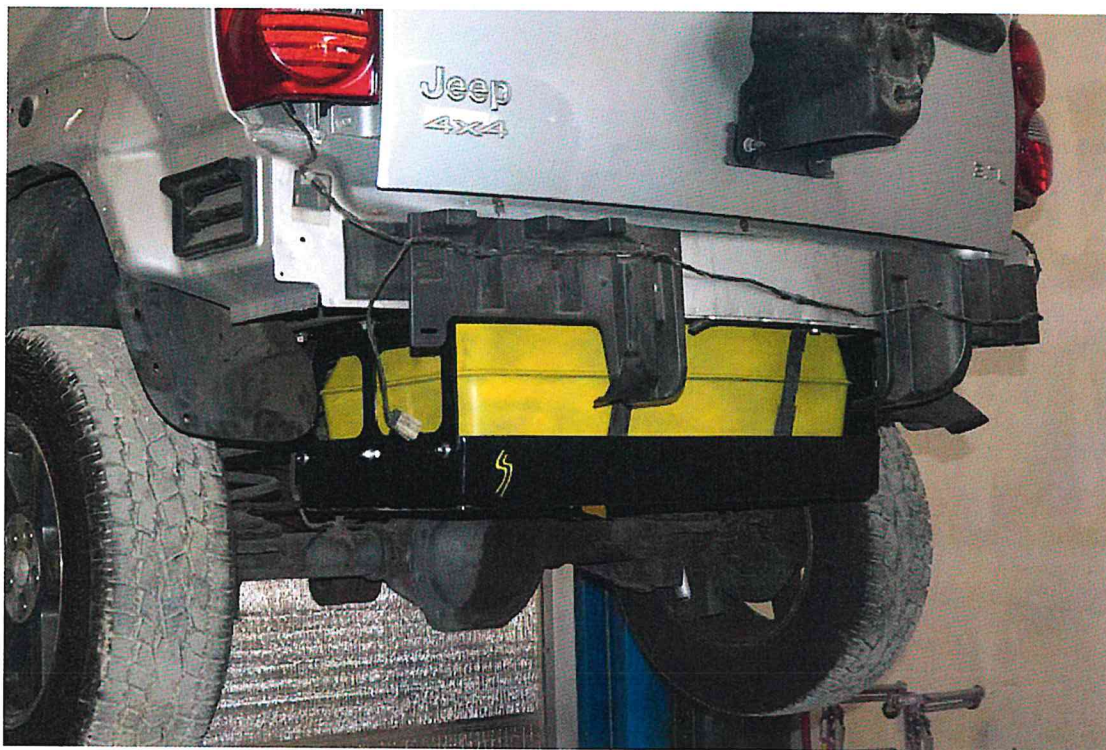
The 2003 Jeep Liberty was equipped with a Fuel Tank Encapsulation Prototype. The FTEP was constructed by modifying a skid plate manufactured by SFK Manufacturing, Model JP-4002. The design process, fabrication, and installation of the modifications made to the skid plate were done under the direction of Paul V. Sheridan. A series of steel plates with a thickness of 3/16" were welded to the skid plate to encapsulate the target vehicle's fuel tank, a single 1/2" thick plate was used on part of the mounting surface of the FTEP. A photo of the short 1/2" thick plate used can be found in Figure 53 of Appendix A. The FTEP was mounted to the vehicle's rear frame rails using the six bolts originally used to mount the trailer hitch to the vehicle and to the rear transverse rail by four additional bolts and nuts. The vehicle's fuel tank was painted yellow and the FTEP was painted orange for photographic purposes.

FIGURE 33. 2003 Jeep Liberty with SFK Manufacturing Model JP-4002 Skid Plate Installed

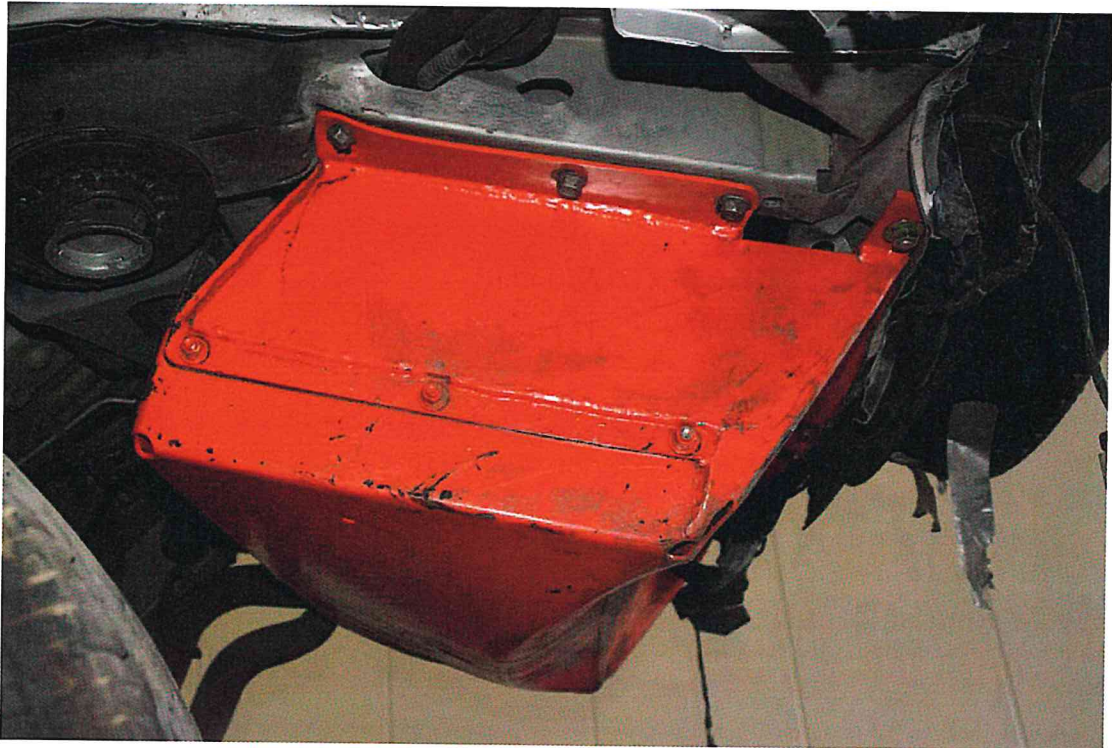
A post-test inspection of the FTEP and the 2003 Jeep Liberty's fuel tank was conducted on December 21, 2018. The FTEP remained attached to the vehicle by all but the three right side frame rail bolts. The fuel tank remained attached to the vehicle by the OEM strap attachments. Upon removal of the FTEP and fuel tank from the vehicle, a plastic output nipple on the top of the fuel tank was found cracked. The Stoddard solvent was drained from the vehicle to confirm that no measurable amount of solvent leaked as a result of the impact test. The driver side doors on the target vehicle were operable after the impact, the outside door handle on the right front passenger door was broken but the door was operable using the interior door handle, the right rear passenger door was jammed shut.

FIGURE 108. Post-Test Fuel Tank Inspection

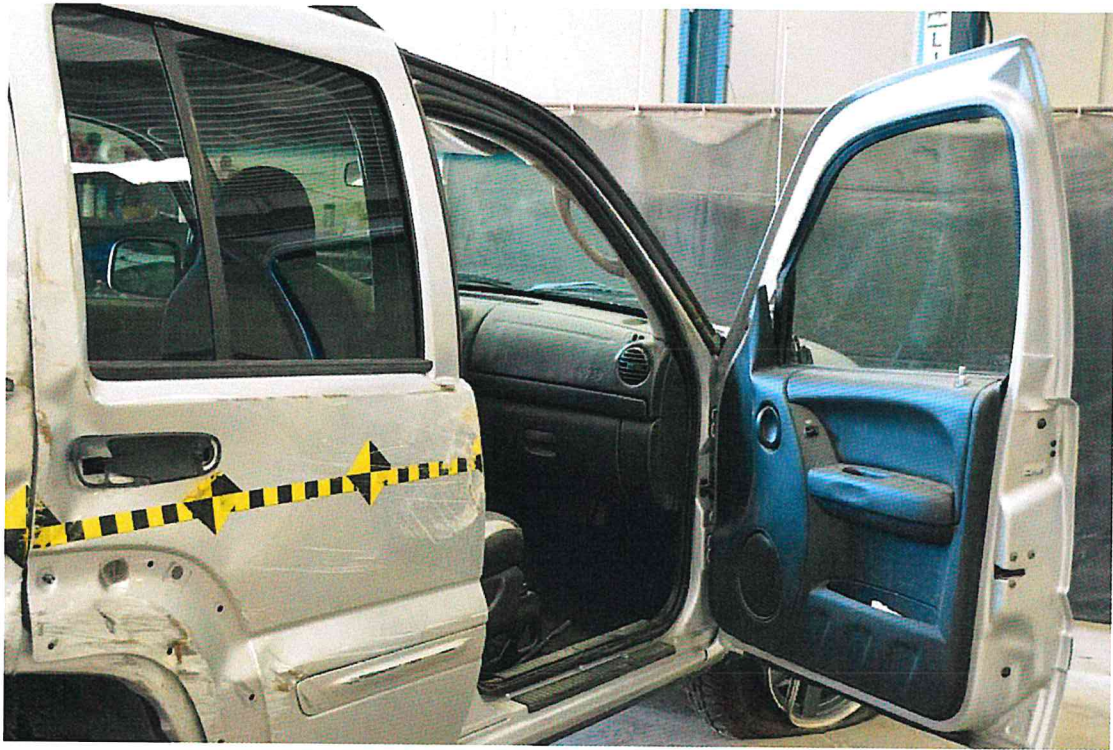
FIGURE 149. Post-Test Door Opening

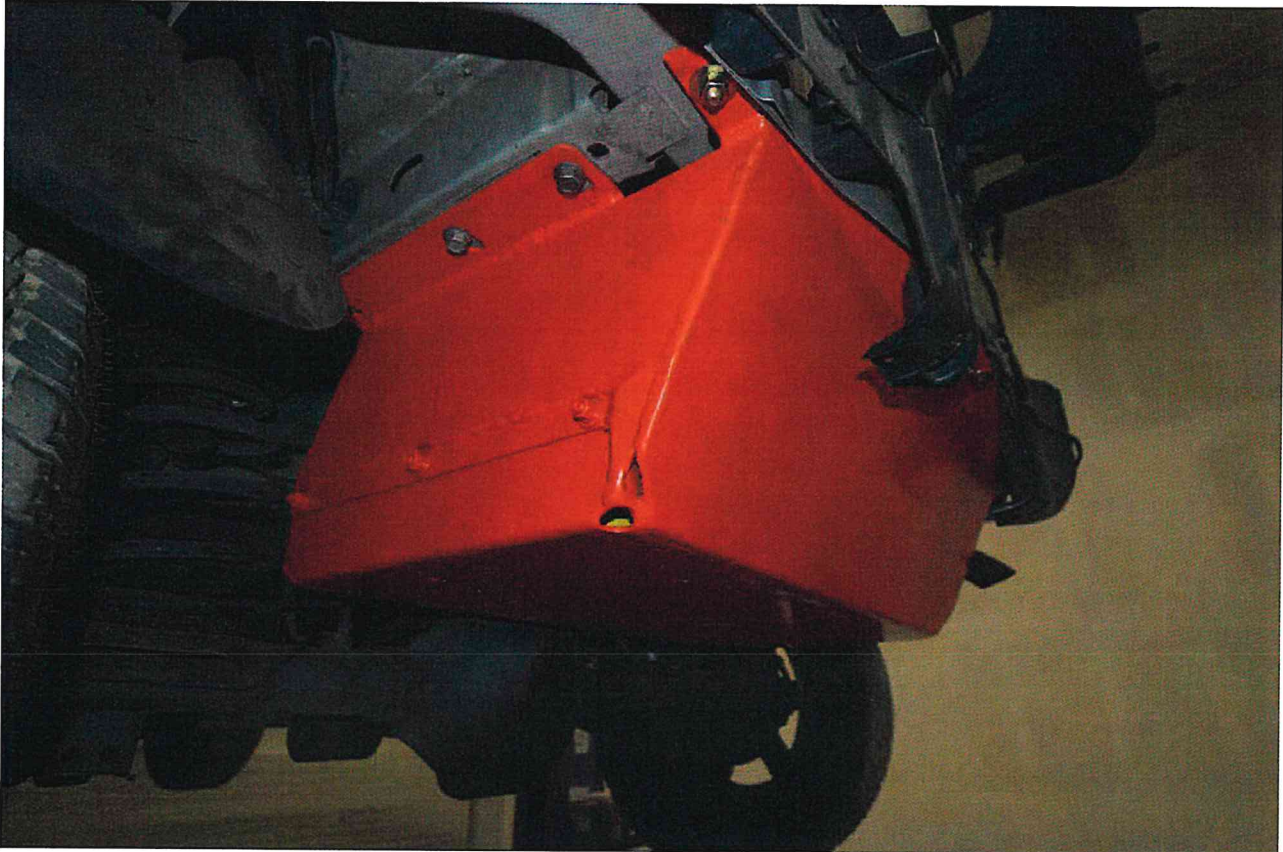
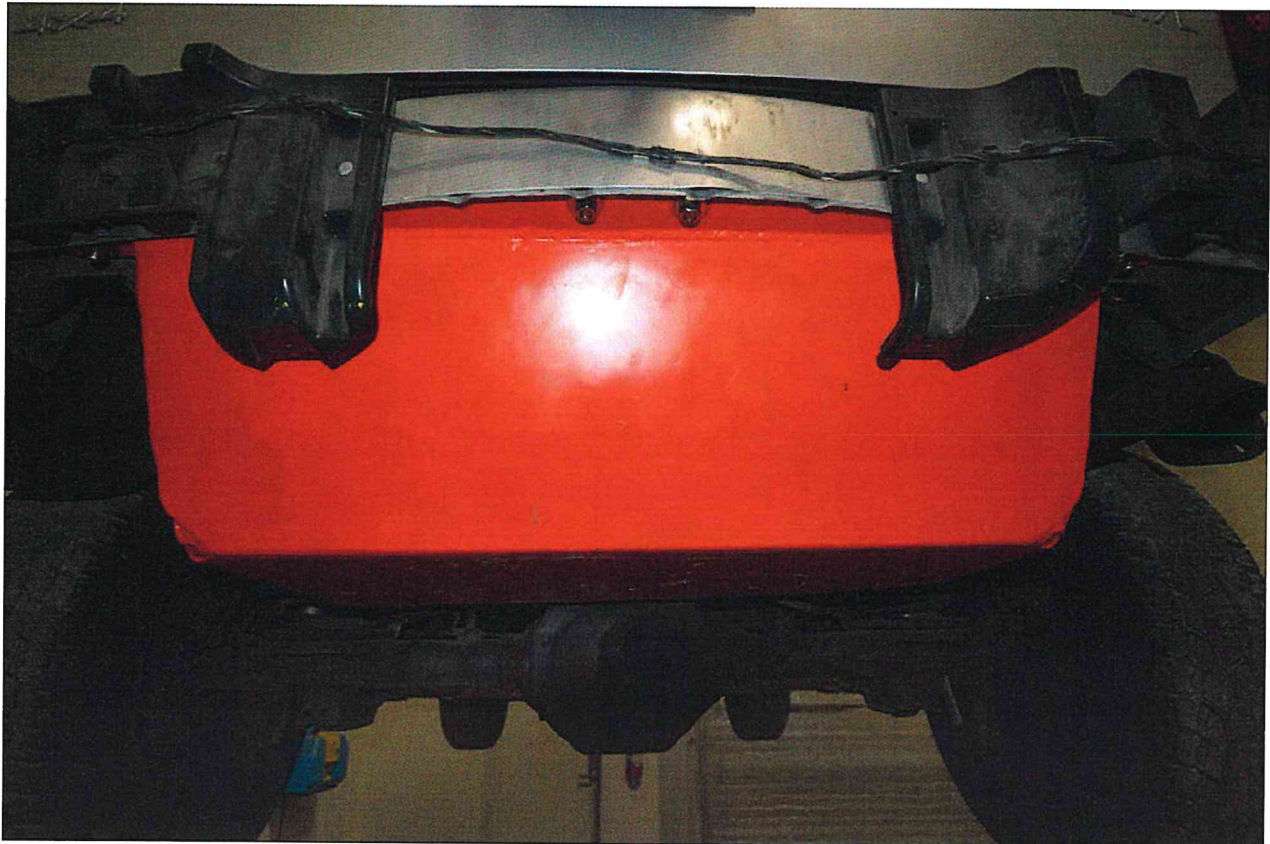
Pictorial presentation/review of the mock-up, fabrication/construction, and installation process of the FTEP onto a typical Jeep Liberty KJ
