EA12-005 Reconstruction Testing for KJ Jeep Liberty and ZJ Grand Cherokee

July 2014

U.S Department of Transportation
National Highway Traffic Safety Administration

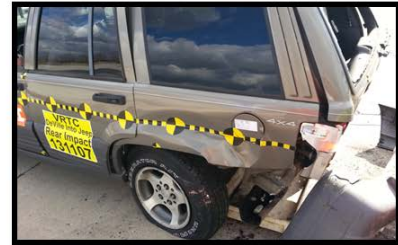
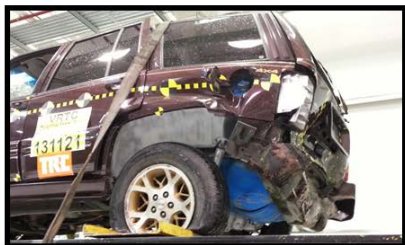
post-crash damage in the left rear D-pillar area, between the baseline test vehicles and the real-world crash is shown in Figure 17. A comparison of post-crash damage in the rear bumper reinforcement area between the baseline test vehicles and the real-world crash is shown in Figure 18. A comparison of post-crash damage in the rear lift gate area between the baseline test vehicles and the real-world crash is shown in Figure 19. A comparison of post-crash damage in the right rear area between the baseline test vehicles and the real-world crash is shown in Figure 20. A comparison of post-crash damage of the fuel tank area, between Test# 3 (no hitch-receiver) and Test #7 (hitch-receiver) is shown in Figure 21 and Figure 22, respectively.

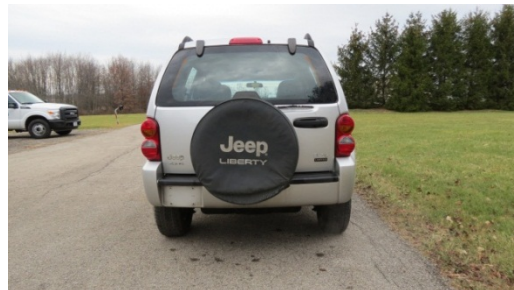
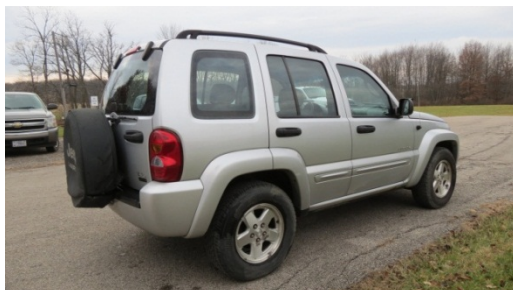
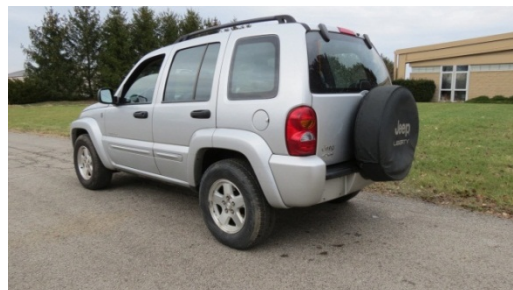
2004 Jeep Liberty, VIN: 1J4GL58K94Wxxxxxx
Target Vehicle Test# 8

The reconstruction of the F-150 into the KJ Liberty demonstrated the hitch was capable of withstanding a higher energy impact without the hitch-receiver cross-member fracturing and without piercing the tank. Damage to the tested Jeep Liberty indicated that the energy levels were consistent with, if not in excess of that achieved in the real-world crash. The presence of the aftermarket tow drawbar and tow ball inserted into hitch-receiver in the real-world crash seems to have increased the leverage acting upon the cross-member and may have contributed to the overload fracture. The droplets of fuel leakage during and immediately after the test that originated from the vent and vapor tube connectors ceased shortly after the impact. Significant leakage did not occur until the vehicle was rolled in the rollover fixture. The source of the leak was the overfill vent connector and the charcoal vapor connector, which had broken off of the top of the fuel pump assembly.
