Center for Auto Safety White Paper on Concerns With  
Chrysler Recall of the Jeep Grand Cherokee and Liberty  
Presented to NHTSA July 1, 2013

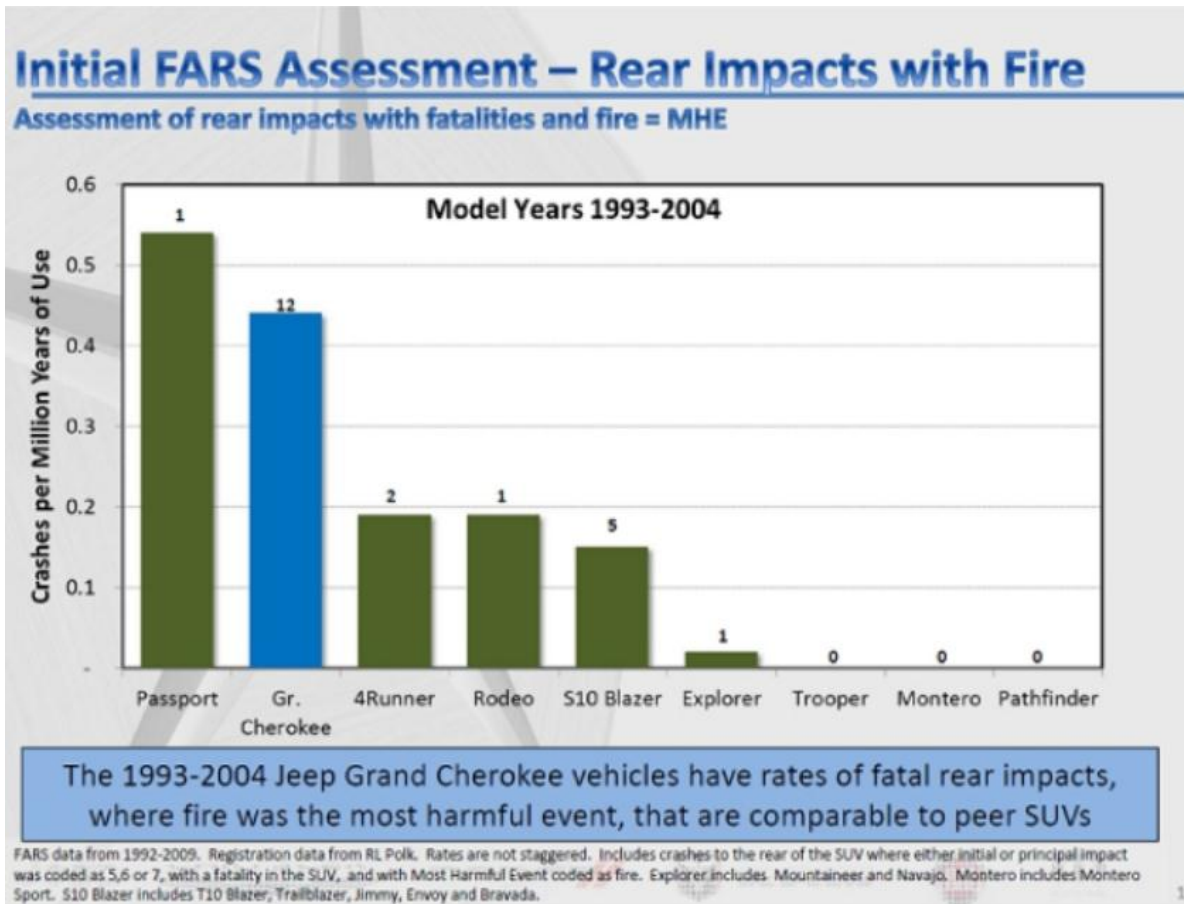
Looking at Chrysler's own chart which normalized these results (Figure 2) for the Grand Cherokee – with 12 cases where fire was the most harmful fatal event – had 4.4 per hundred thousand vehicle-years of use. The Honda Passport, which is a sister of the Isuzu Rodeo and should have been included with them, had only one crash on this chart, but when we looked at this case it was not even a rear impact but rather a frontal with a Chevrolet Tahoe.<sup>6</sup> (Also, because of the small population of these vehicles, there were a

Figure 2. A chart submitted by Chrysler as part of their early response to NHTSA's investigation. Note that while Chrysler combined sisters and clones in most cases, it did not combine the very small volume Honda Passport with its sister Isuzu Rodeo.
