EA12-005 Reconstruction Testing for KJ Jeep Liberty and ZJ Grand Cherokee

July 2014

U.S Department of Transportation
National Highway Traffic Safety Administration

1. Report No.	2. Government Accession No.	3. Recipient's Catalog No.	
4. Title and Subtitle EA12-005 Reconstruction Testing for KJ Jeep Liberty and ZJ Grand Cherokee		5. Report Date July 2014

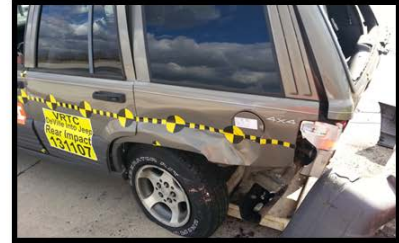
Figure 17 - Comparison of post-crash damage of the left rear D-pillar area between the baseline tests and the real-world crash

post-crash damage in the left rear D-pillar area, between the baseline test vehicles and the real-world crash is shown in Figure 17. A comparison of post-crash damage in the rear bumper reinforcement area between the baseline test vehicles and the real-world crash is shown in Figure 18. A comparison of post-crash damage in the rear lift gate area between the baseline test vehicles and the real-world crash is shown in Figure 19. A comparison of post-crash damage in the right rear area between the baseline test vehicles and the real-world crash is shown in Figure 20. A comparison of post-crash damage of the fuel tank area, between Test# 3 (no hitch-receiver) and Test #7 (hitch-receiver) is shown in Figure 21 and Figure 22, respectively.

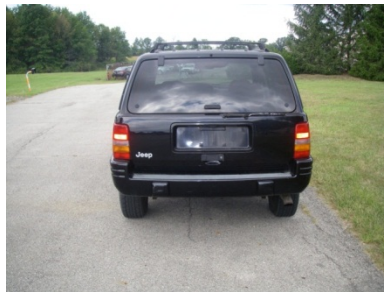
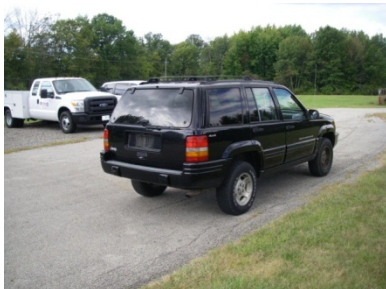
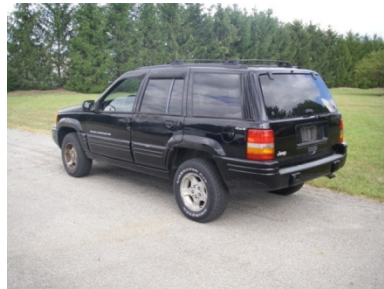
1998 Jeep Grand Cherokee
VIN: 1J4GZ48S1WCxxxxxx
Target Vehicle Test# 3

The reconstruction of the Cadillac Deville into the ZJ Jeep Grand Cherokee revealed a repeatable failure mode with the crushed and rusted frame rail pulling on the fuel filler hoses until they broke the connections from the plastic tank. It was confirmed that a vehicle with little to no rust could withstand the crash. The hitch-receiver bracket and mounting bolts provided a structural reinforcement that prevented the collapse of the moderately rusted frame rail relief tunnel in testing.

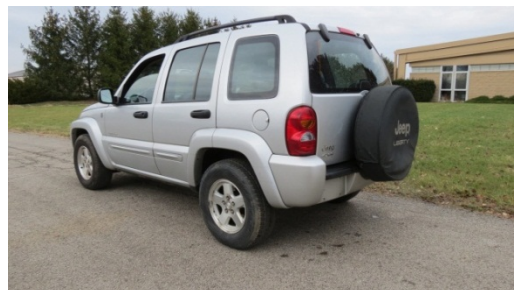
2004 Jeep Liberty, VIN: 1J4GL58K94Wxxxxxx
Target Vehicle Test# 8

The reconstruction of the F-150 into the KJ Liberty demonstrated the hitch was capable of withstanding a higher energy impact without the hitch-receiver cross-member fracturing and without piercing the tank. Damage to the tested Jeep Liberty indicated that the energy levels were consistent with, if not in excess of that achieved in the real-world crash. The presence of the aftermarket tow drawbar and tow ball inserted into hitch-receiver in the real-world crash seems to have increased the leverage acting upon the cross-member and may have contributed to the overload fracture. The droplets of fuel leakage during and immediately after the test that originated from the vent and vapor tube connectors ceased shortly after the impact. Significant leakage did not occur until the vehicle was rolled in the rollover fixture. The source of the leak was the overfill vent connector and the charcoal vapor connector, which had broken off of the top of the fuel pump assembly.
