December 19, 2011

RE: *Kline et al. v. Loman Auto Group*

As requested, Kineticcorp investigated and reconstructed a fatal motor vehicle accident that occurred on February 24, 2007 at approximately 8:53 a.m. The crash occurred on southbound Interstate 287 at milepost 42.8 in Parsippany, New Jersey. A 1998 Subaru Outback, driven by Natalie Rawls, slowed or stopped in the right travel lane of southbound I-287. Susan Morris Kline slowed or stopped her 1996 Jeep Cherokee behind the Subaru. The Jeep was then impacted in the rear by a 2004 Toyota Sienna operated by Victoria Morgan-Alcala. As a result of this initial impact the Jeep was pushed into the rear of the Subaru before coming to rest between the right and center lanes of I-287. During the accident sequence a fire erupted. As a result of the crash, Ms. Kline was killed. In the area of the accident, southbound I-287 is an asphalt roadway with three lanes of travel bordered to the right by a gore area separating the through-travel lanes from the exit lane for Parsippany Road. Figure 1, a photograph taken by police, shows the accident scene. At the time of the accident the weather was clear and the roadway was dry, straight and leve

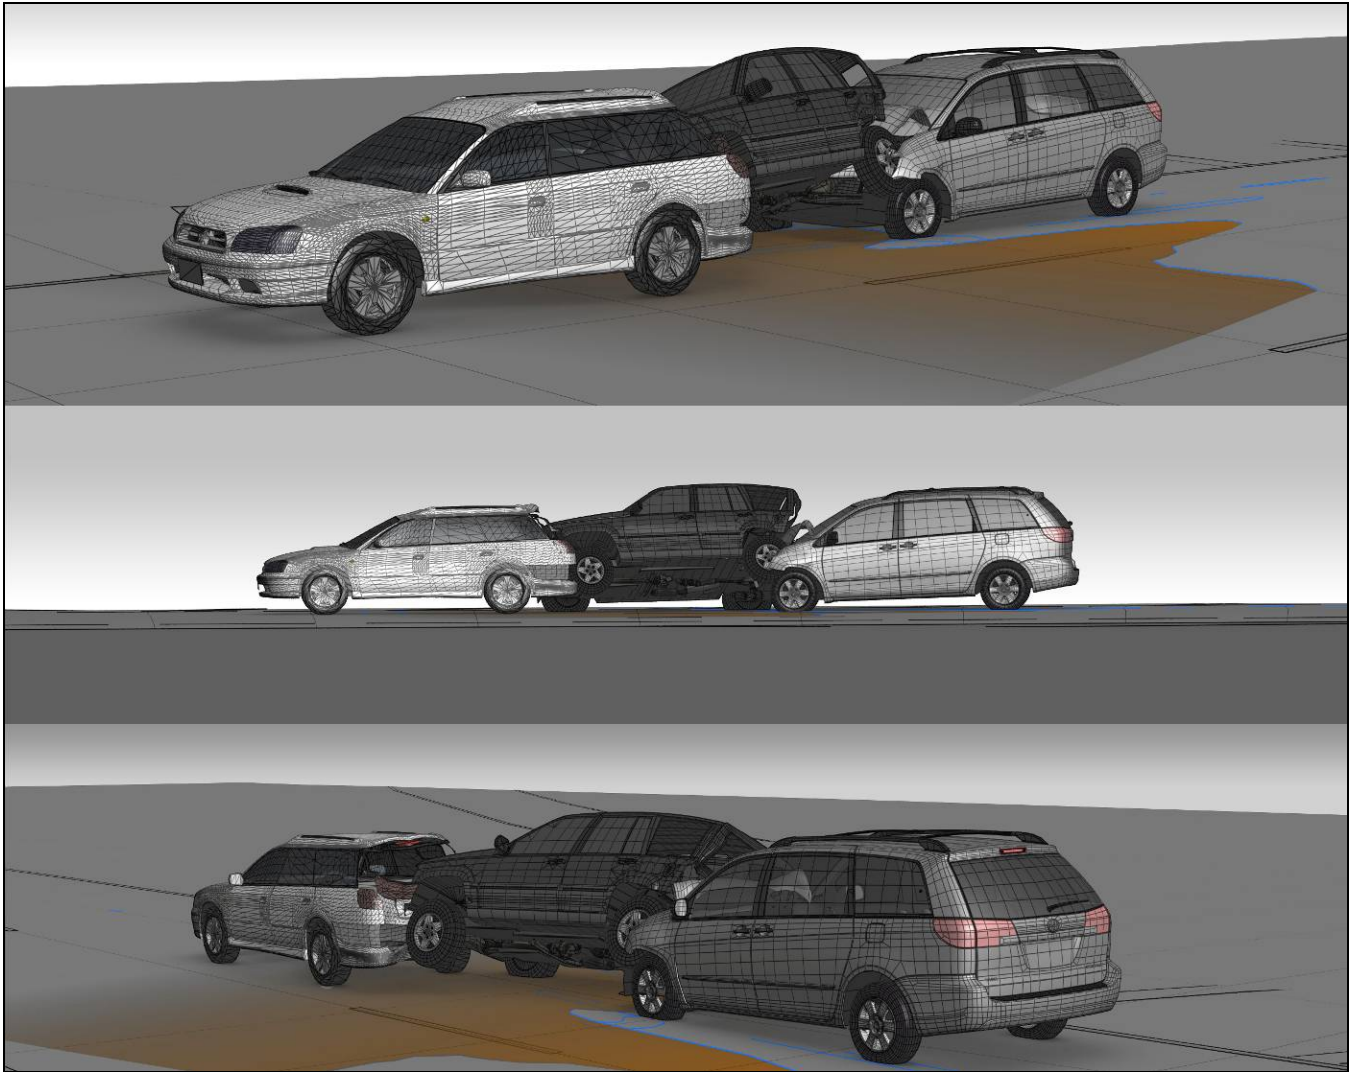
Figure 9

The vehicles then traveled to rest. The collision locked the rear right tire of the Subaru, causing it to leave a dark tire mark that led to its rest position. The Subaru traveled approximately 130 feet after the impact and came to rest on the shoulder. The Toyota traveled approximately 40 feet before coming to rest in the right lane. As the Jeep was crushed between the Subaru and the Toyota, it began to rotate counter-clockwise. The Jeep traveled approximately 50 feet, and rotated approximately 180 degrees before coming to rest straddling the right and middle lanes. The motion of the Jeep as it traveled to rest is depicted in Figure 10.
