Subject: Chrysler Group, LLC Failure-to-Warn/Comply under 49 CFR § 573.6, et al.

Reference 2: EA12-005 File Update (Chrysler Jeep Fuel Tank System Safety Defect)

Chrysler Jeep Fuel System Defect Investigation EA12-005

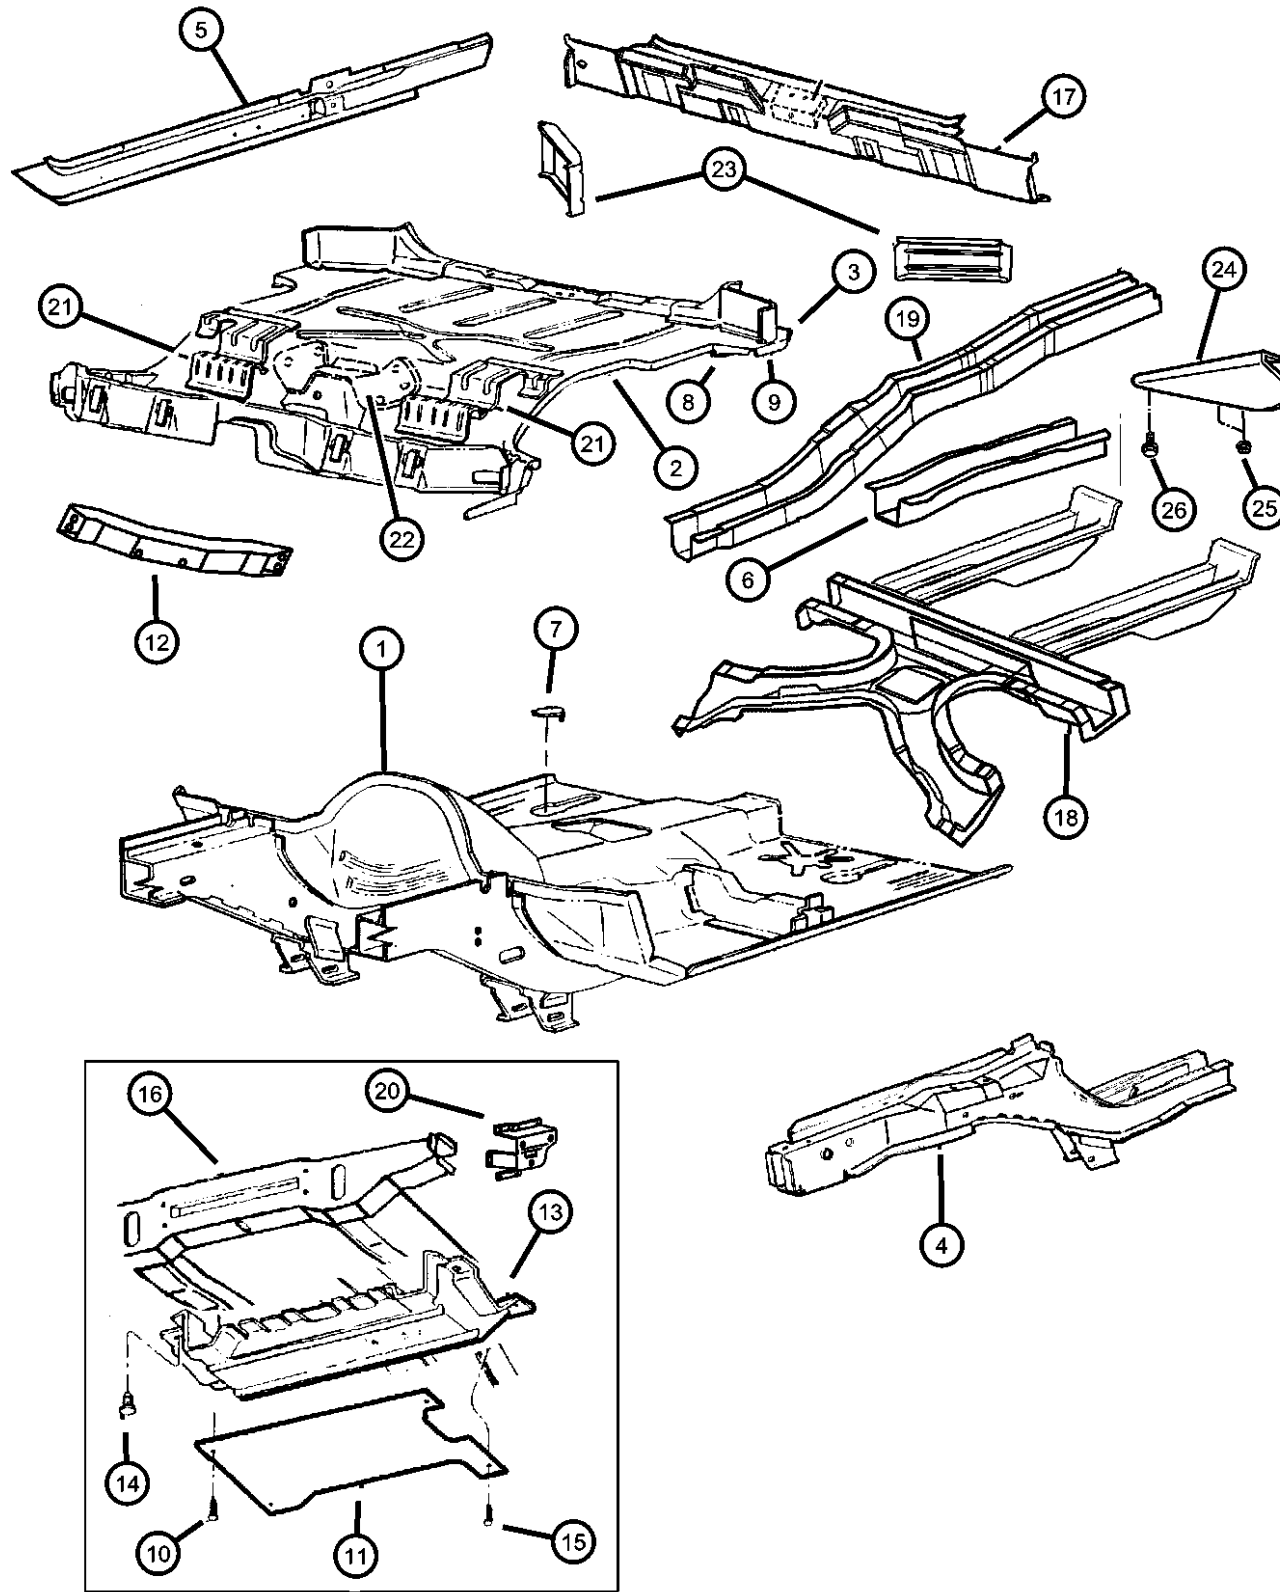
Pans, Floor
Figure SZJ-210

The intrinsic and foreseeable safety defect of an engineering design that allows for direct collision impact/breach to an unprotected fuel tank system and/or its components. (ATTACHMENT 1) ^{4 5}

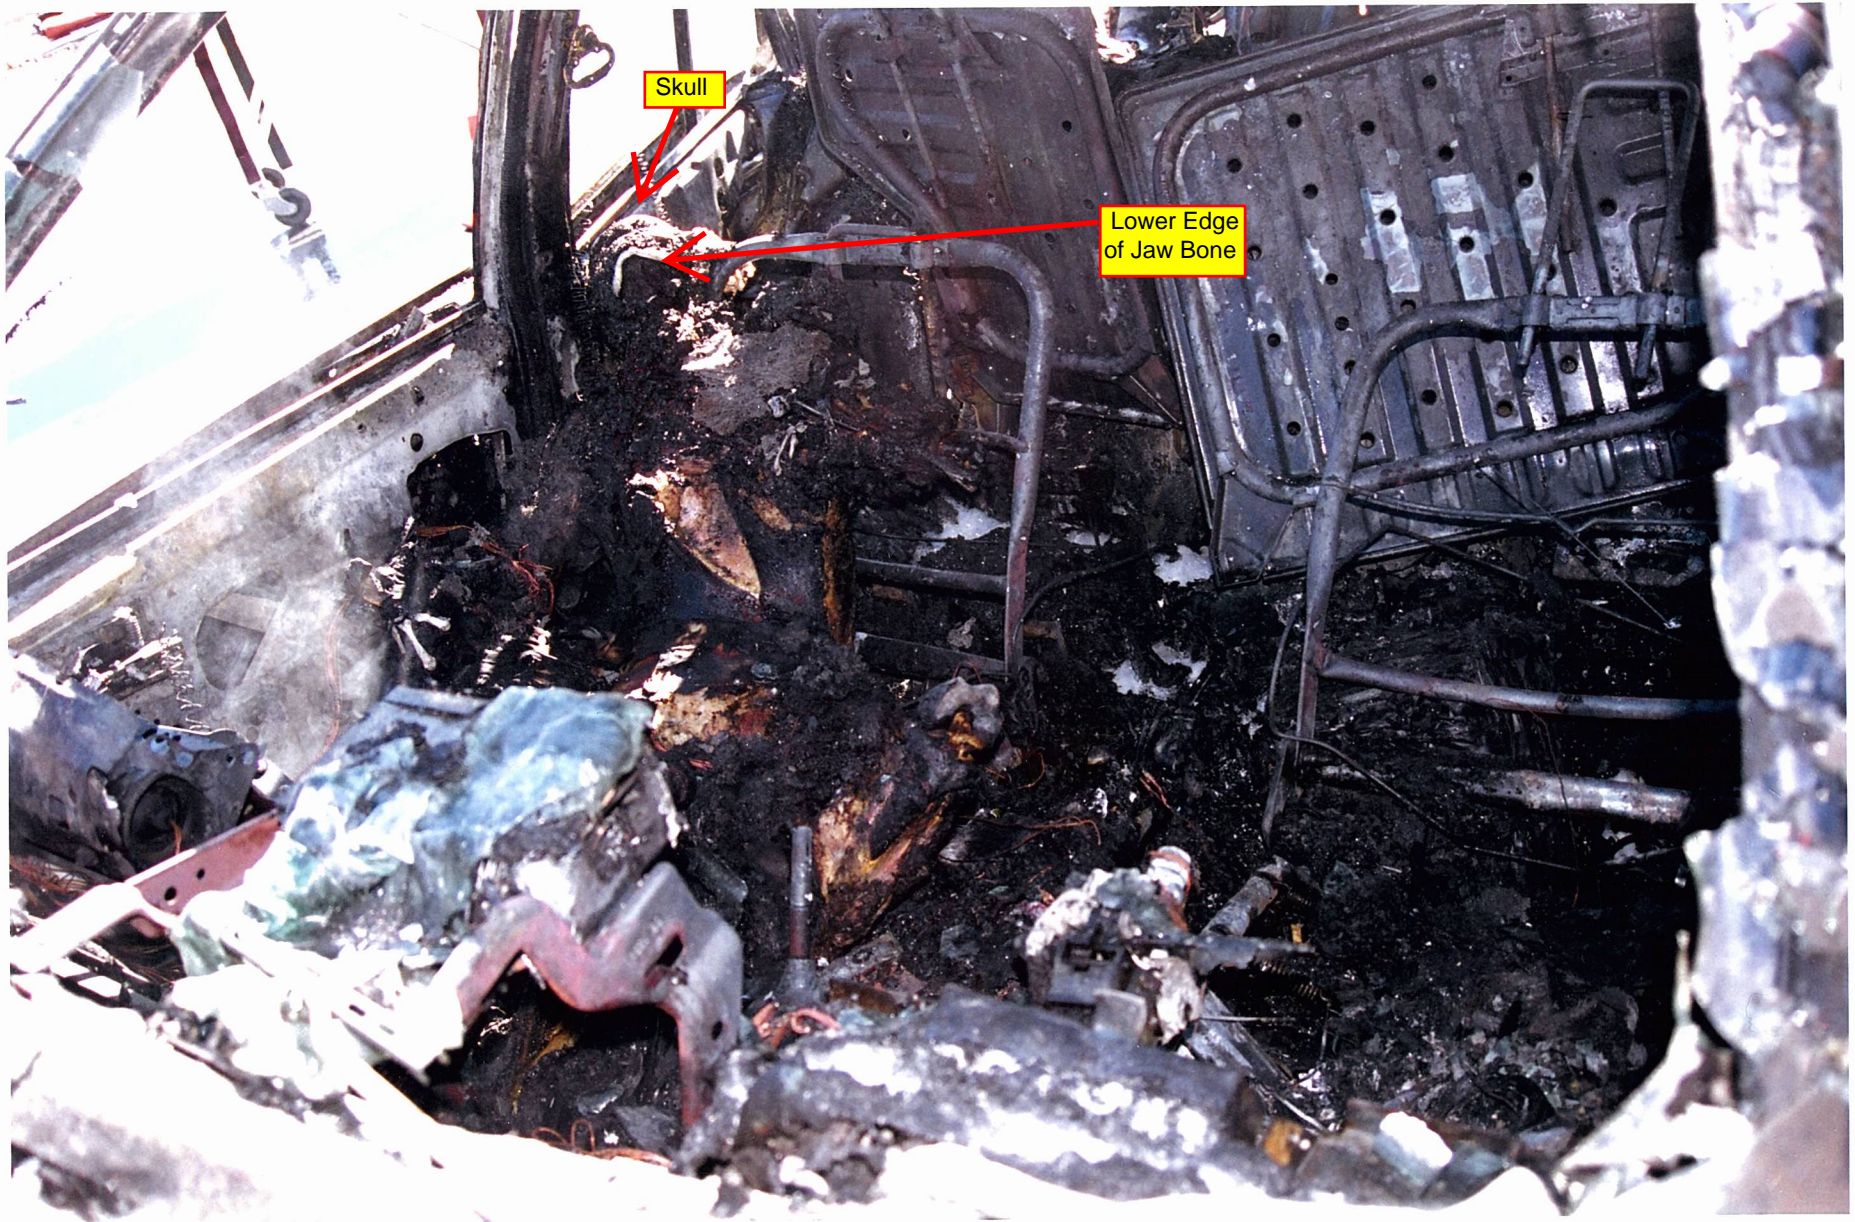
Skull

Lower Edge
of Jaw Bone

Mrs. Susan Kline (death victim):
Post fuel fed fire-death caused by defective fuel system/
tank design in Jeep Grand Cherokee SUVs

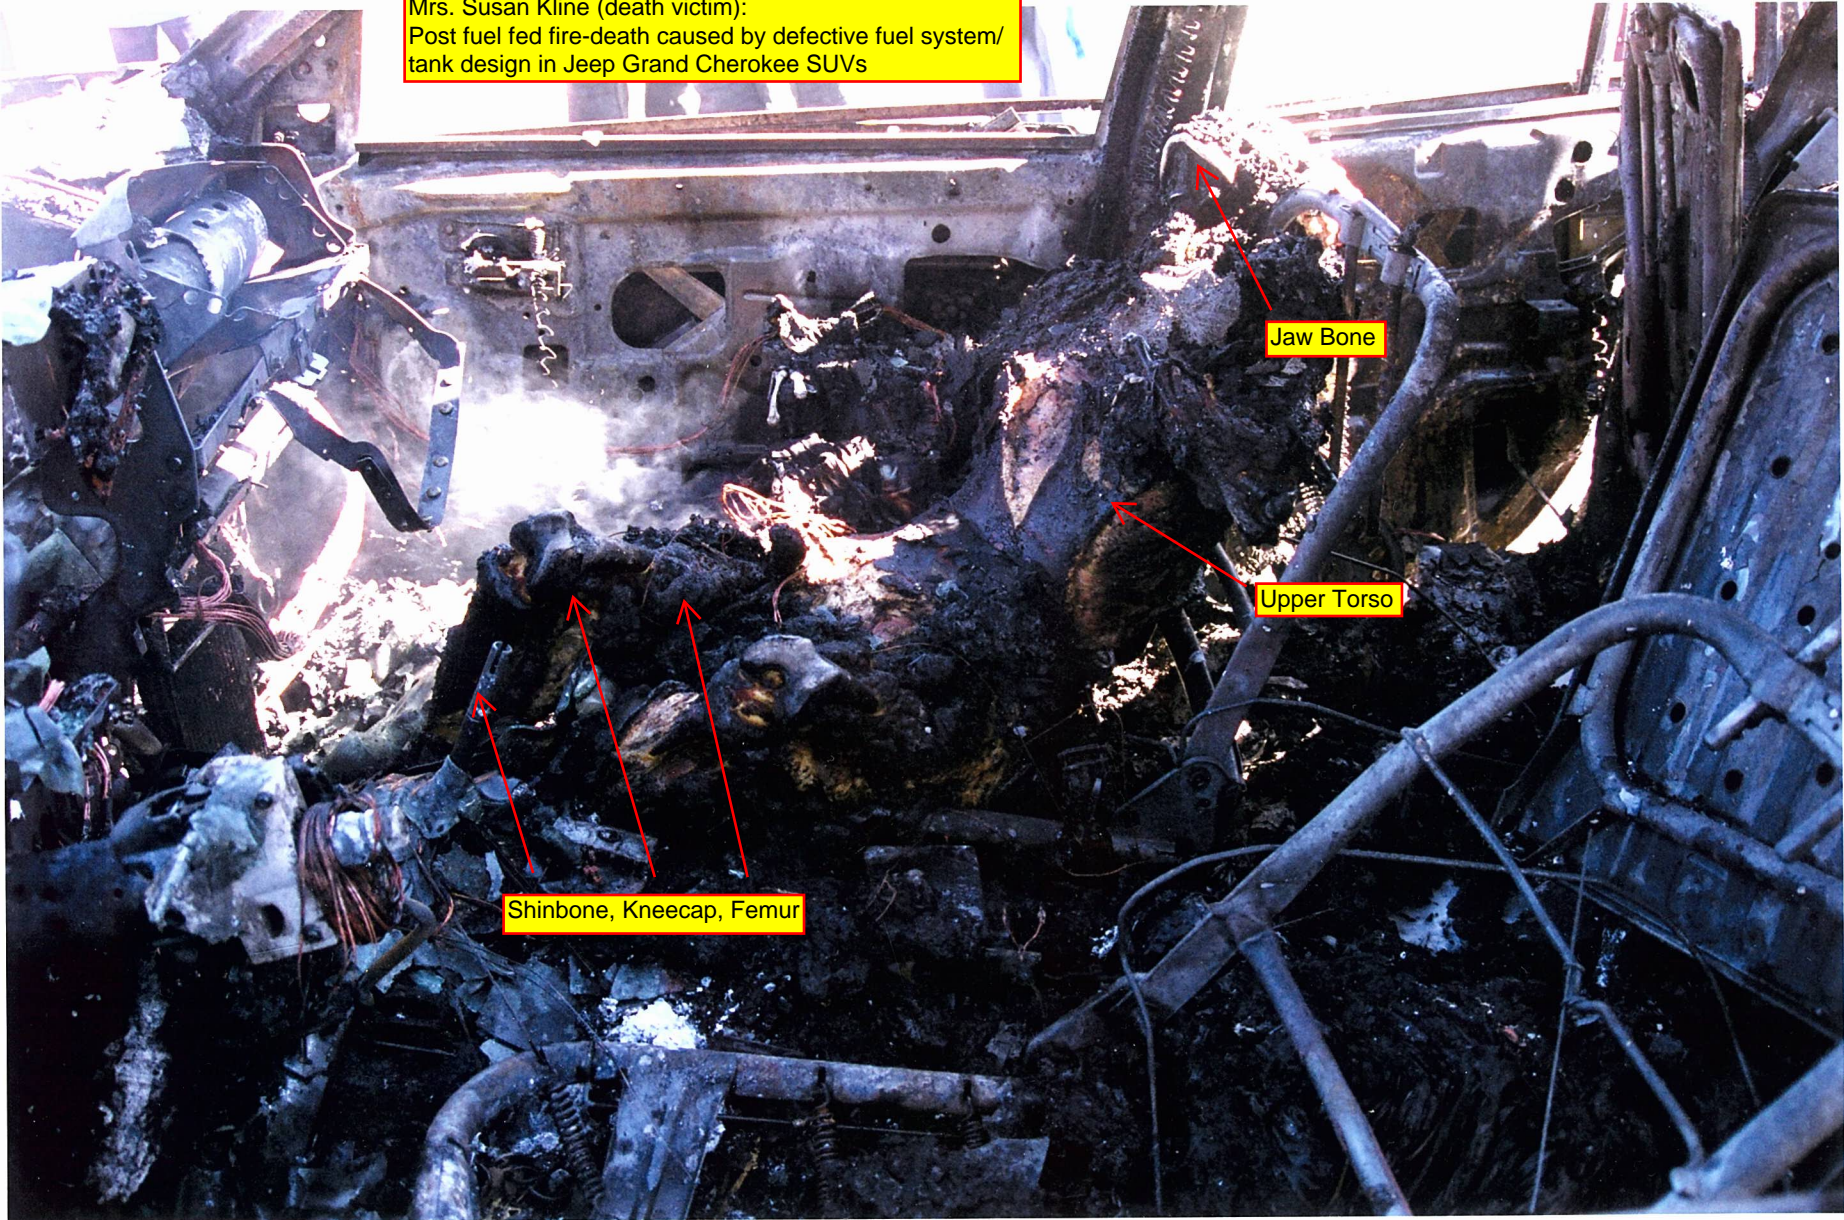
Jaw Bone

Upper Torso
