Reference EA12-005

Subject: Chrysler Group LLC Assertions - Karco ZJ-Body Impact Test of 16 May 2011
Reference: EA12-005 File Update (Chrysler Jeep Fuel Tank System Defect)

In April 2011 my expertise was solicited by Mr. Clarence Ditlow, Director for the Washington D.C. based Center for Auto Safety (CAS), regarding a planned real world crash test of a 1996 ZJ-Body Jeep Grand Cherokee fuel system. My role as representative for CAS also included confirmation of test vehicle (Jeep Grand Cherokee) condition as competent, representative and authentic for the stated test purpose(s).

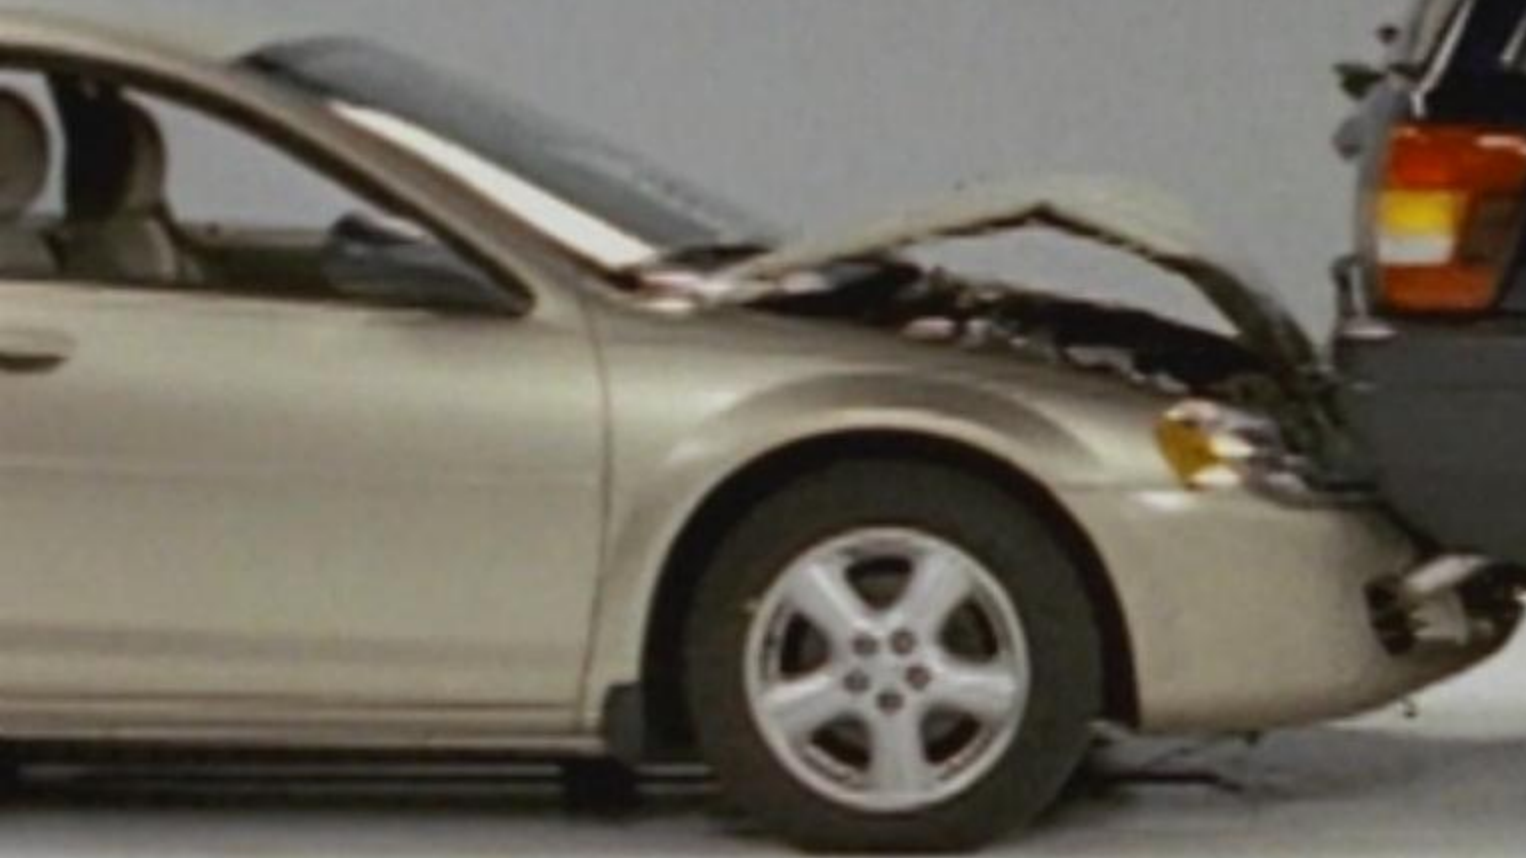
**Underride Mode Caused by
10 mph Bumper Test:
Dodge Stratus into rear of Jeep
Grand Cherokee**

**WJ-Body "Brush Guard"
Damaged, had to be Replaced**

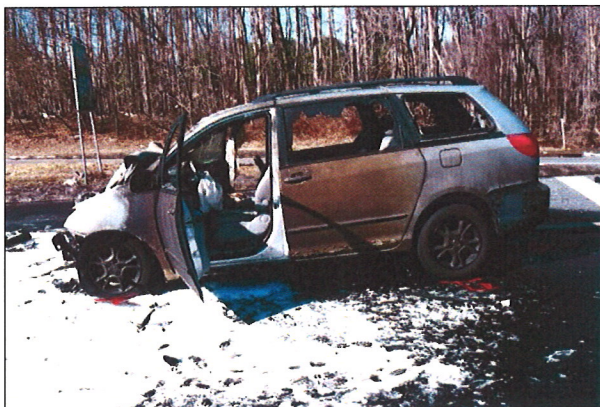
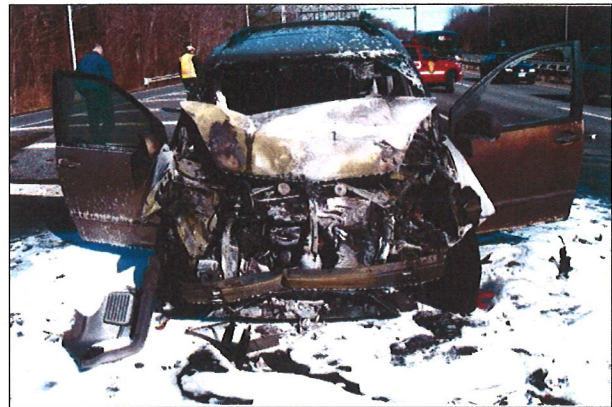
2004 Toyota: The Toyota involved in this crash was a 2004 model year Sienna XLE (VIN - 5TDZA22C34S052135). This vehicle was equipped with a 3.3-liter 6-cylinder gasoline engine and an automatic transmission. Figure 2 shows the Toyota at the accident scene. As can be seen in the figure, the Toyota shows signs of frontal impact and fire damage. The Toyota was not available for Kineticorp’s inspection.

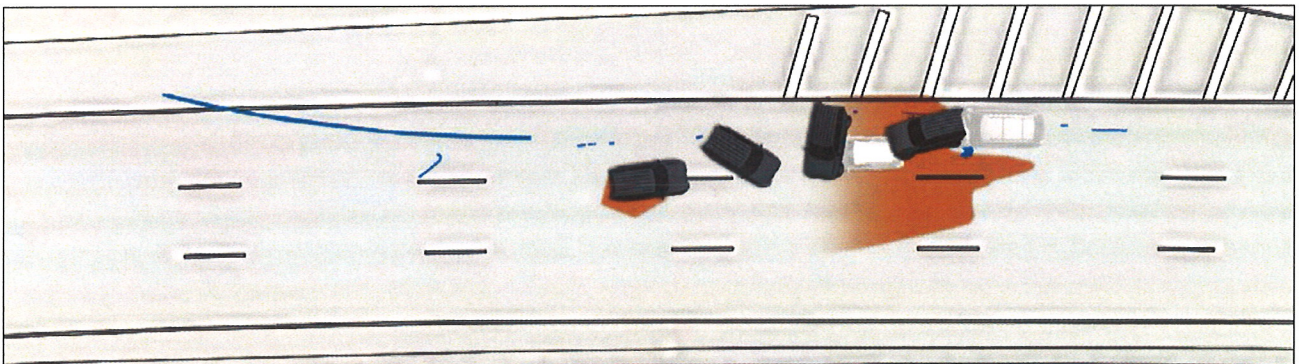
Figure 10

The vehicles then traveled to rest. The collision locked the rear right tire of the Subaru, causing it to leave a dark tire mark that led to its rest position. The Subaru traveled approximately 130 feet after the impact and came to rest on the shoulder. The Toyota traveled approximately 40 feet before coming to rest in the right lane. As the Jeep was crushed between the Subaru and the Toyota, it began to rotate counter-clockwise. The Jeep traveled approximately 50 feet, and rotated approximately 180 degrees before coming to rest straddling the right and middle lanes. The motion of the Jeep as it traveled to rest is depicted in Figure 10.

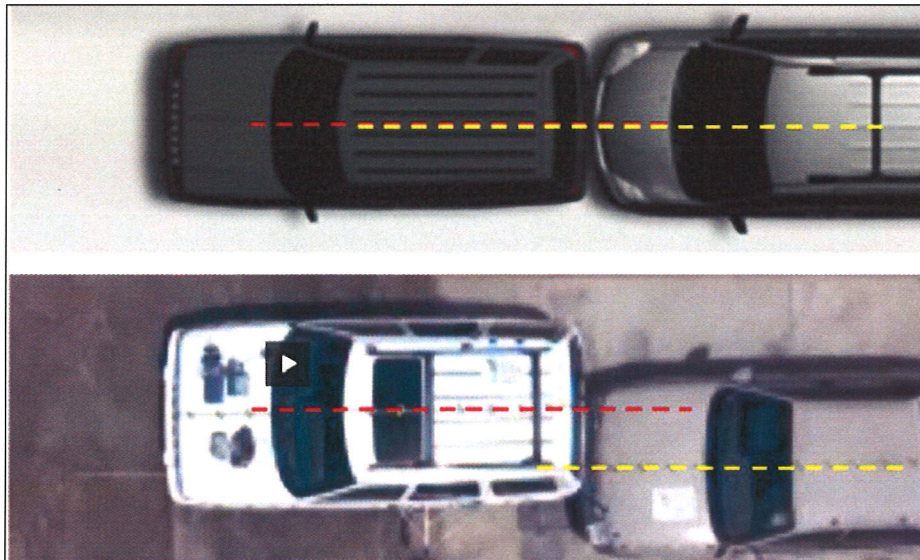
In the subject accident, the Toyota impacted squarely into the entire rear of the Jeep. In the KARCOTest, the collision was offset, such that the entire rear of the Jeep was not directly involved in the collision. This offset in the test is significant because less of the vehicle's width is available to absorb the impact energy. In other words, offset collisions are more severe in terms of energy absorption demands placed on the impacted vehicle. Since the subject accident was a full overlap collision, the offset tests are misrepresentative of the subject accident. The top image in Figure 14 depicts the lateral alignment of the vehicles in the subject accident. The red line indicates the center of the Jeep, the yellow line indicates the center of the Toyota. The KARCOTest is depicted below.² In the KARCOTest, the Taurus is offset significantly to the left at impact. Due to the lateral and vertical alignment differences, no meaningful comparisons can be made between the subject accident and the KARCOTest results. It should also be noted that components in the test Jeeps were removed, such as the spare tire, door panels and the rear side windows. At this time Kineticcorp has not made a determination as to the effect of removing these items in the tests.

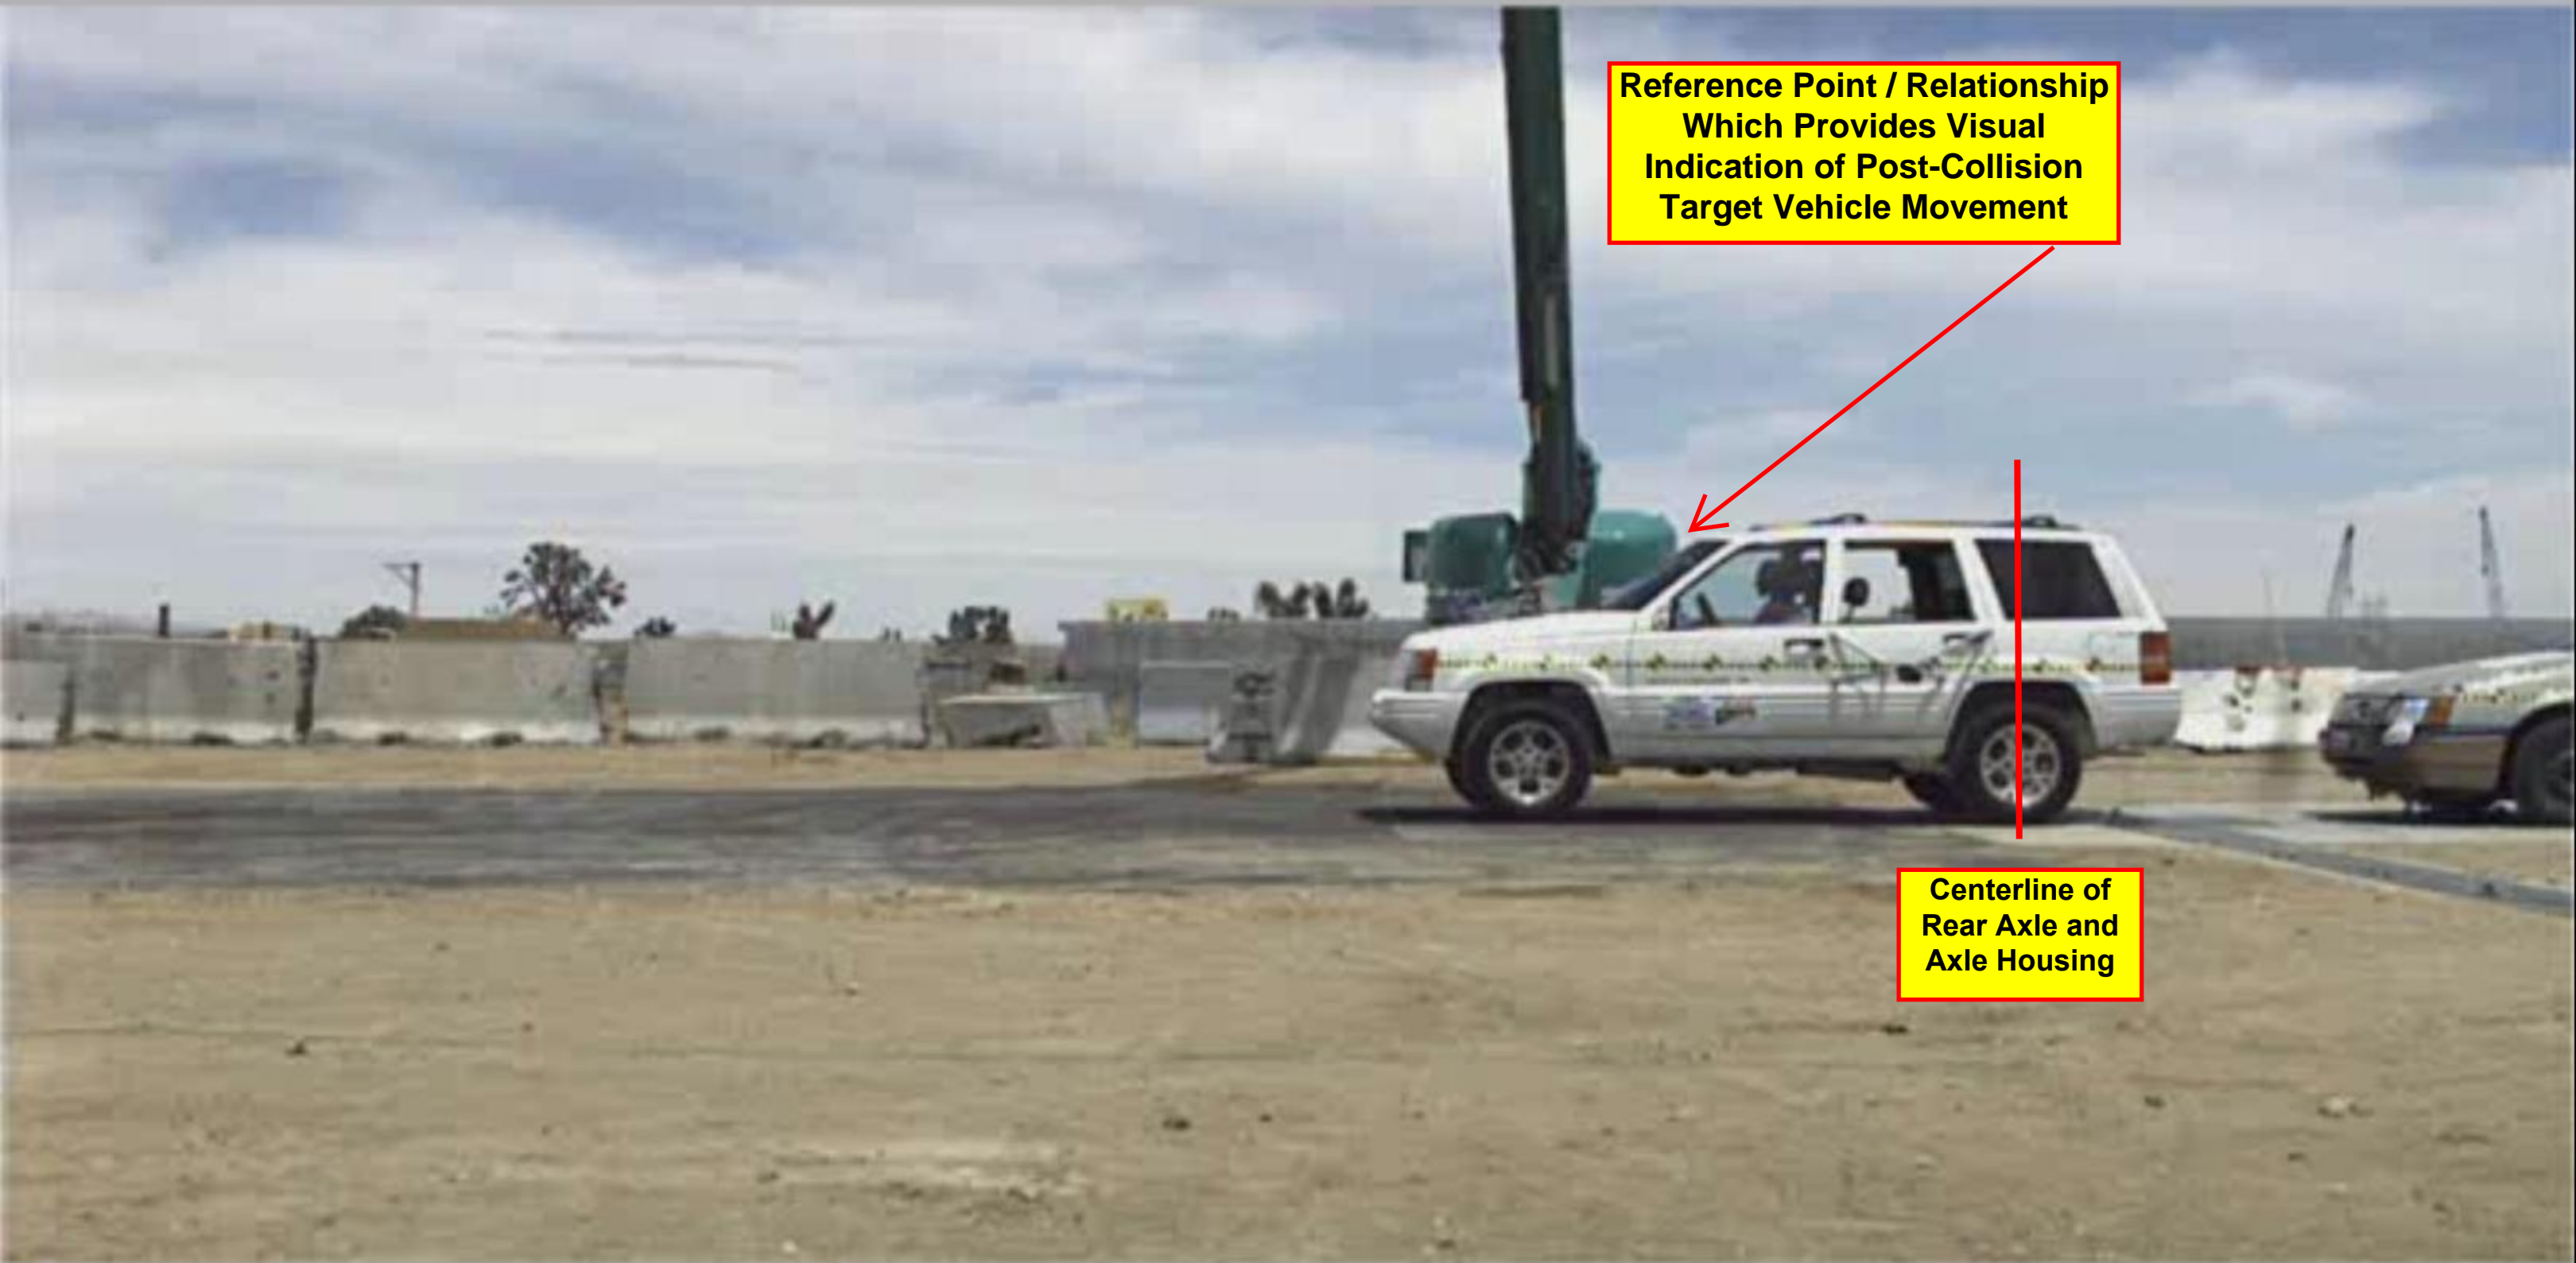
Camera View-01

Reference Point / Relationship
Which Provides Visual
Indication of Post-Collision
Target Vehicle Movement

Centerline of
Rear Axle and
Axle Housing

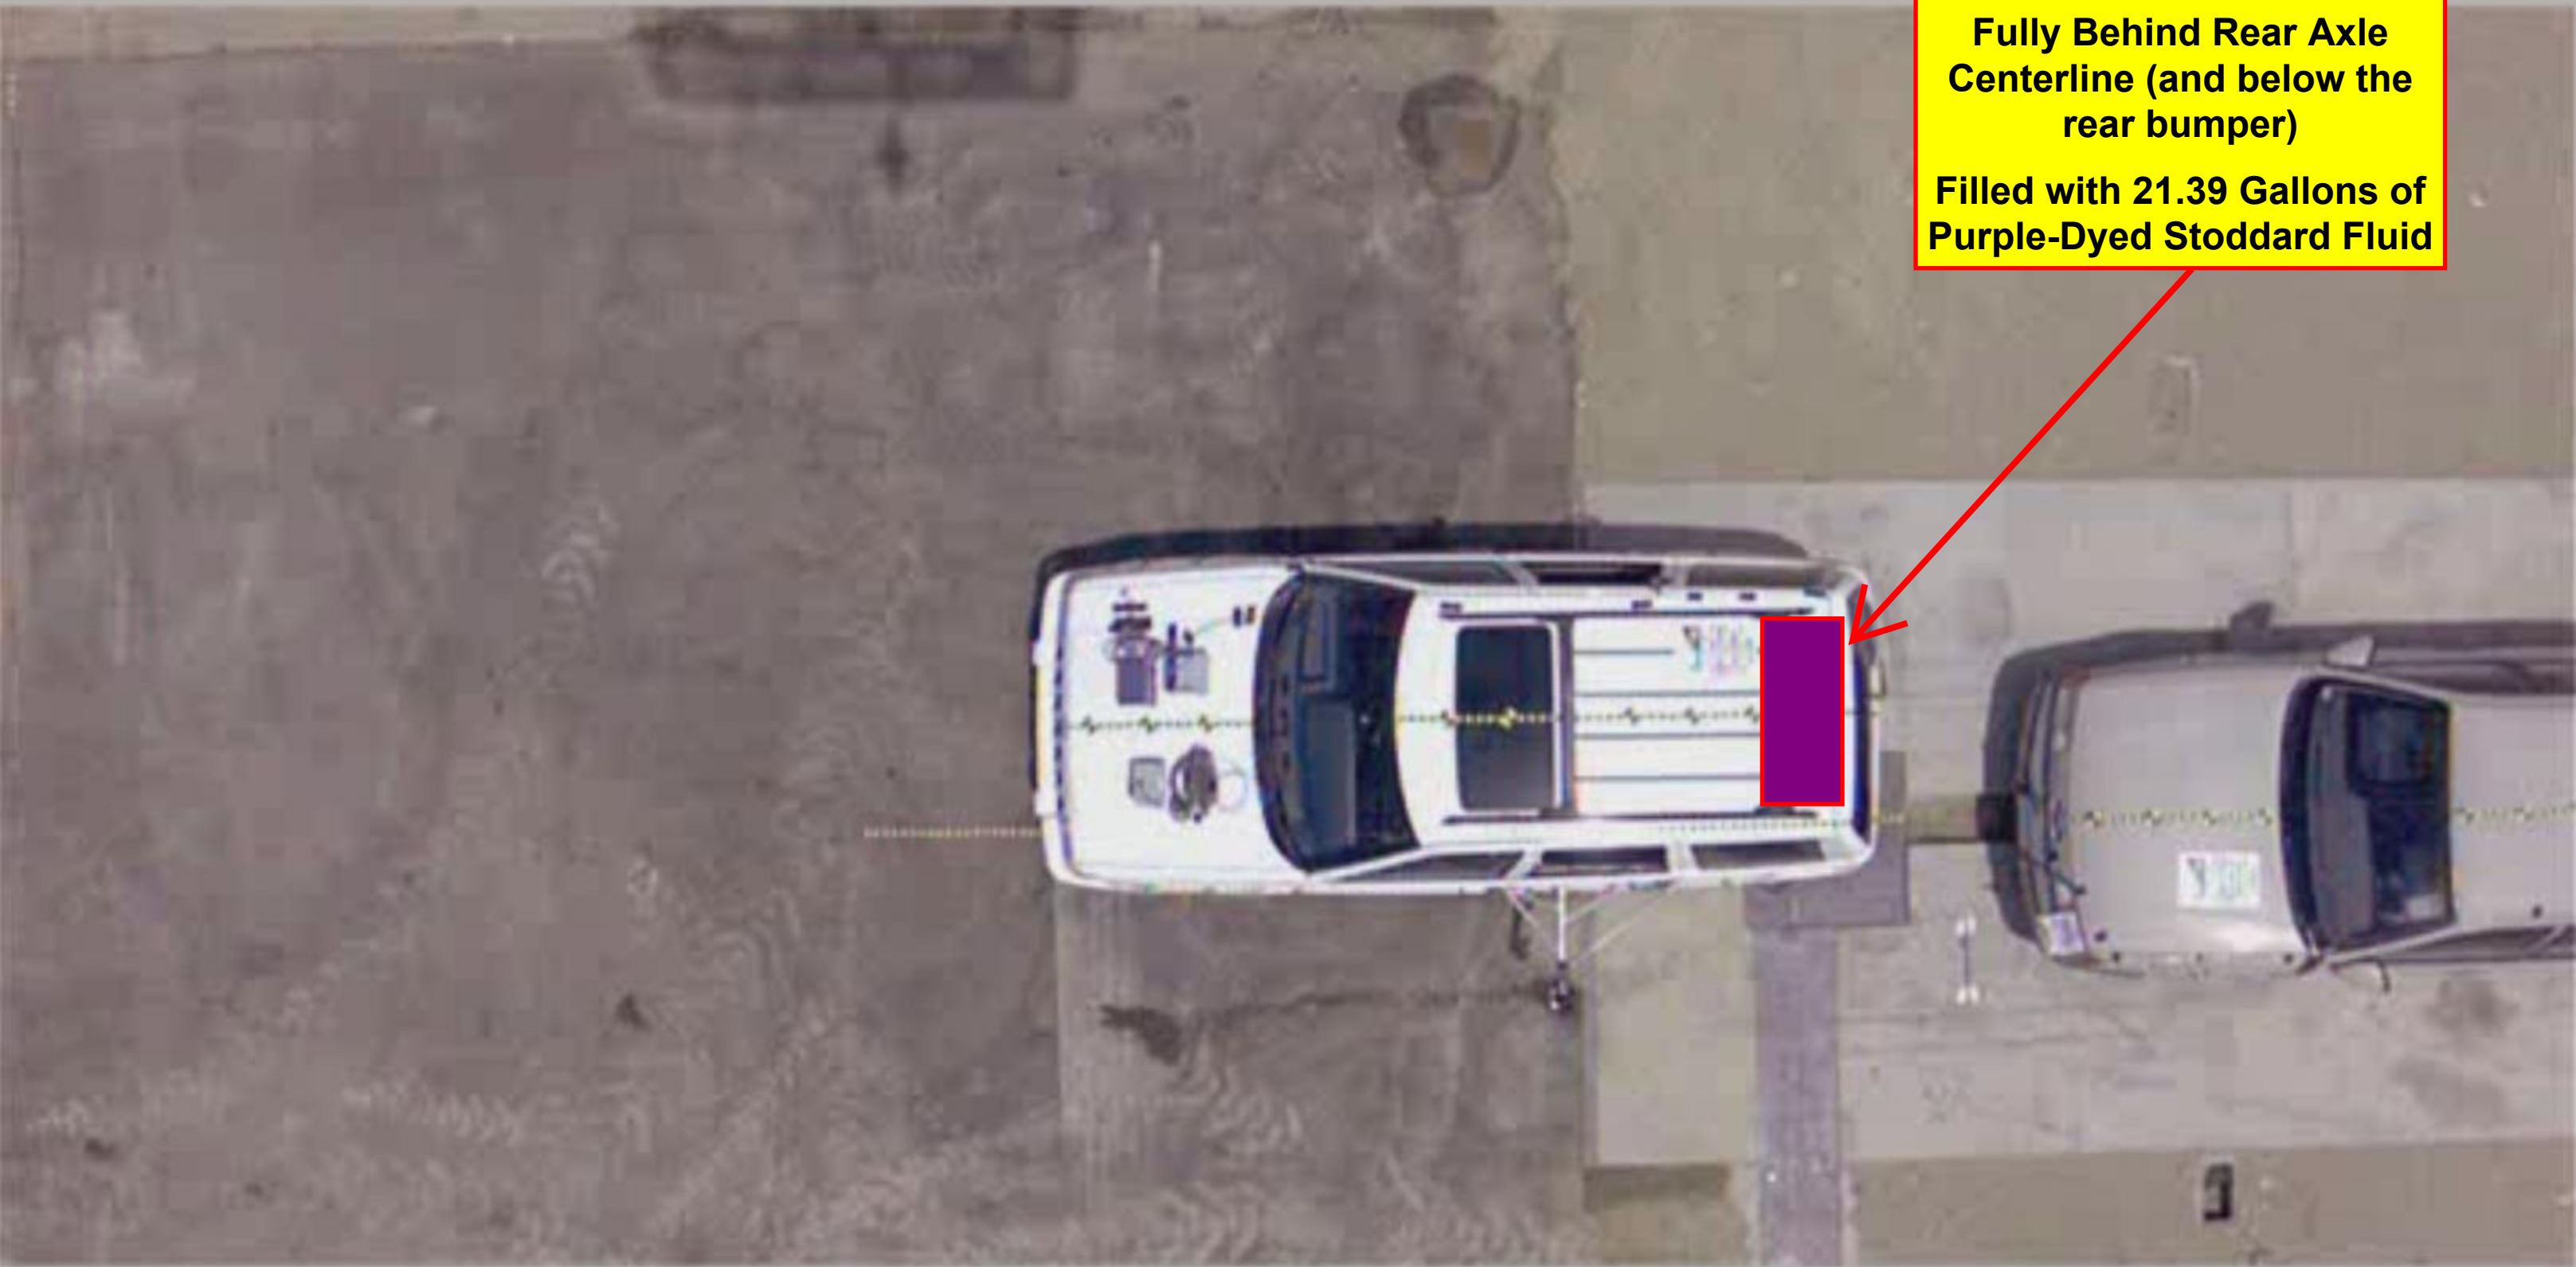
Camera View-02

Purple Rectangle Shows
Approximate Position of
Polyethylene Fuel Tank:
Fully Behind Rear Axle
Centerline (and below the
rear bumper)
Filled with 21.39 Gallons of
Purple-Dyed Stoddard Fluid

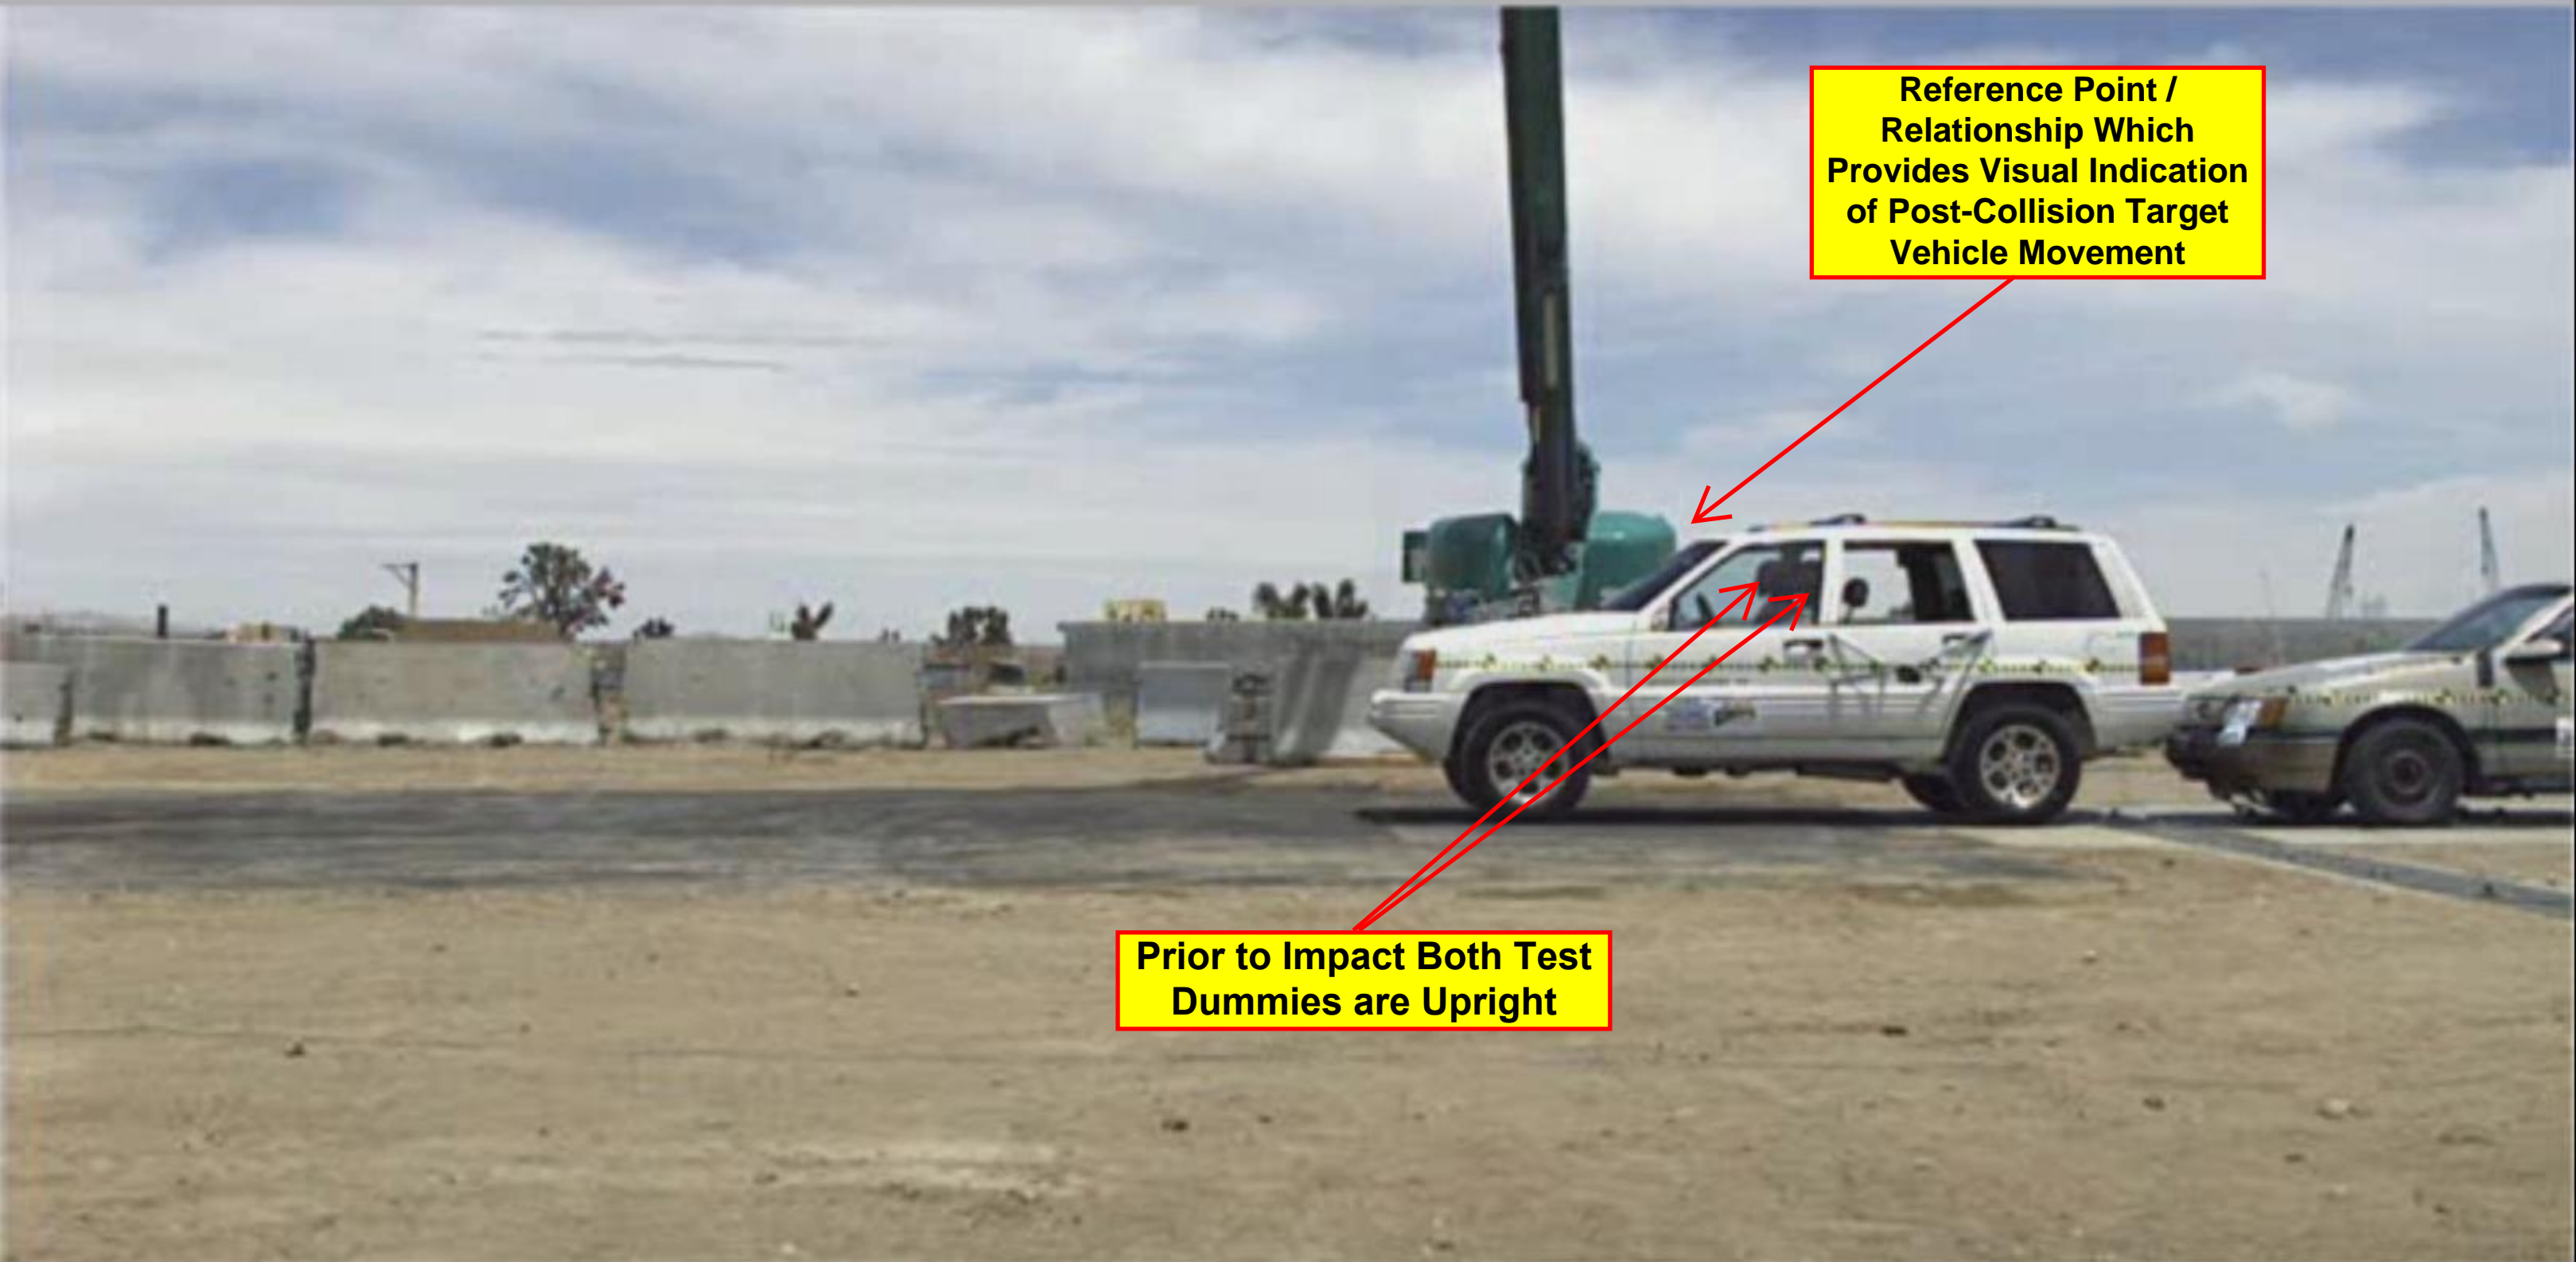
Camera View-01

At $T = 0.000$ contact between the bullet vehicle and the target Jeep Grand Cherokee has occurred. A reference point is indicated for analysis of the post-collision target vehicle movement in the X-axis. The fuel tank stoddard fill (21.39 gallons), and the lack of purple-dyed stoddard staining of the impact pad is emphasized.

Reference Point /
Relationship Which
Provides Visual Indication
of Post-Collision Target
Vehicle Movement

Prior to Impact Both Test
Dummies are Upright

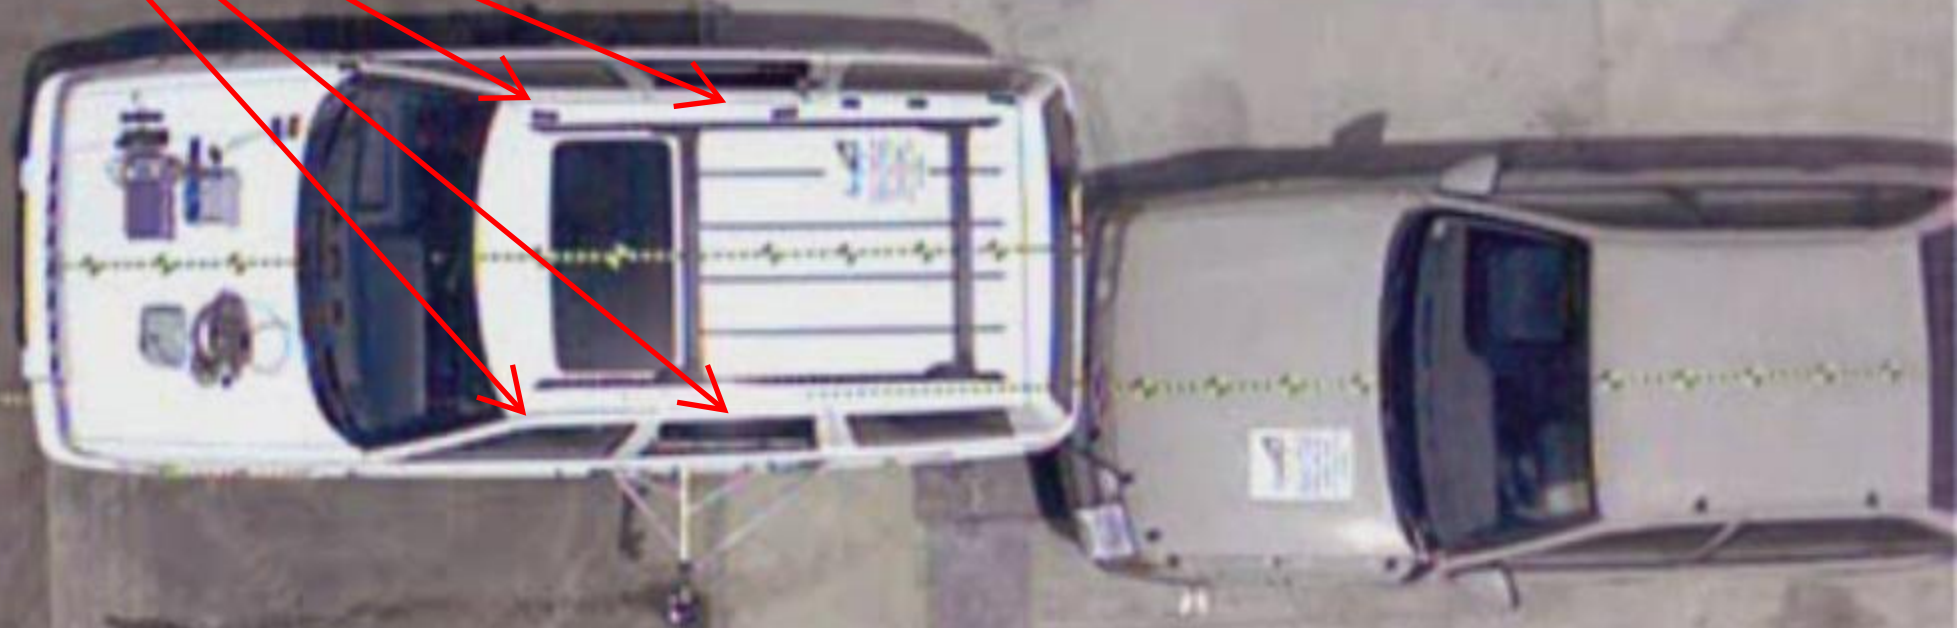
Camera View-02

**No Bodyside or Door Frame
Deformation**
**All Four Doors are Operative Which
Allow for Emergency Egress**
