Reference EA12-005

Subject: Chrysler Group LLC Assertions - Karco ZJ-Body Impact Test of 16 May 2011
Reference: EA12-005 File Update (Chrysler Jeep Fuel Tank System Defect)

In April 2011 my expertise was solicited by Mr. Clarence Ditlow, Director for the Washington D.C. based Center for Auto Safety (CAS), regarding a planned real world crash test of a 1996 ZJ-Body Jeep Grand Cherokee fuel system. My role as representative for CAS also included confirmation of test vehicle (Jeep Grand Cherokee) condition as competent, representative and authentic for the stated test purpose(s).

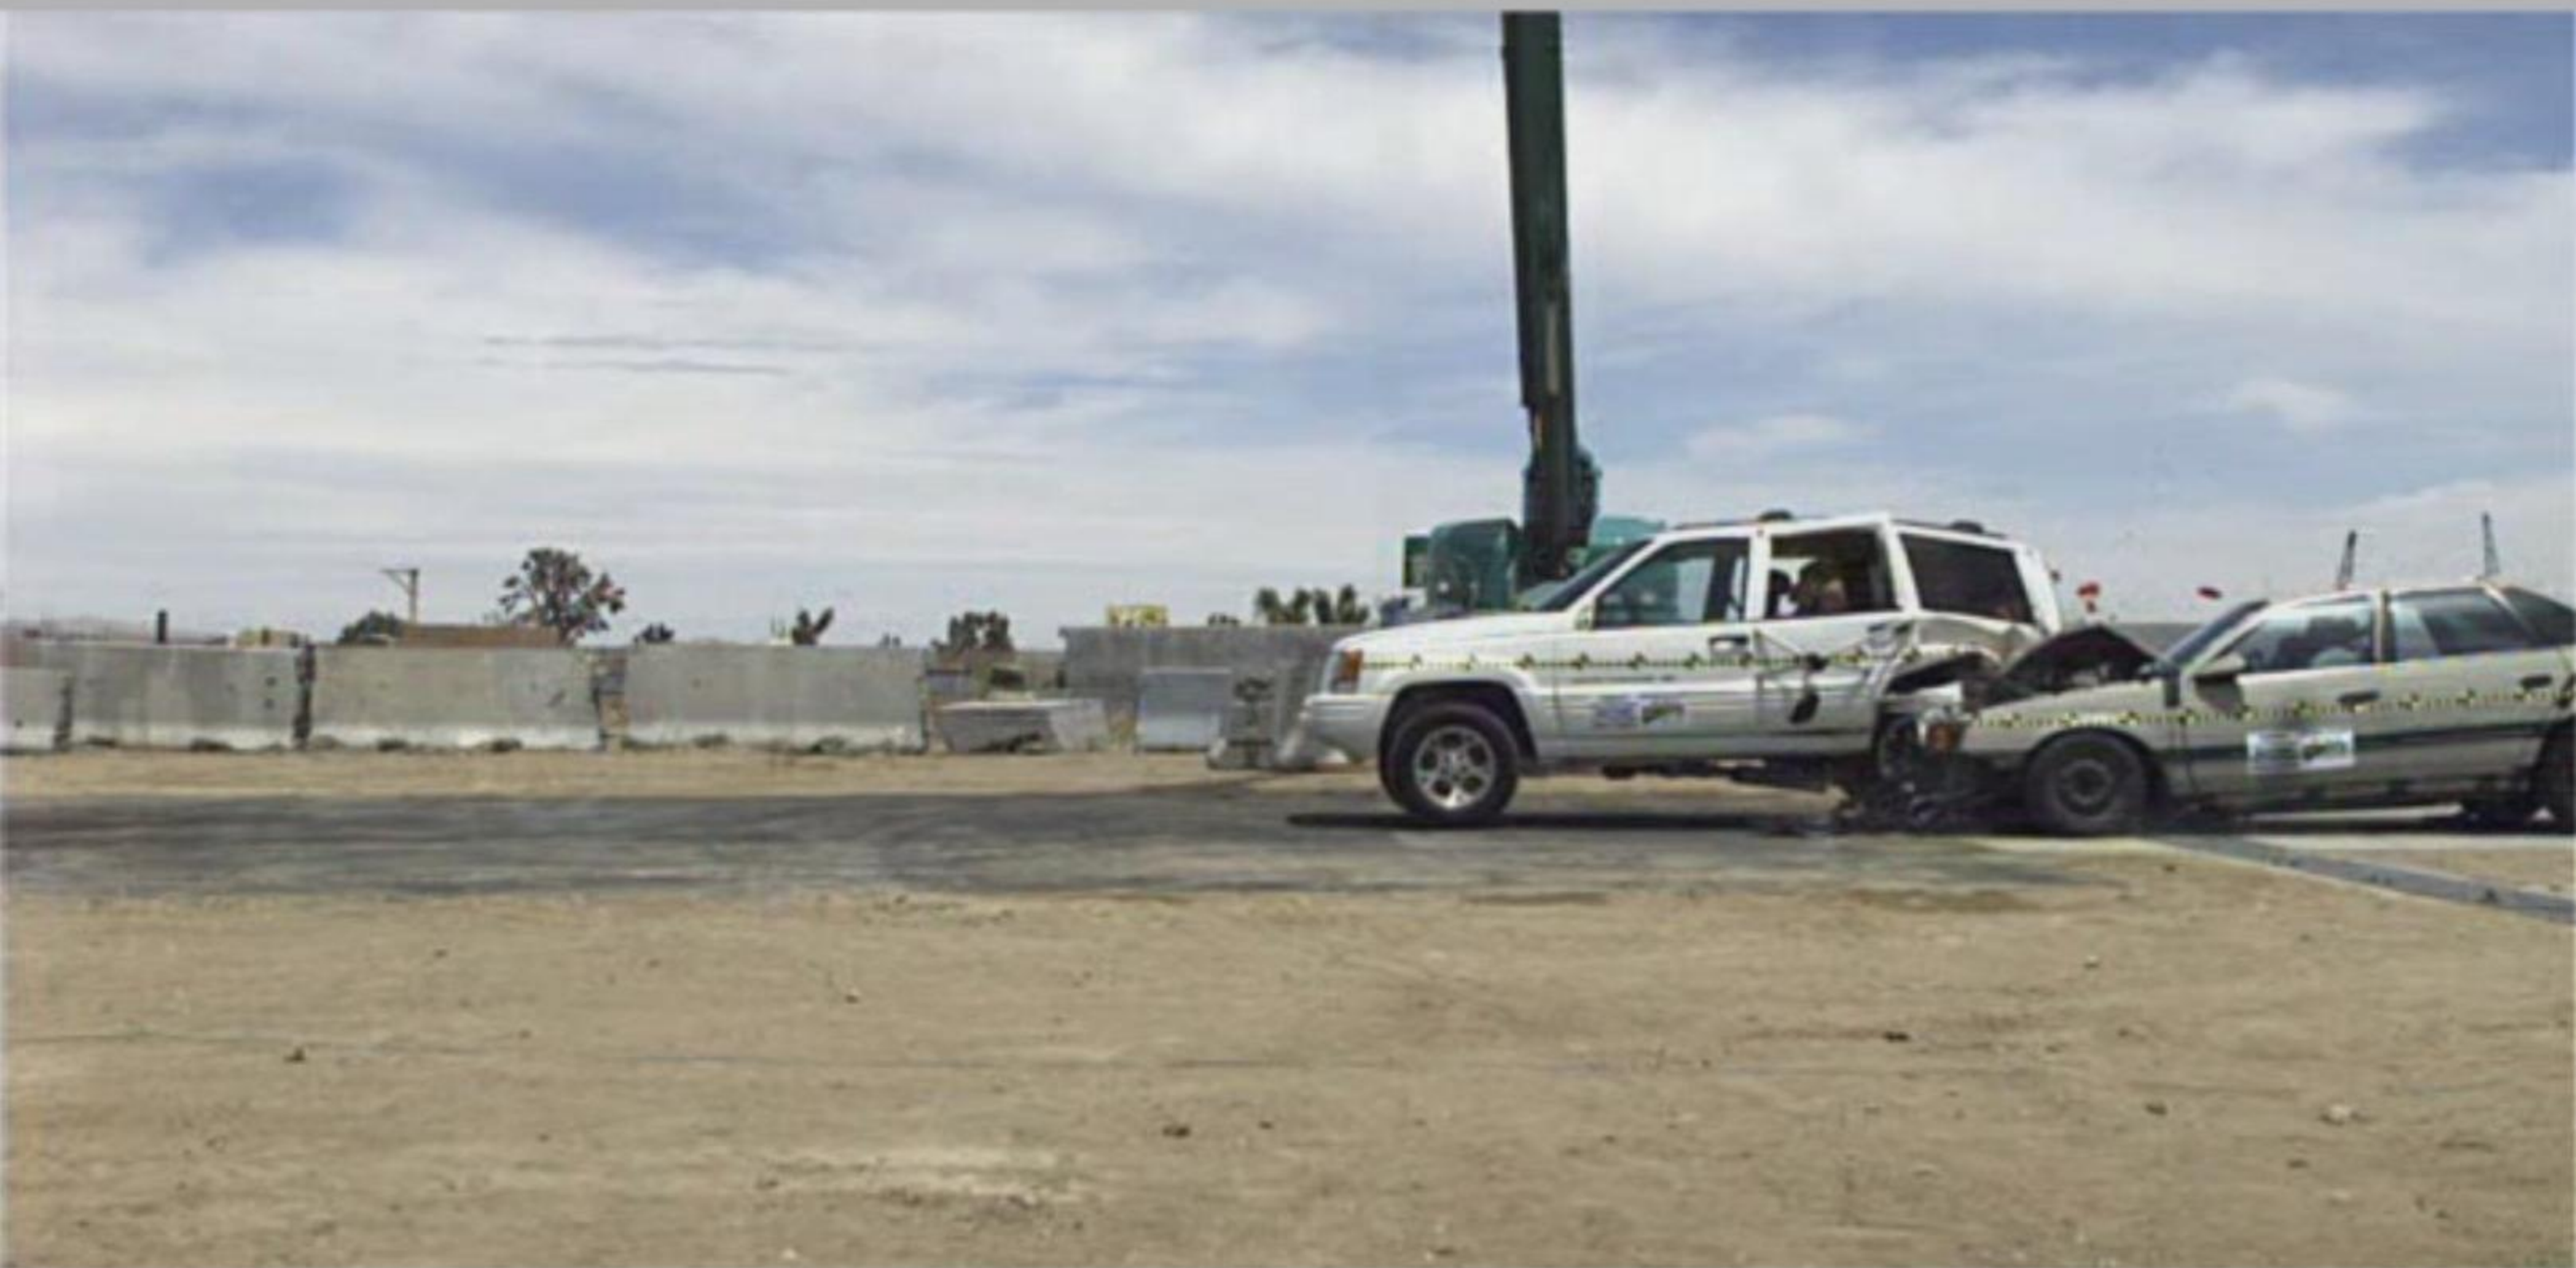
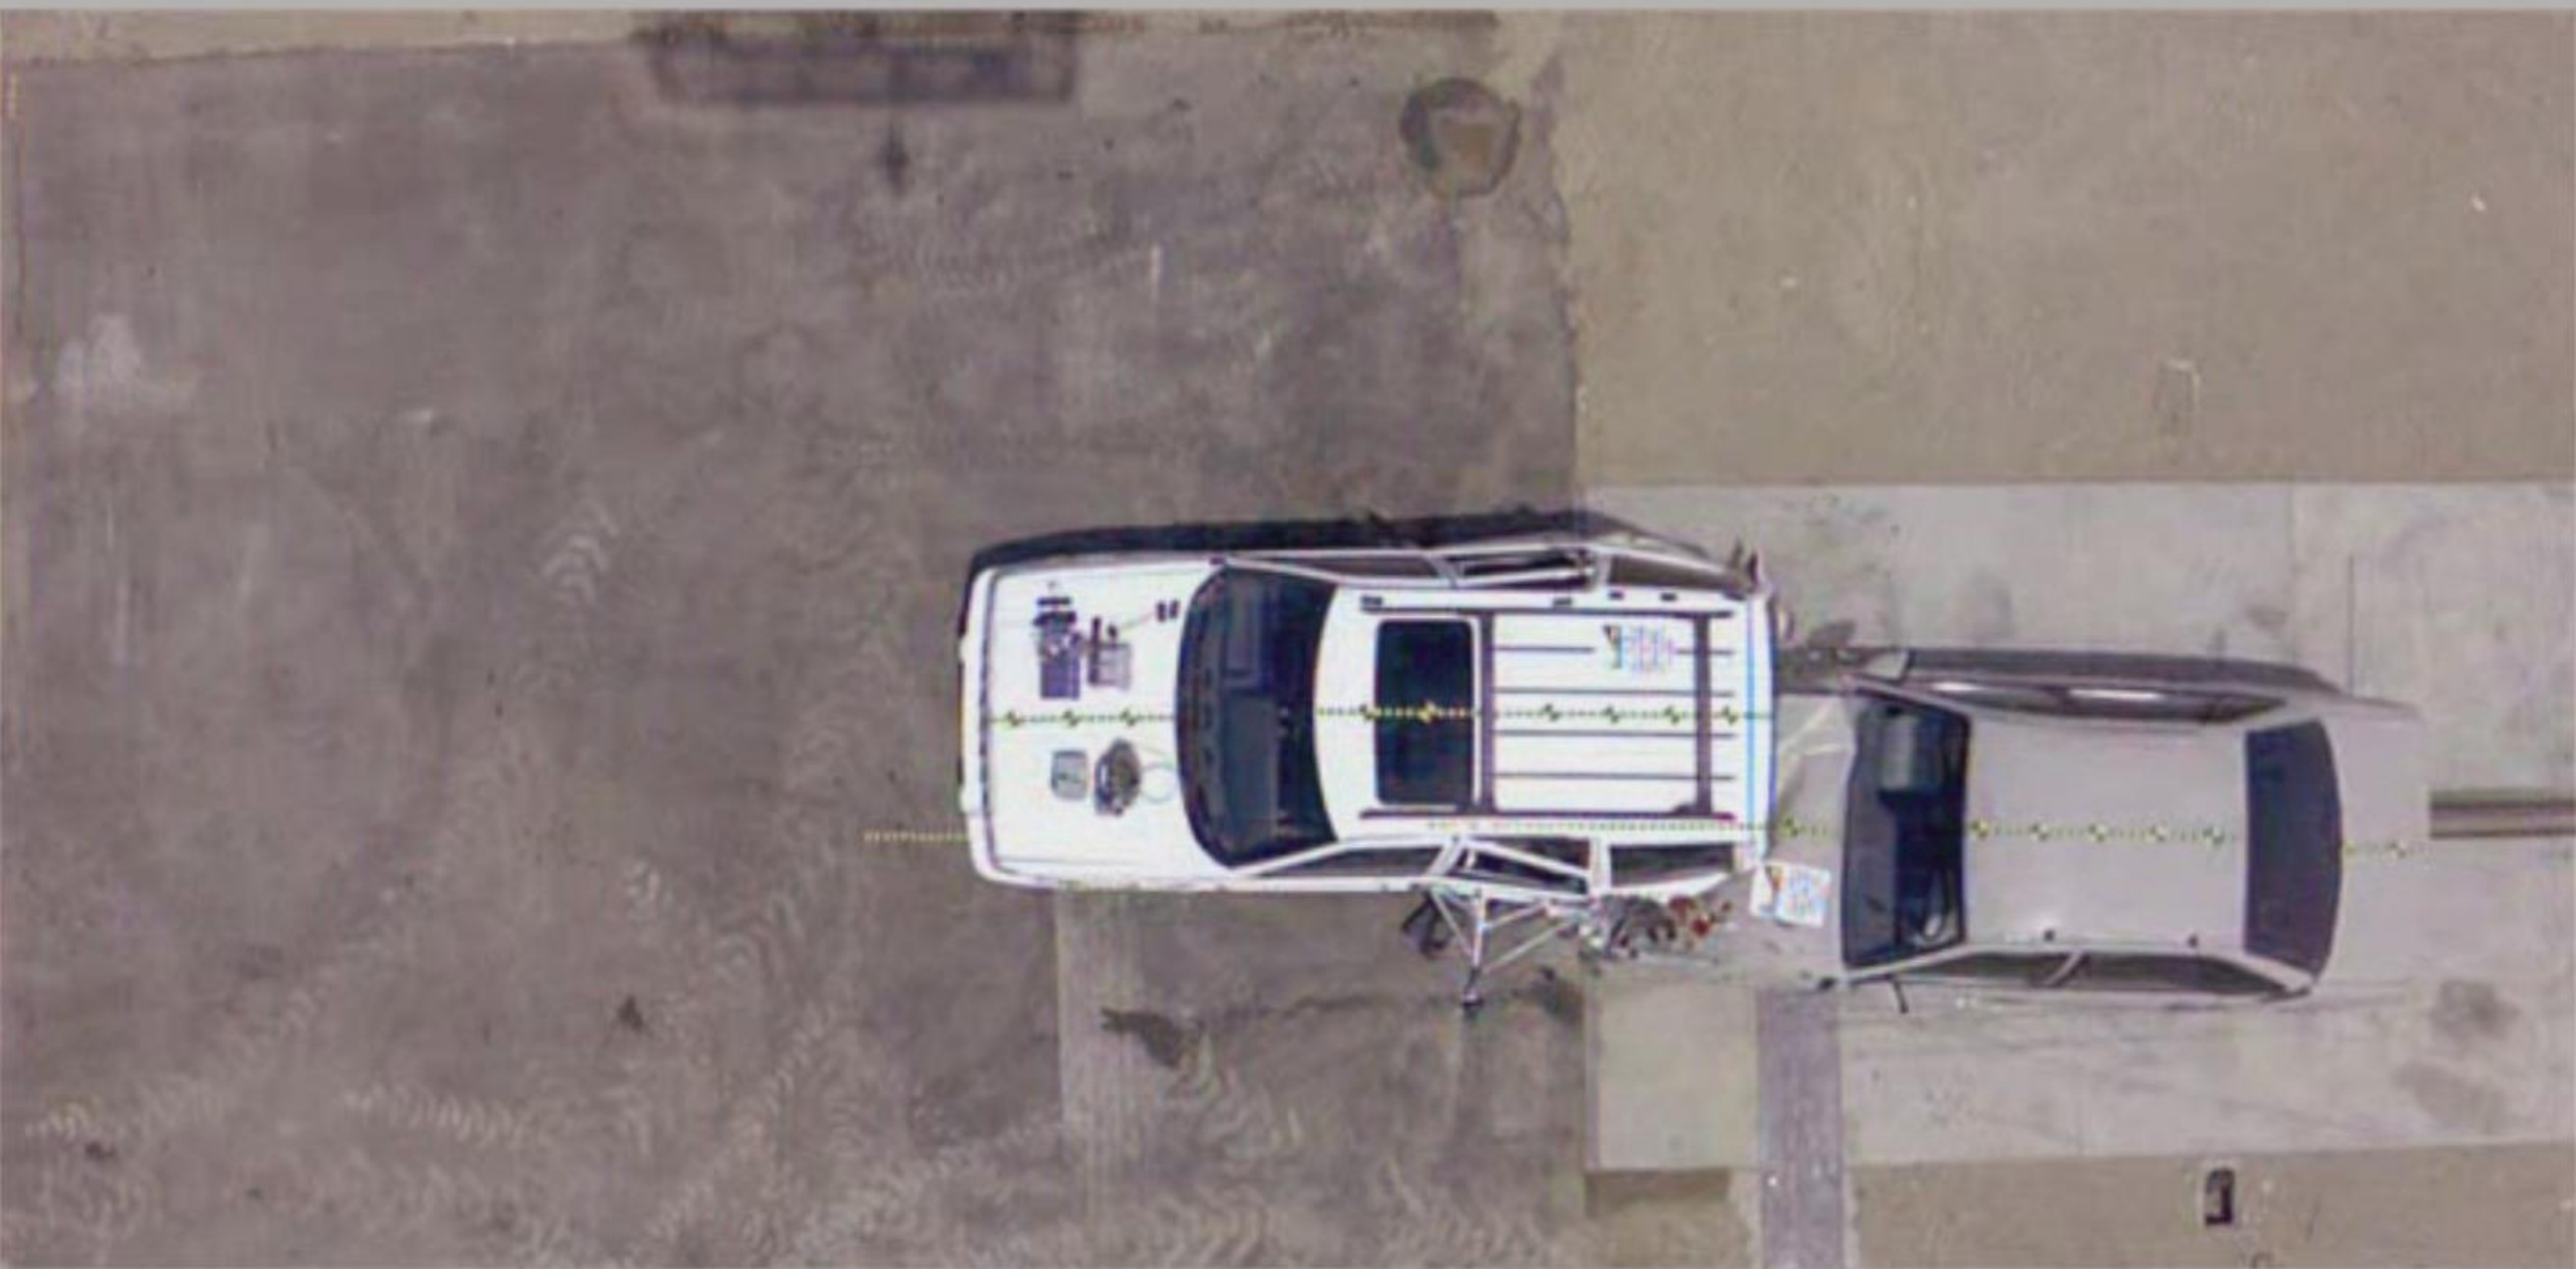
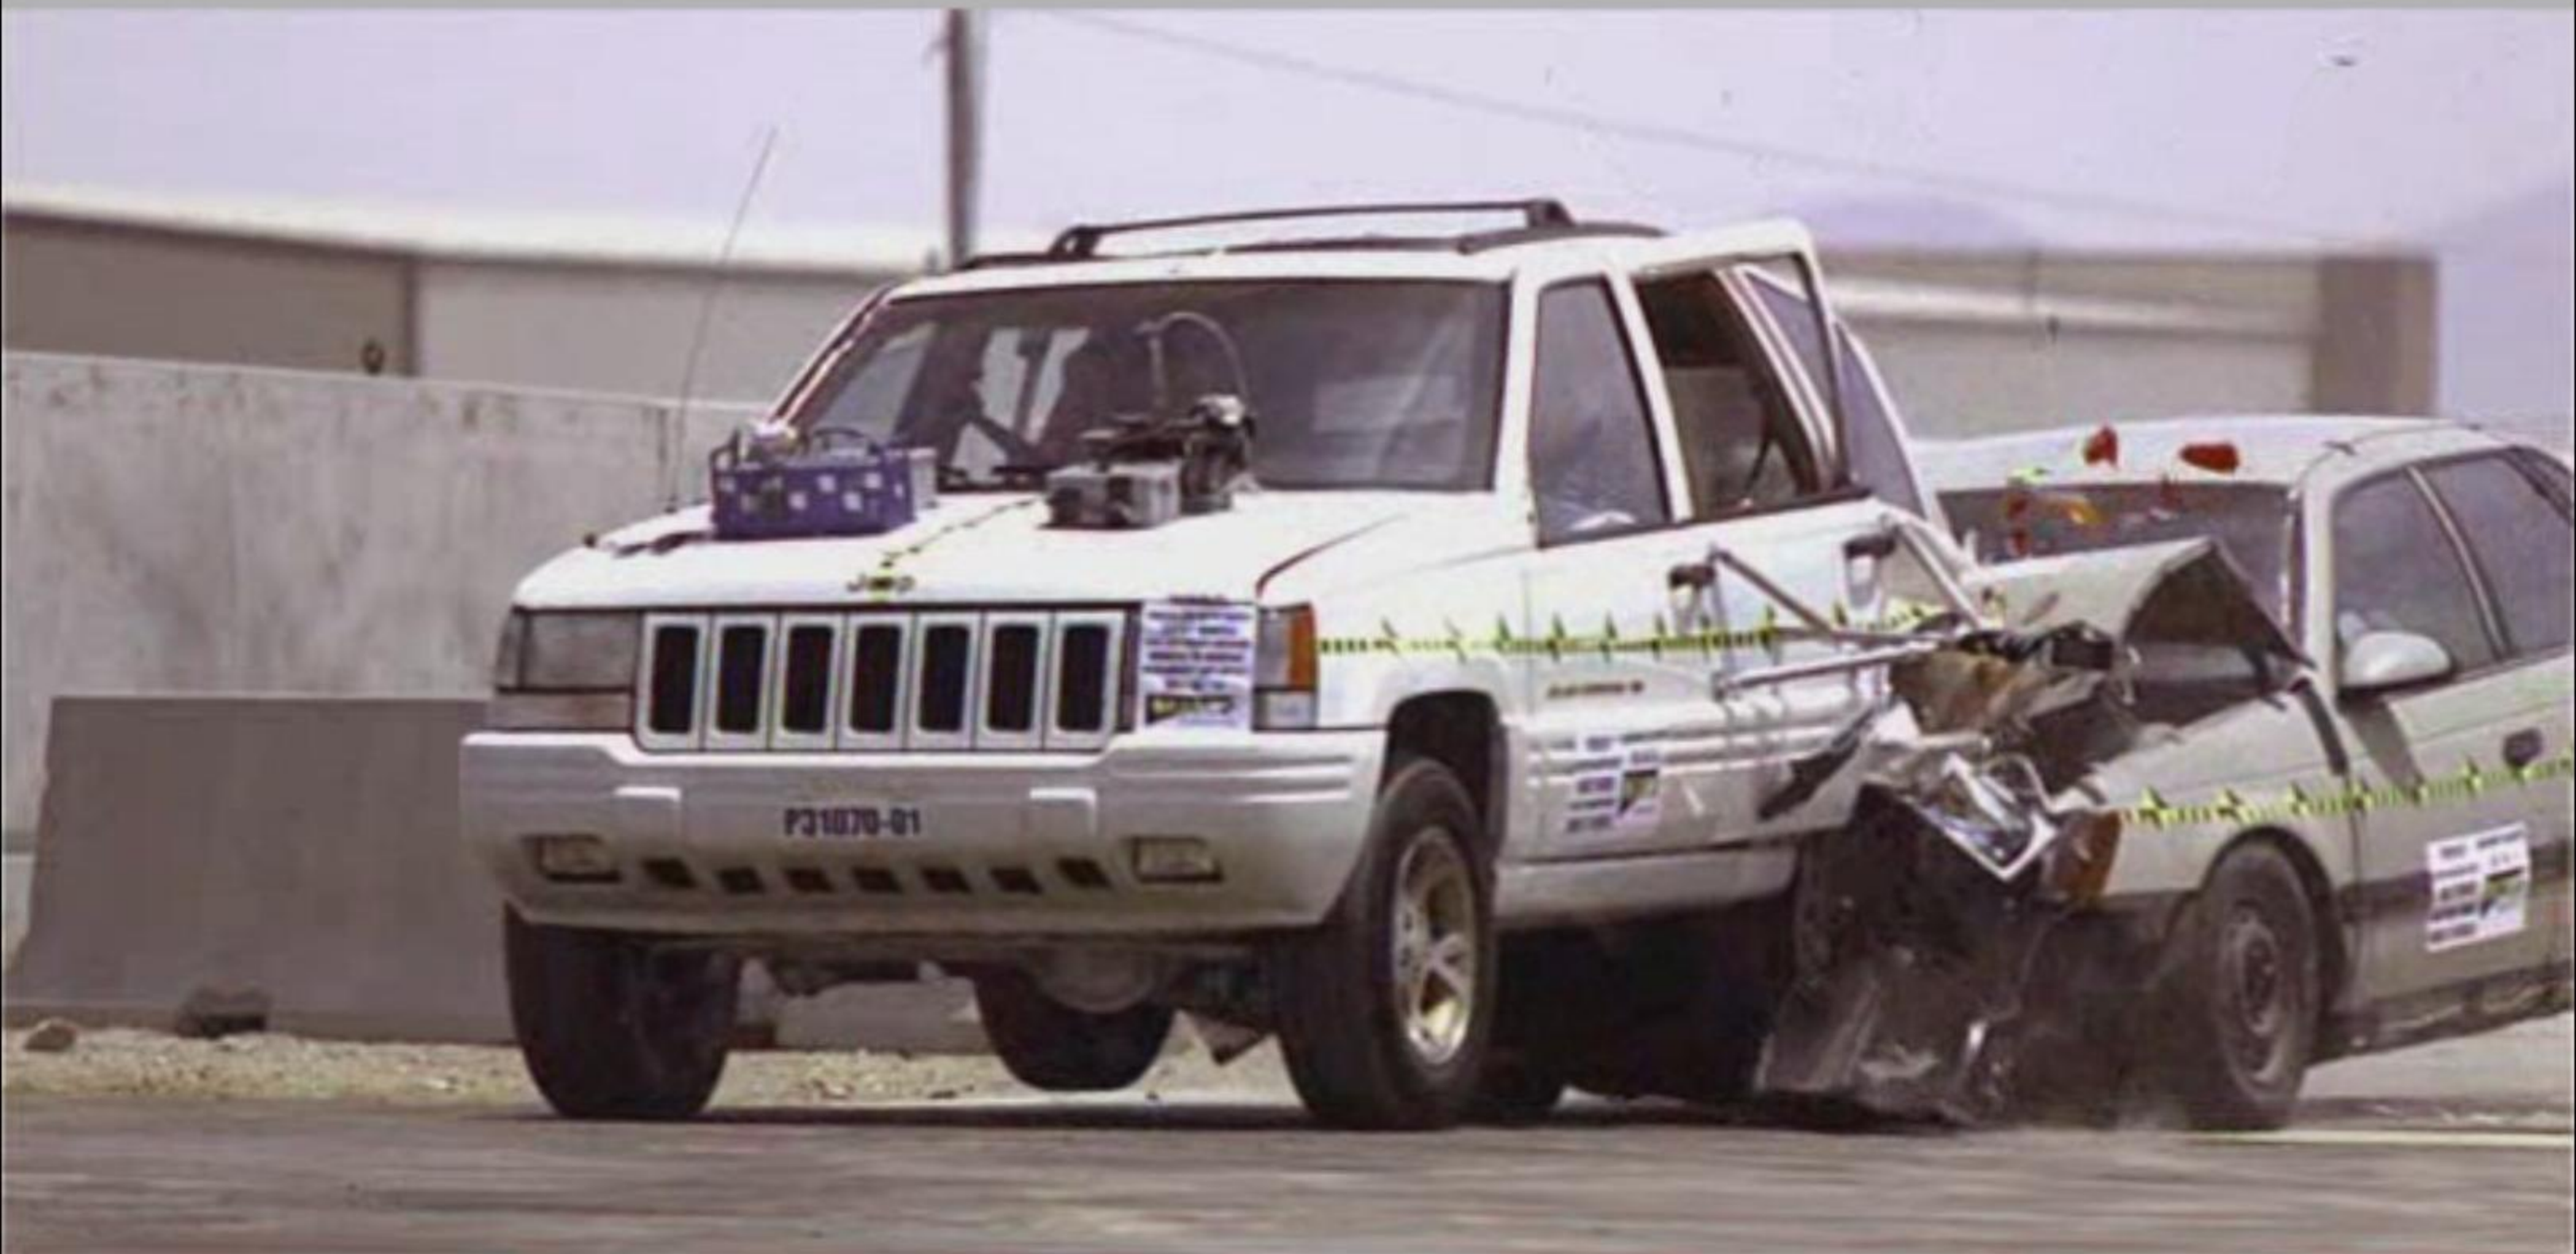
At T = +0.119, the target vehicle has commenced appreciable movement in the X-axis direction. This separation sequence, which moves the target /bullet vehicles off the impact pad, exposes the surface, and accommodates viewing of the stoddard evidence of a fuel tank breach which I assert occurred back at T = +0.052.
