Date: 3 September 2012

VIA FEDEX AIRBILL 8007 – 9341 - 5860

**Subject: Chrysler Group LLC Assertions - Karco ZJ-Body Impact Test of 16 May 2011**  
**Reference: EA12-005 File Update (Chrysler Jeep Fuel Tank System Defect)**

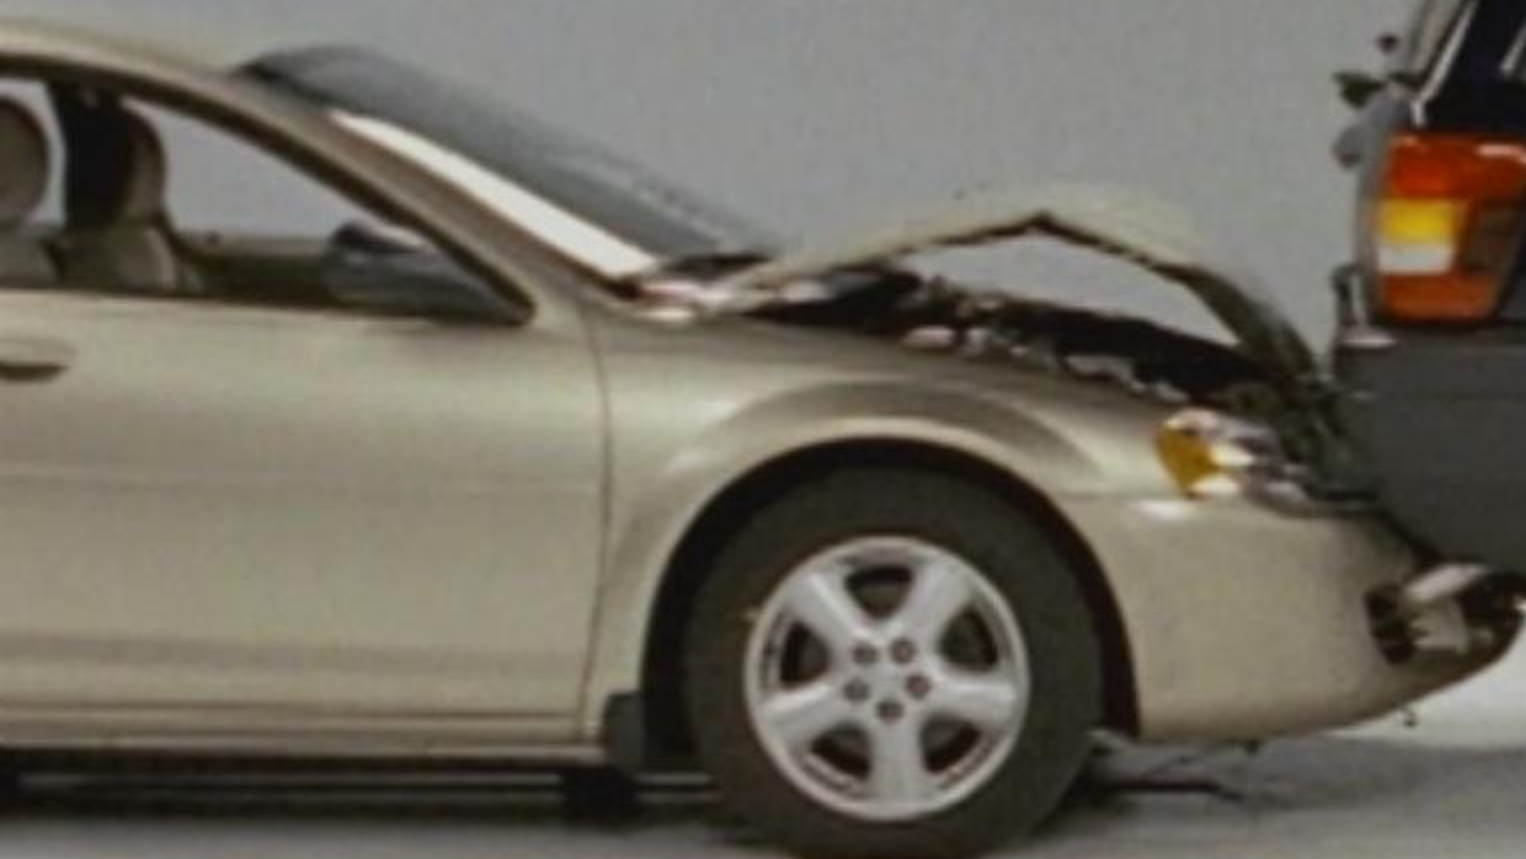
**Dodge Stratus**

**Underride Mode Caused by  
10 mph Bumper Test:  
Dodge Stratus into rear of Jeep  
Grand Cherokee**

**WJ-Body "Brush Guard"  
Damaged, had to be Replaced**

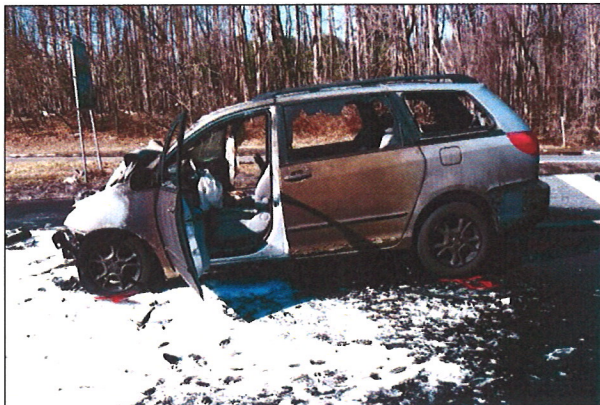
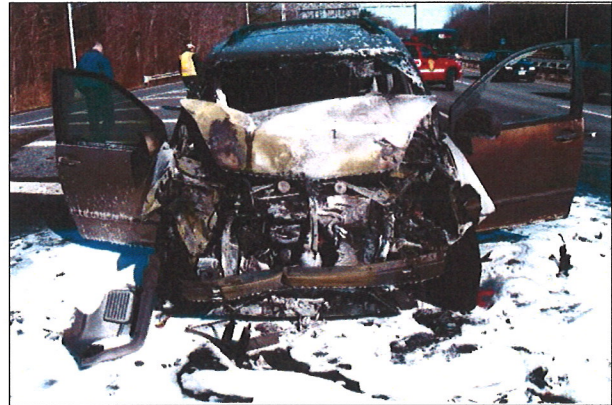
2004 Toyota: The Toyota involved in this crash was a 2004 model year Sienna XLE (VIN - 5TDZA22C34S052135). This vehicle was equipped with a 3.3-liter 6-cylinder gasoline engine and an automatic transmission. Figure 2 shows the Toyota at the accident scene. As can be seen in the figure, the Toyota shows signs of frontal impact and fire damage. The Toyota was not available for Kineticorp’s inspection.

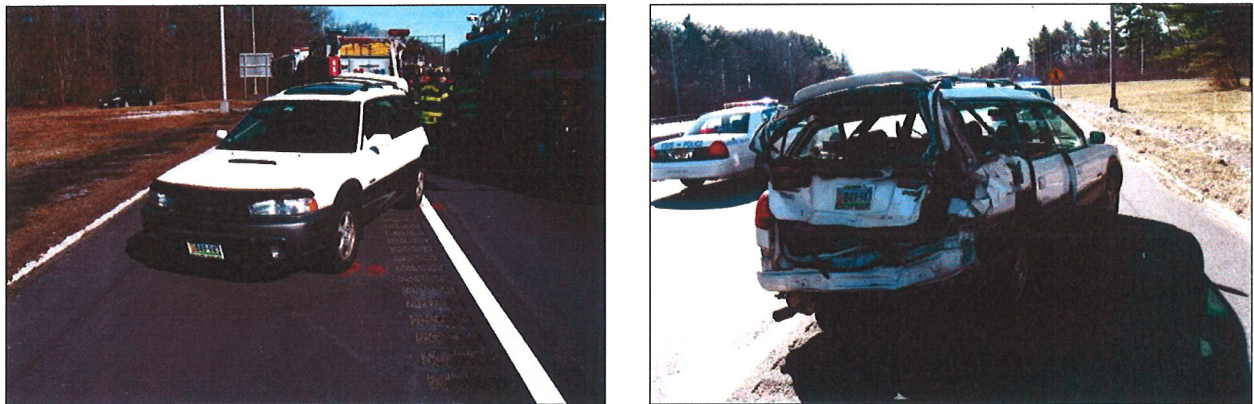
Figure42

1998 Subaru: The Subaru involved in this accident was a 1998 model year Legacy, Outback Edition (VIN - 4S3BG6852W7610862). This 4-door wagon was equipped with a 2.5-liter, 4-cylinder gasoline engine and an automatic transmission. Figure 4 shows the Subaru at the time of the accident. As can be seen in the figure, the Subaru sustained damage to the rear of the vehicle. The Subaru was not available for Kineticcorp's inspection.

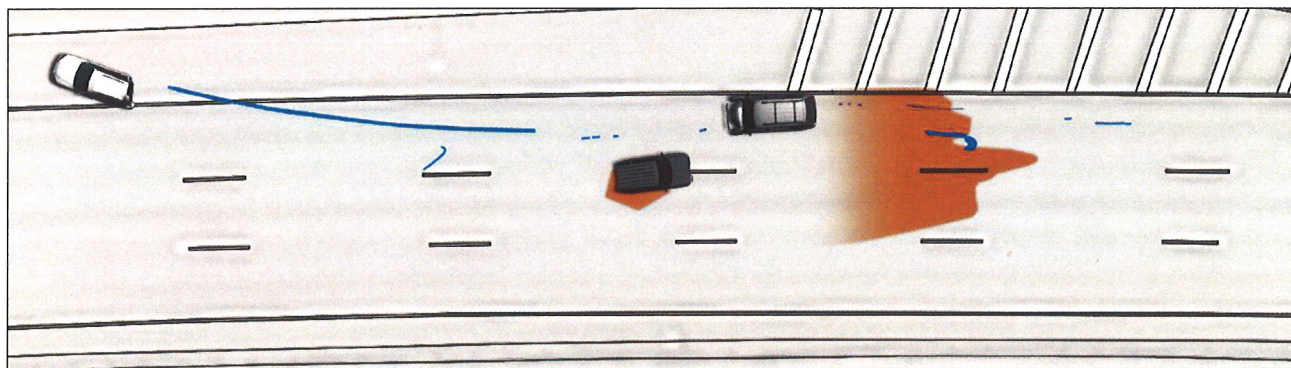
Figure 6 depicts our accident scene diagram, including the rest positions of the vehicles that were located using photogrammetry. Glass, gouge marks and tire marks are indicated in blue. Fluid and burn areas are shown in orange.

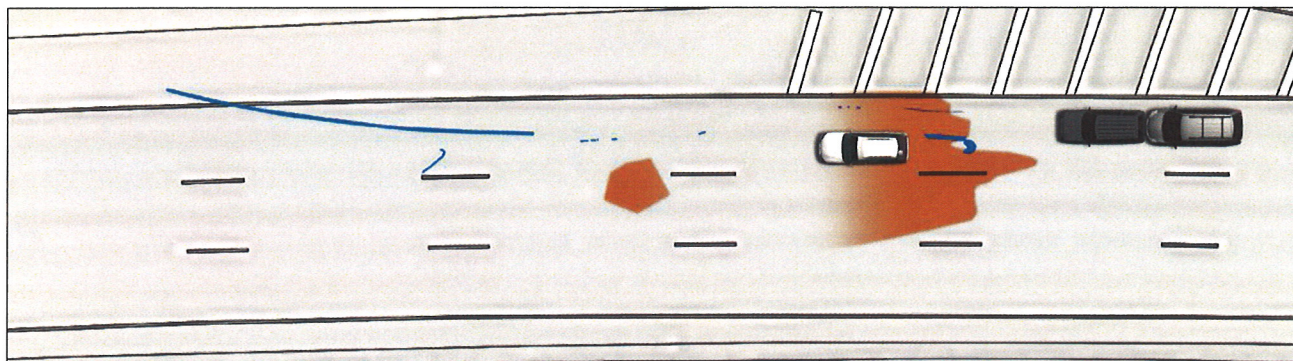
Analysis: Gouge and tire mark evidence were used to locate the points of impact on the roadway. Figure 7 depicts the location of the vehicles at first impact as dictated by the physical evidence.

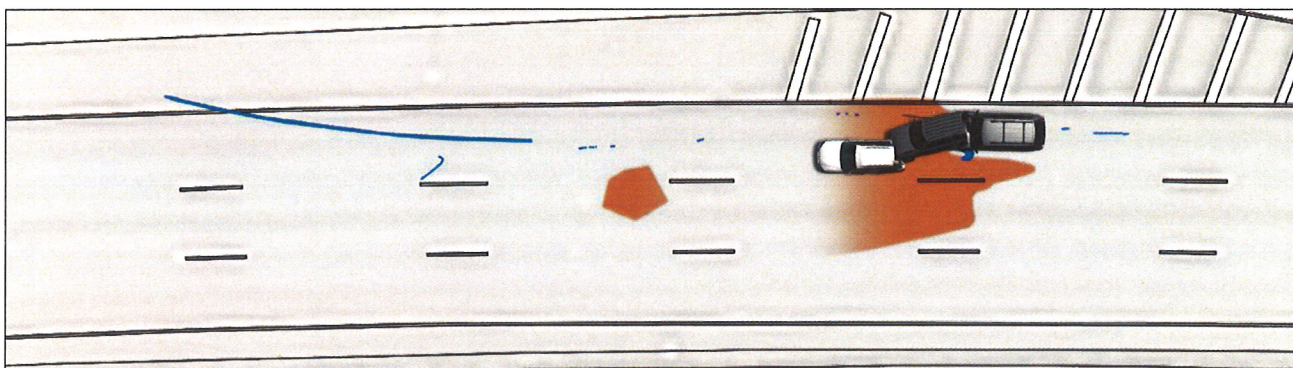
After the initial impact, the Jeep and Toyota traveled approximately 30 feet before impacting the rear of the Subaru. Figure 8 depicts the position of the vehicles at the second impact. As seen in the figure, the Jeep is crushed between the Toyota and Subaru. During impact two, the Jeep and Toyota were both damaged more extensively, as evidenced by the glass deposit at the location of the impact. As the Jeep was crushed, it rolled towards the passenger side and the Toyota underrode the rear of the Jeep as depicted in Figure 9. The Jeep rolled approximately 25 degrees based on the damage pattern to the rear lift gates of the Jeep and the Subaru. Specifically, the window opening of the Jeep's rear lift gate exhibits more damage to the right side than the left, consistent with the Jeep being rolled to the right as the Toyota penetrated underneath the rear on the Jeep. Also, the rear lift gate of the Subaru exhibits damage consistent with the front of the Jeep being lifted up above the Subaru's rear bumper. Additionally, the right rear wheel of the Jeep gouged the pavement as it rolled to the right.

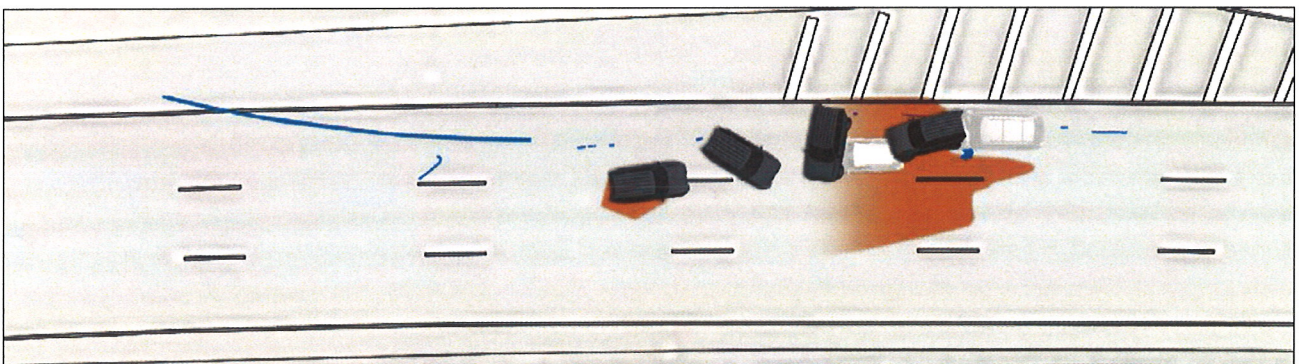
Figure 10

The vehicles then traveled to rest. The collision locked the rear right tire of the Subaru, causing it to leave a dark tire mark that led to its rest position. The Subaru traveled approximately 130 feet after the impact and came to rest on the shoulder. The Toyota traveled approximately 40 feet before coming to rest in the right lane. As the Jeep was crushed between the Subaru and the Toyota, it began to rotate counter-clockwise. The Jeep traveled approximately 50 feet, and rotated approximately 180 degrees before coming to rest straddling the right and middle lanes. The motion of the Jeep as it traveled to rest is depicted in Figure 10.

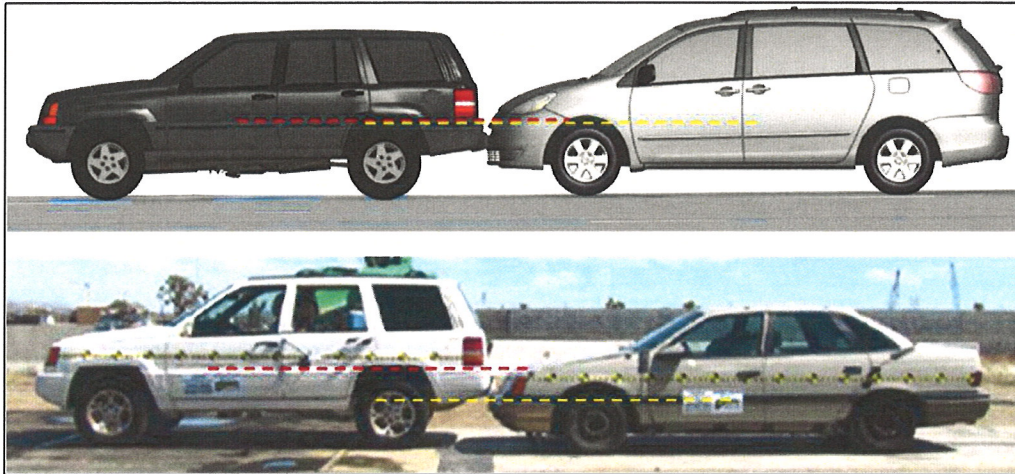
The subject accident was significantly different than the KARCO tests in terms of the lateral and vertical alignment of the vehicles. The top image in Figure 13 depicts the initial impact alignment between the Toyota and the Jeep. The image below shows the alignment between the Taurus and Jeep from test TR-P31070-01-NC. The top of the bumper of each vehicle has been indicated, the Jeep in red and the impacting vehicle in yellow. As depicted, there was good bumper alignment in the subject accident. However, in the KARCO test, the entire bumper of the Taurus was beneath the bumper of the Jeep. The test setup is conducive to vehicle under-ride, the subject accident was not. In both KARCO tests, the tires on the Jeep were significantly larger than the tires on the subject Jeep at the time of the accident. Also, the tires on the test Taurus were significantly smaller than the recommended tire size for that vehicle in test TR-P31070-01-NC. These tire differences make it easier for the Taurus to under-ride the rear of the Jeep in the tests. Further, the test tire pressures were not listed in the test reports and it appears that the tires of the Taurus were underinflated for the test. This would lower front of the Taurus and make it easier for the tires of the Taurus to compress during the impact. Low tire pressure would also make it easier for the Taurus to under-ride the Jeep. The alignment between the test vehicles was drastically different than the alignment during the accident. In terms of under-ride propensity, the vehicle and tire selections in the test are skewed towards a worst case scenario for the Jeep's structural ability to absorb the crash energy. These conditions did not exist in the subject accident.

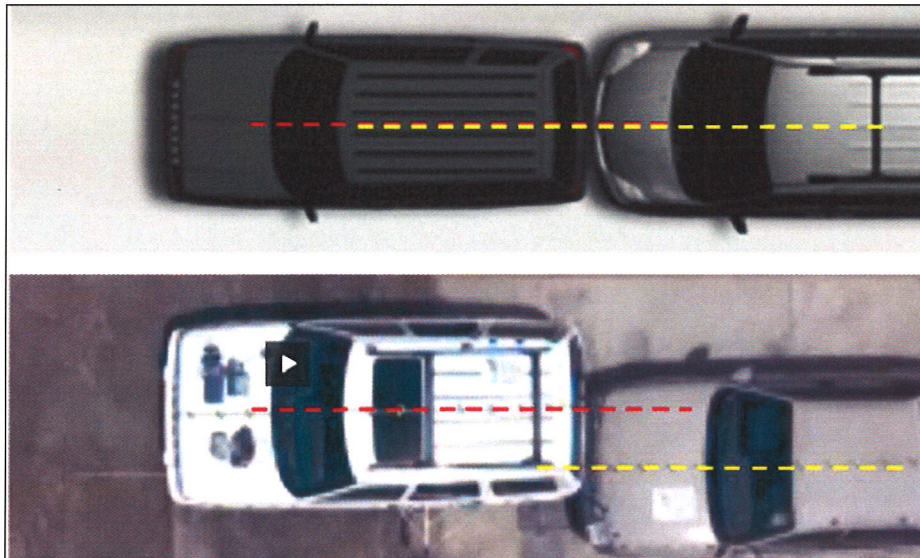
In the subject accident, the Toyota impacted squarely into the entire rear of the Jeep. In the KARCOTest, the collision was offset, such that the entire rear of the Jeep was not directly involved in the collision. This offset in the test is significant because less of the vehicle's width is available to absorb the impact energy. In other words, offset collisions are more severe in terms of energy absorption demands placed on the impacted vehicle. Since the subject accident was a full overlap collision, the offset tests are misrepresentative of the subject accident. The top image in Figure 14 depicts the lateral alignment of the vehicles in the subject accident. The red line indicates the center of the Jeep, the yellow line indicates the center of the Toyota. The KARCOTest is depicted below.<sup>2</sup> In the KARCOTest, the Taurus is offset significantly to the left at impact. Due to the lateral and vertical alignment differences, no meaningful comparisons can be made between the subject accident and the KARCOTest results. It should also be noted that components in the test Jeeps were removed, such as the spare tire, door panels and the rear side windows. At this time Kineticcorp has not made a determination as to the effect of removing these items in the tests.

<sup>2</sup> Note the distortion from the KARCOTest video makes the Jeep appear wider than it is.

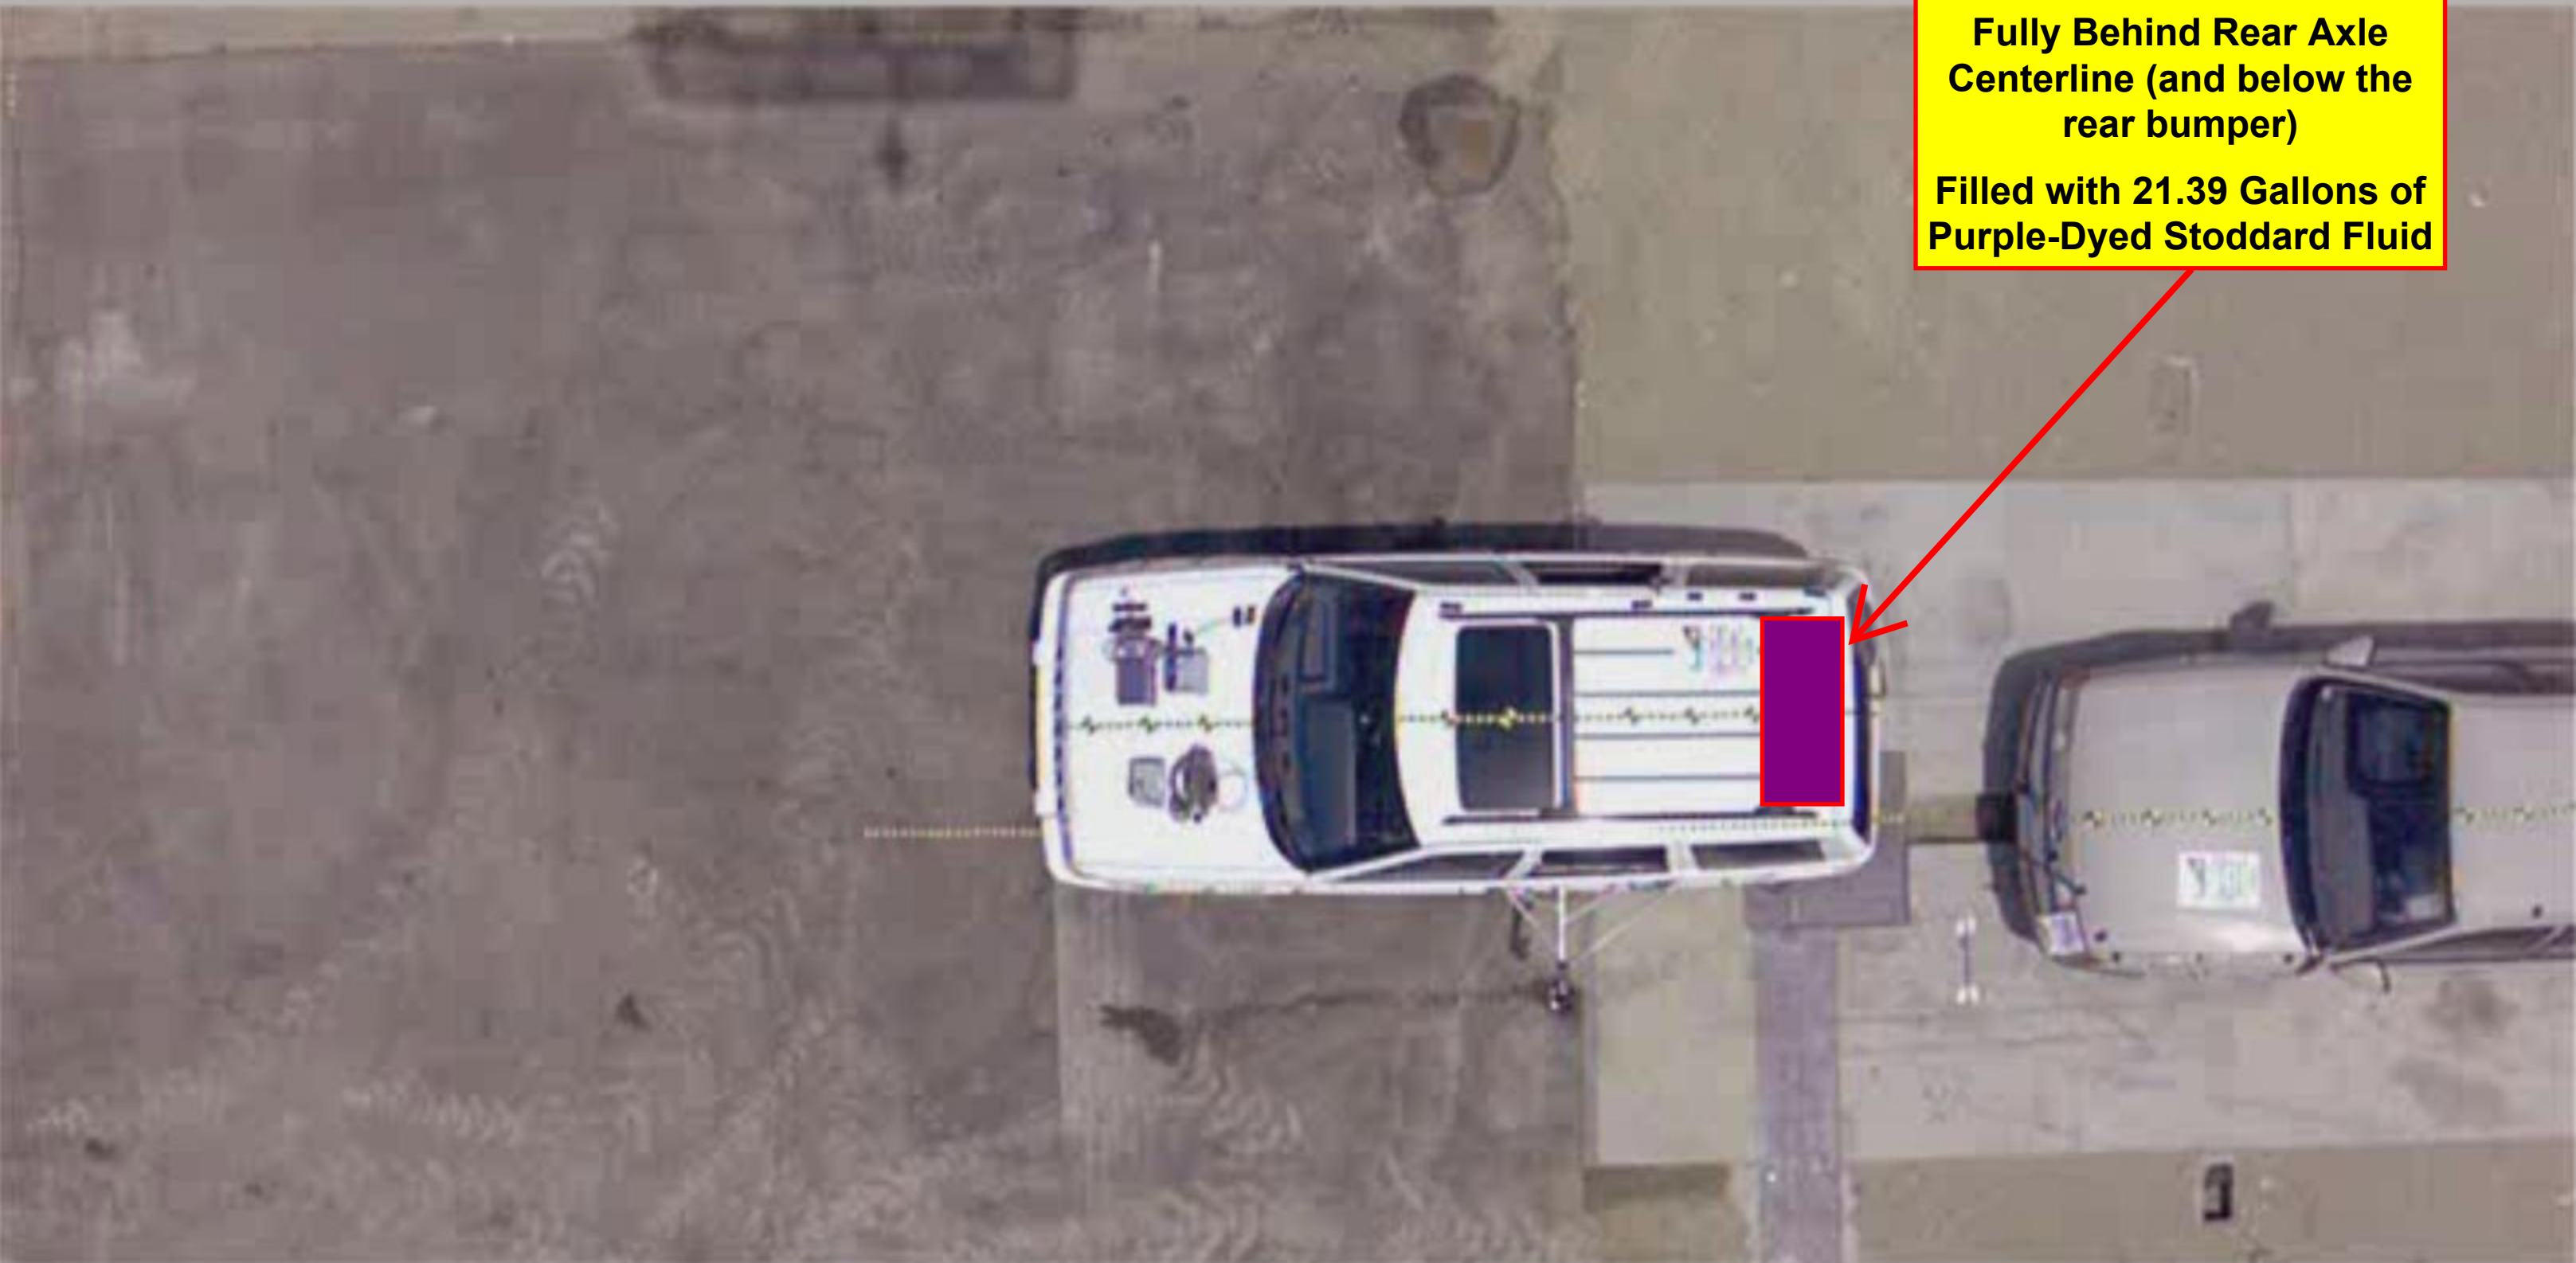
# Camera View-02

Purple Rectangle Shows  
Approximate Position of  
Polyethylene Fuel Tank:  
Fully Behind Rear Axle  
Centerline (and below the  
rear bumper)  
Filled with 21.39 Gallons of  
Purple-Dyed Stoddard Fluid

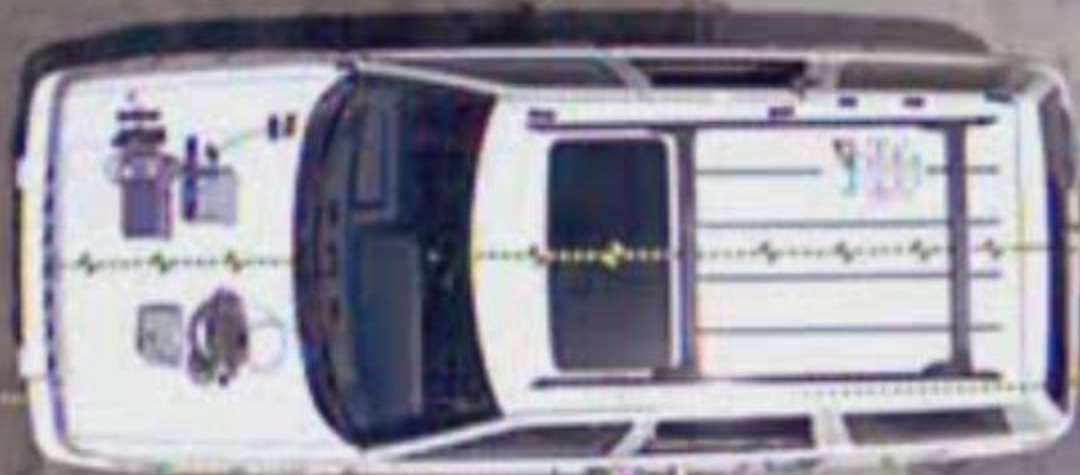
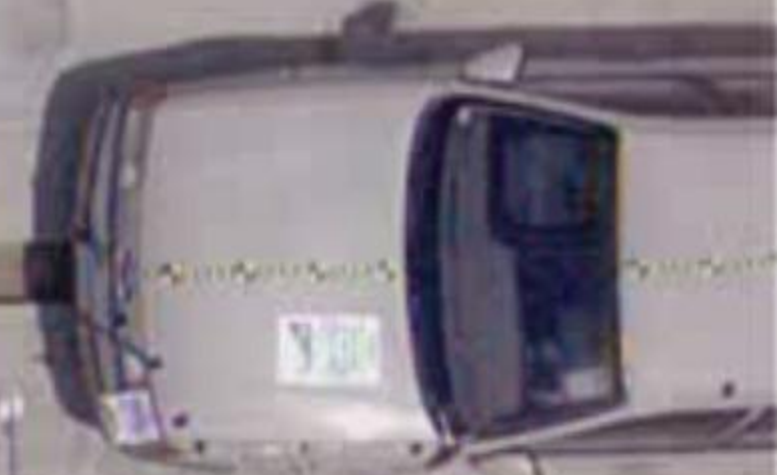
# Camera View-02

No Purple-Dyed Stoddard Stain  
Evidence on Any Area of  
Asphalt Portion of Impact Test Pad  
Prior to Collision of Bullet Vehicle  
into Target Vehicle Fuel Tank

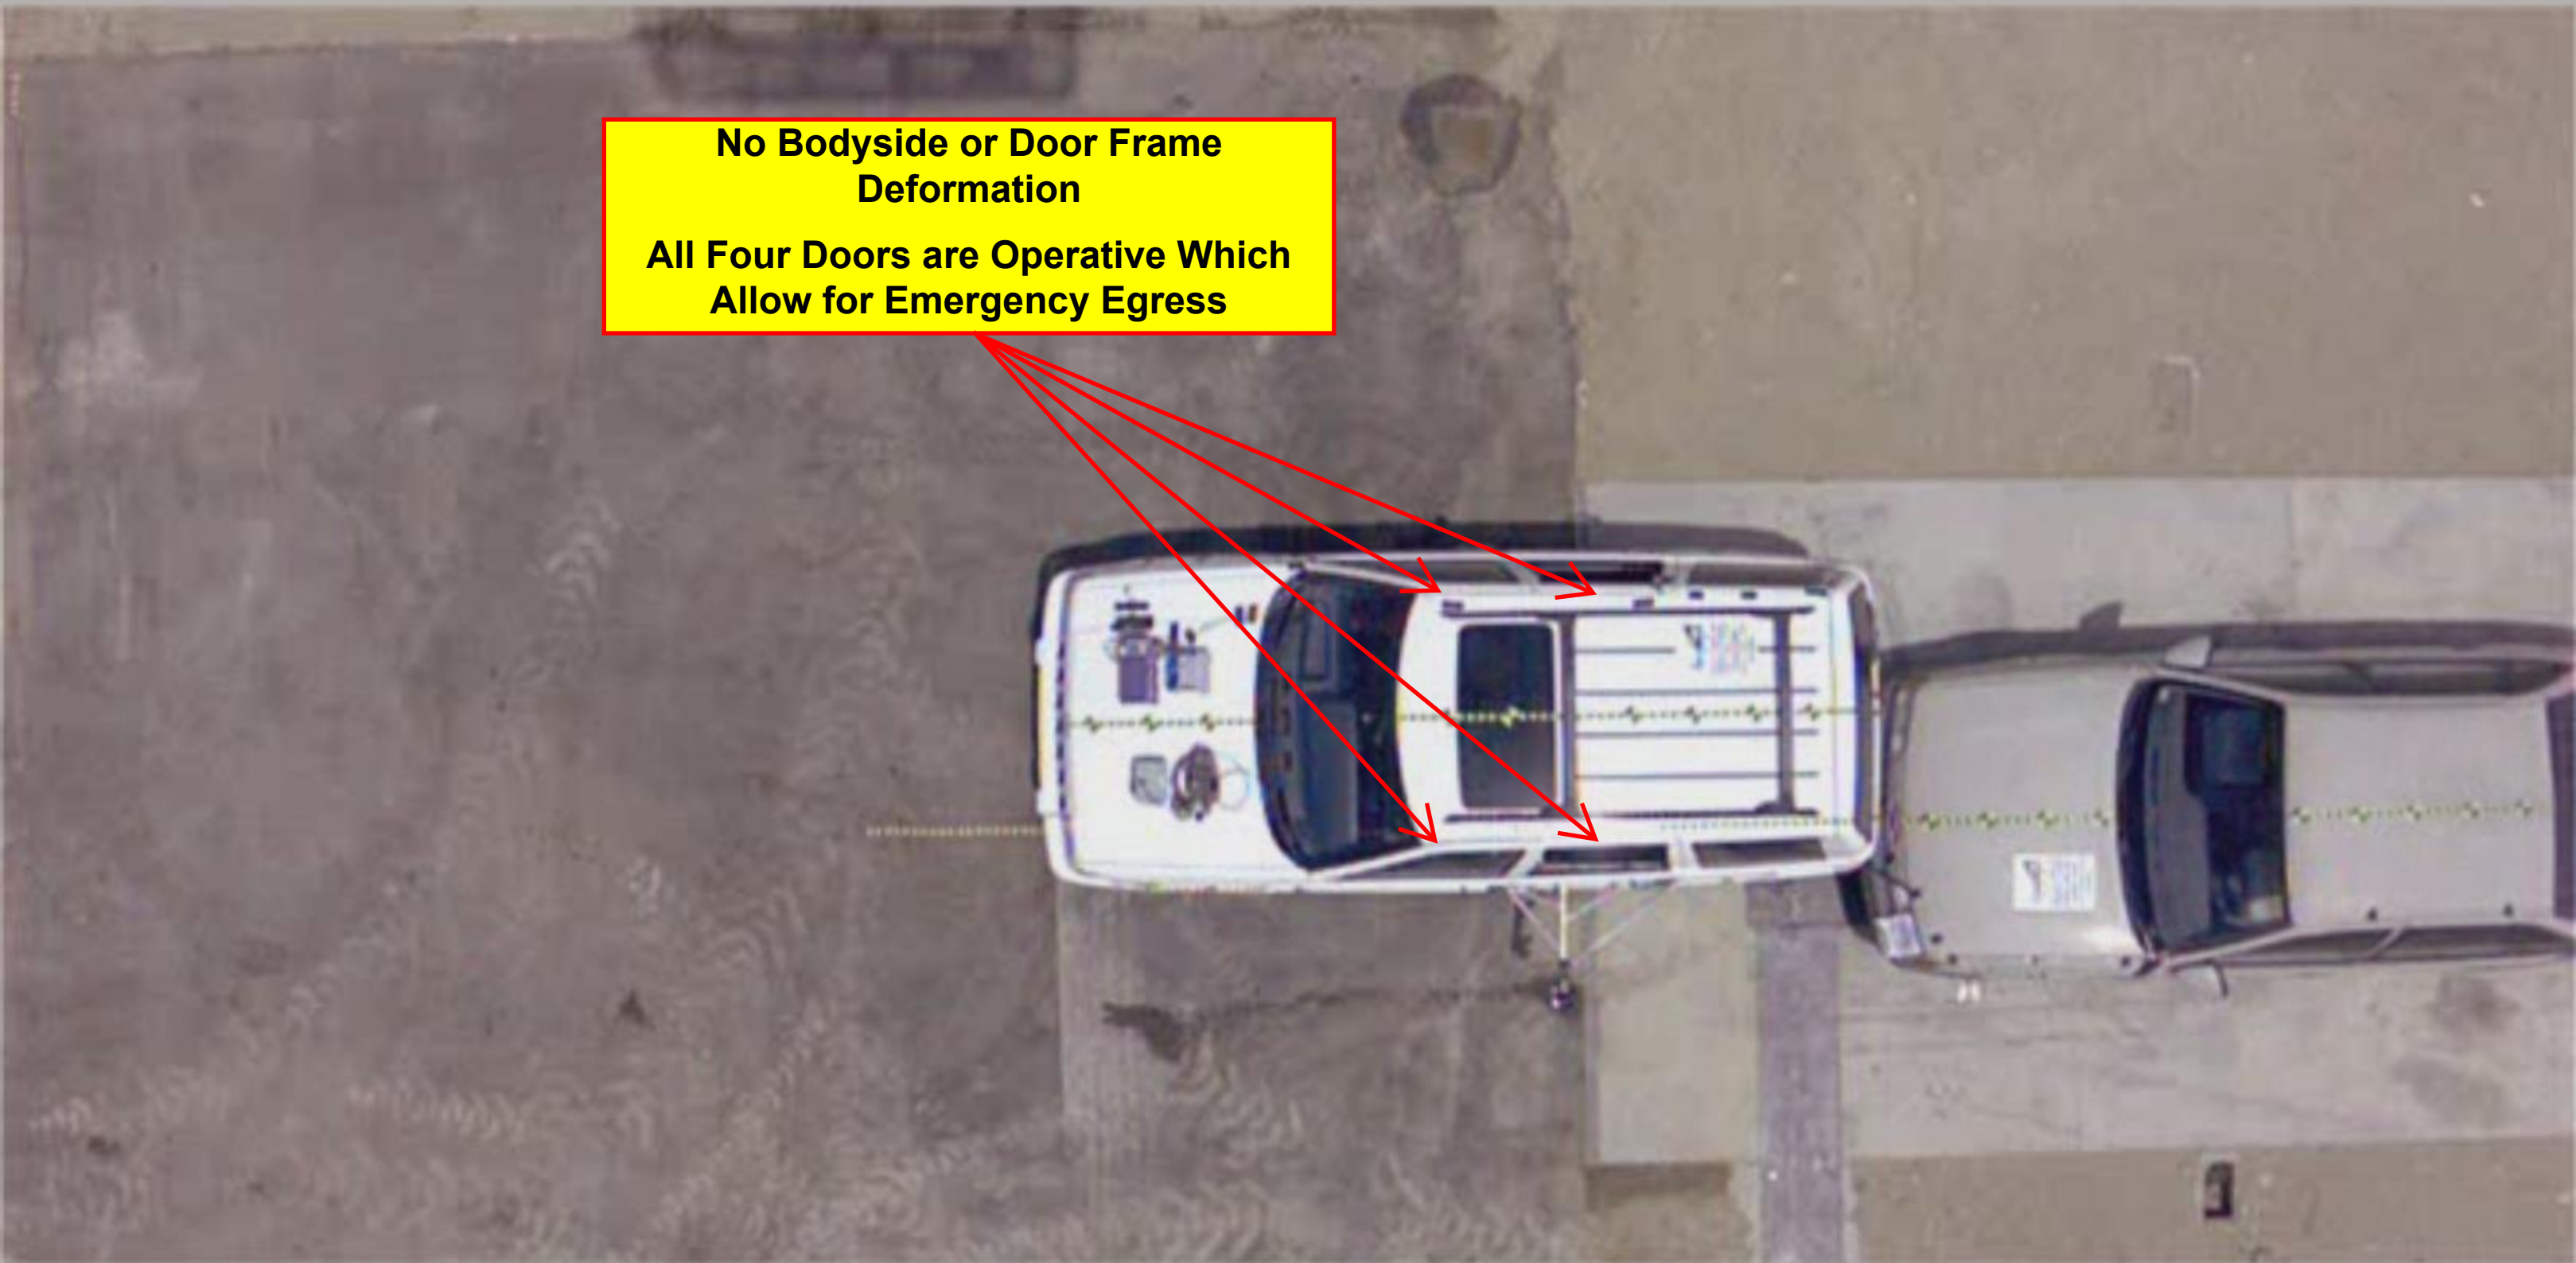
# Camera View-02

**No Bodyside or Door Frame  
Deformation**  
**All Four Doors are Operative Which  
Allow for Emergency Egress**

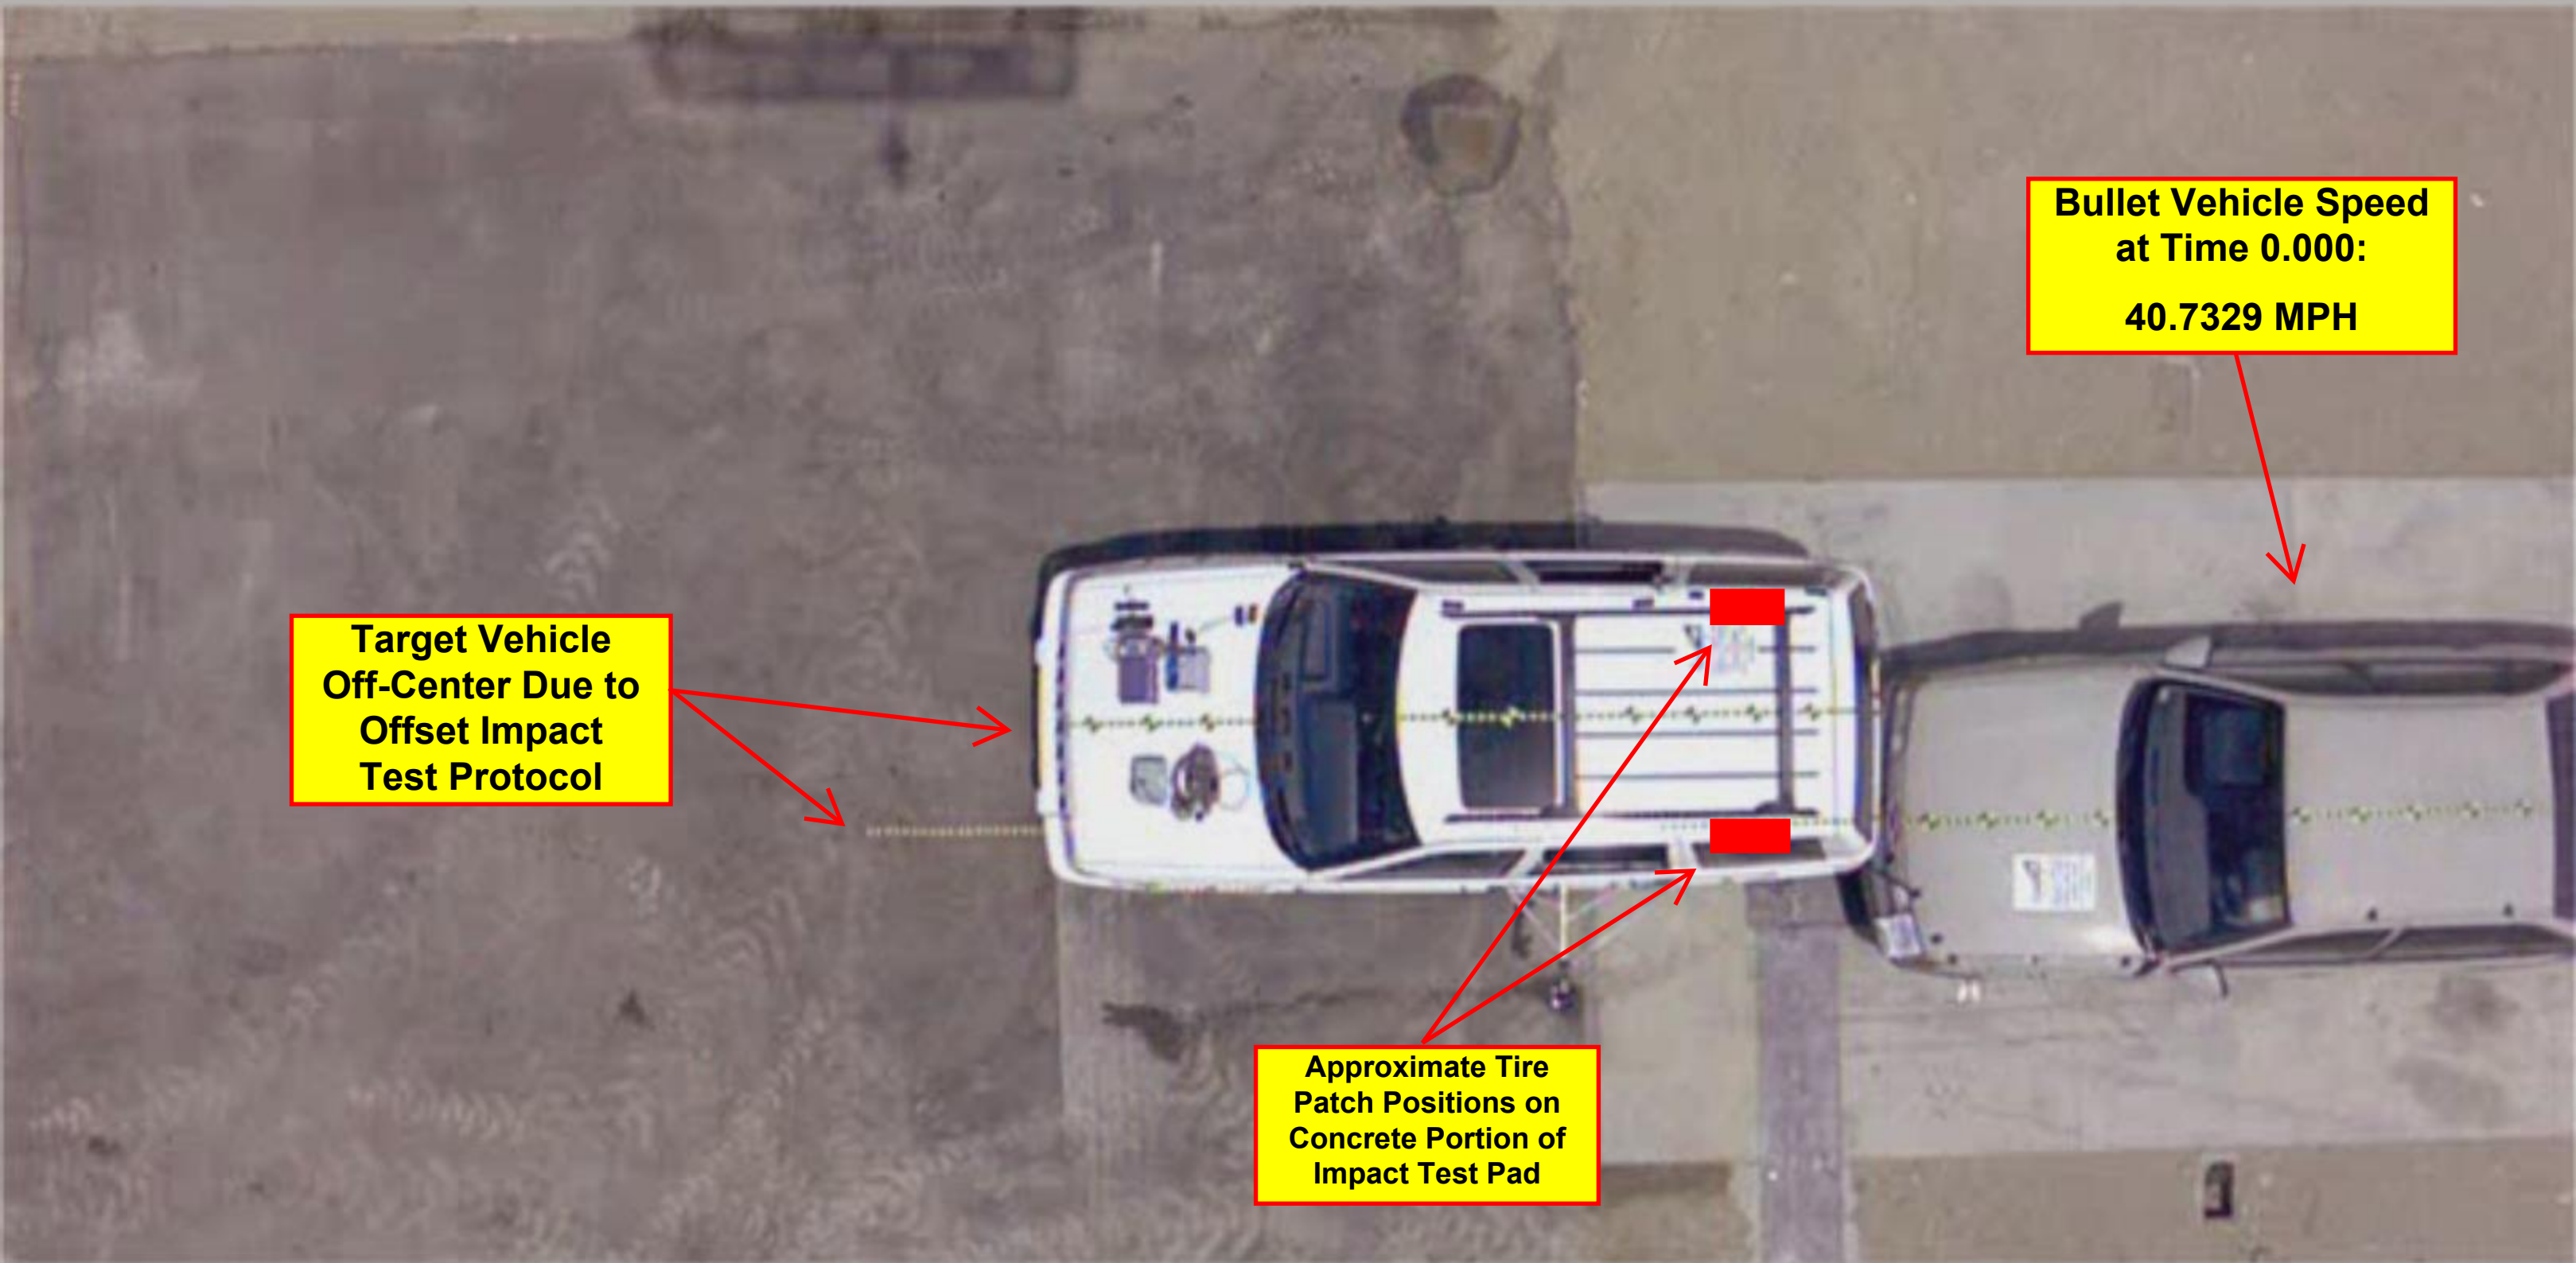
# Camera View-02

**Target Vehicle  
Off-Center Due to  
Offset Impact  
Test Protocol**

**Bullet Vehicle Speed  
at Time 0.000:  
40.7329 MPH**

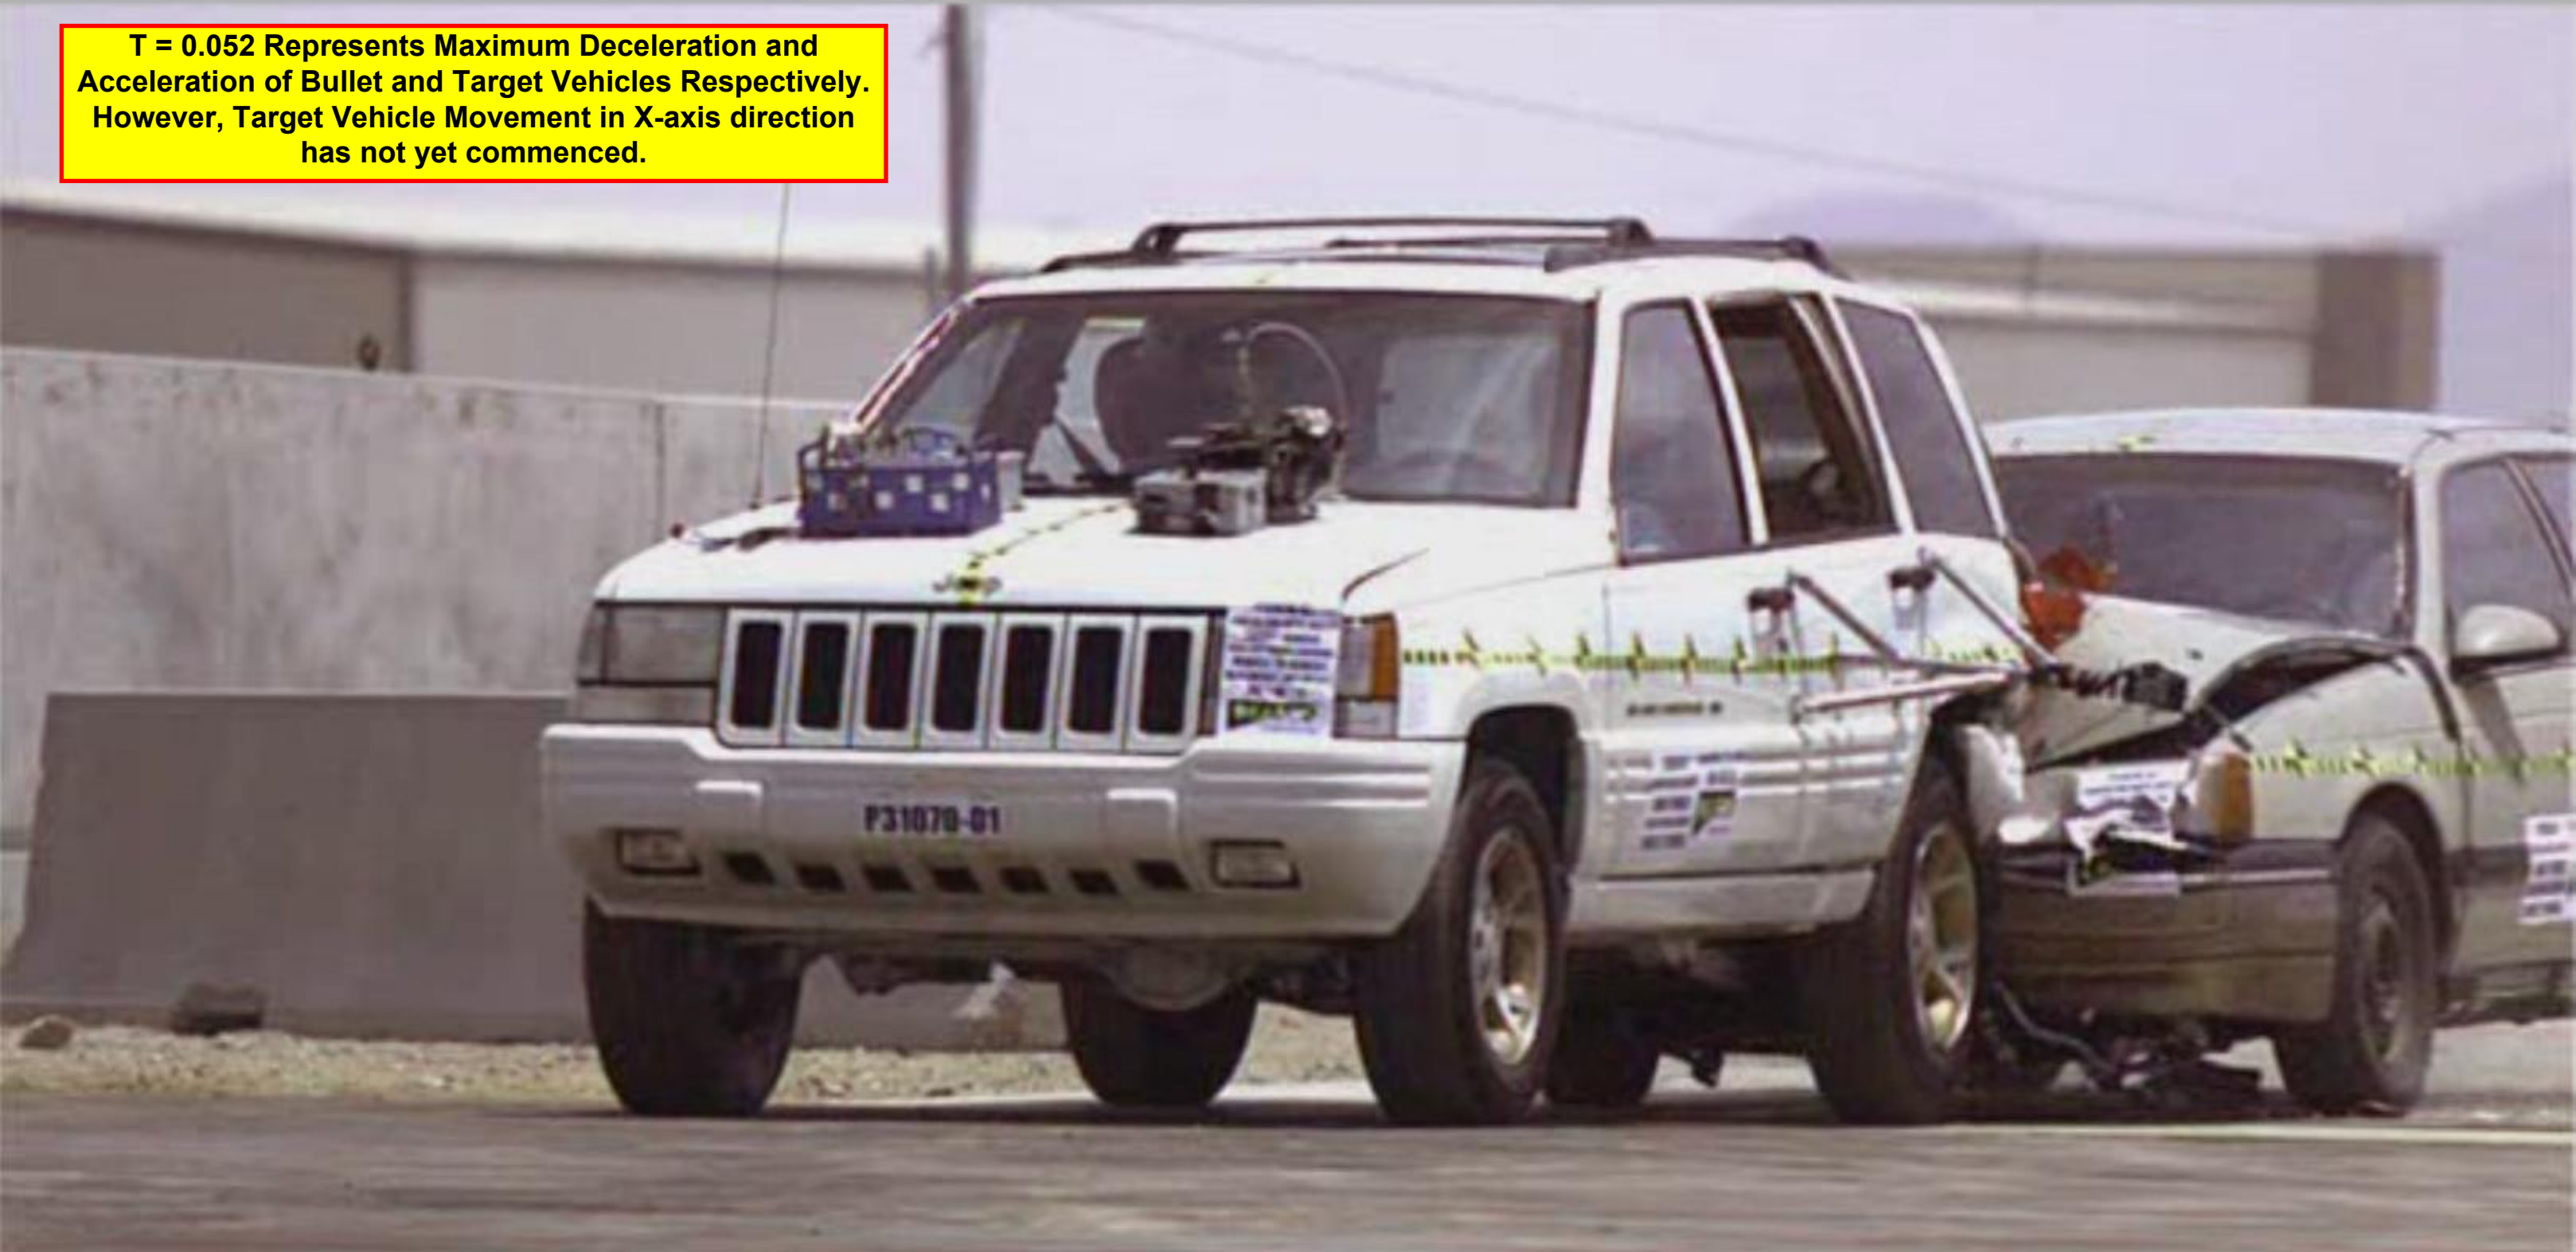
# Camera View-03

T = 0.052 Represents Maximum Deceleration and Acceleration of Bullet and Target Vehicles Respectively. However, Target Vehicle Movement in X-axis direction has not yet commenced.

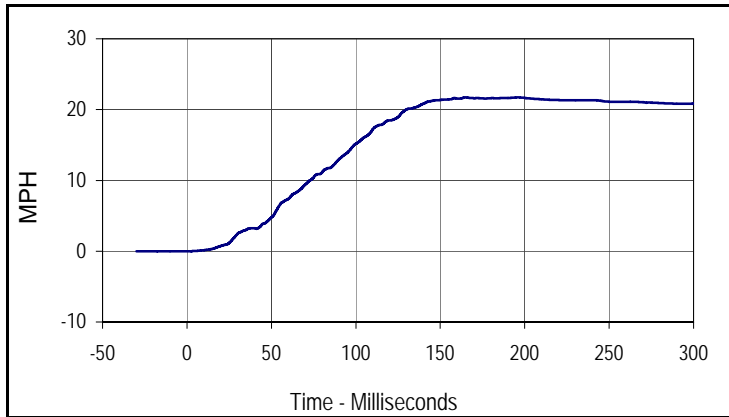
Curve Description			
Target Vehicle Center Tunnel X Velocity			
Plot	Type	SAE Class	Units
010	IN1	180	MPH
Max	Time	Min	Time
21.7	196.0	0.0	1.0
