Date: 3 September 2012

VIA FEDEX AIRBILL 8007 – 9341 - 5860

**Subject: Chrysler Group LLC Assertions - Karco ZJ-Body Impact Test of 16 May 2011**  
**Reference: EA12-005 File Update (Chrysler Jeep Fuel Tank System Defect)**

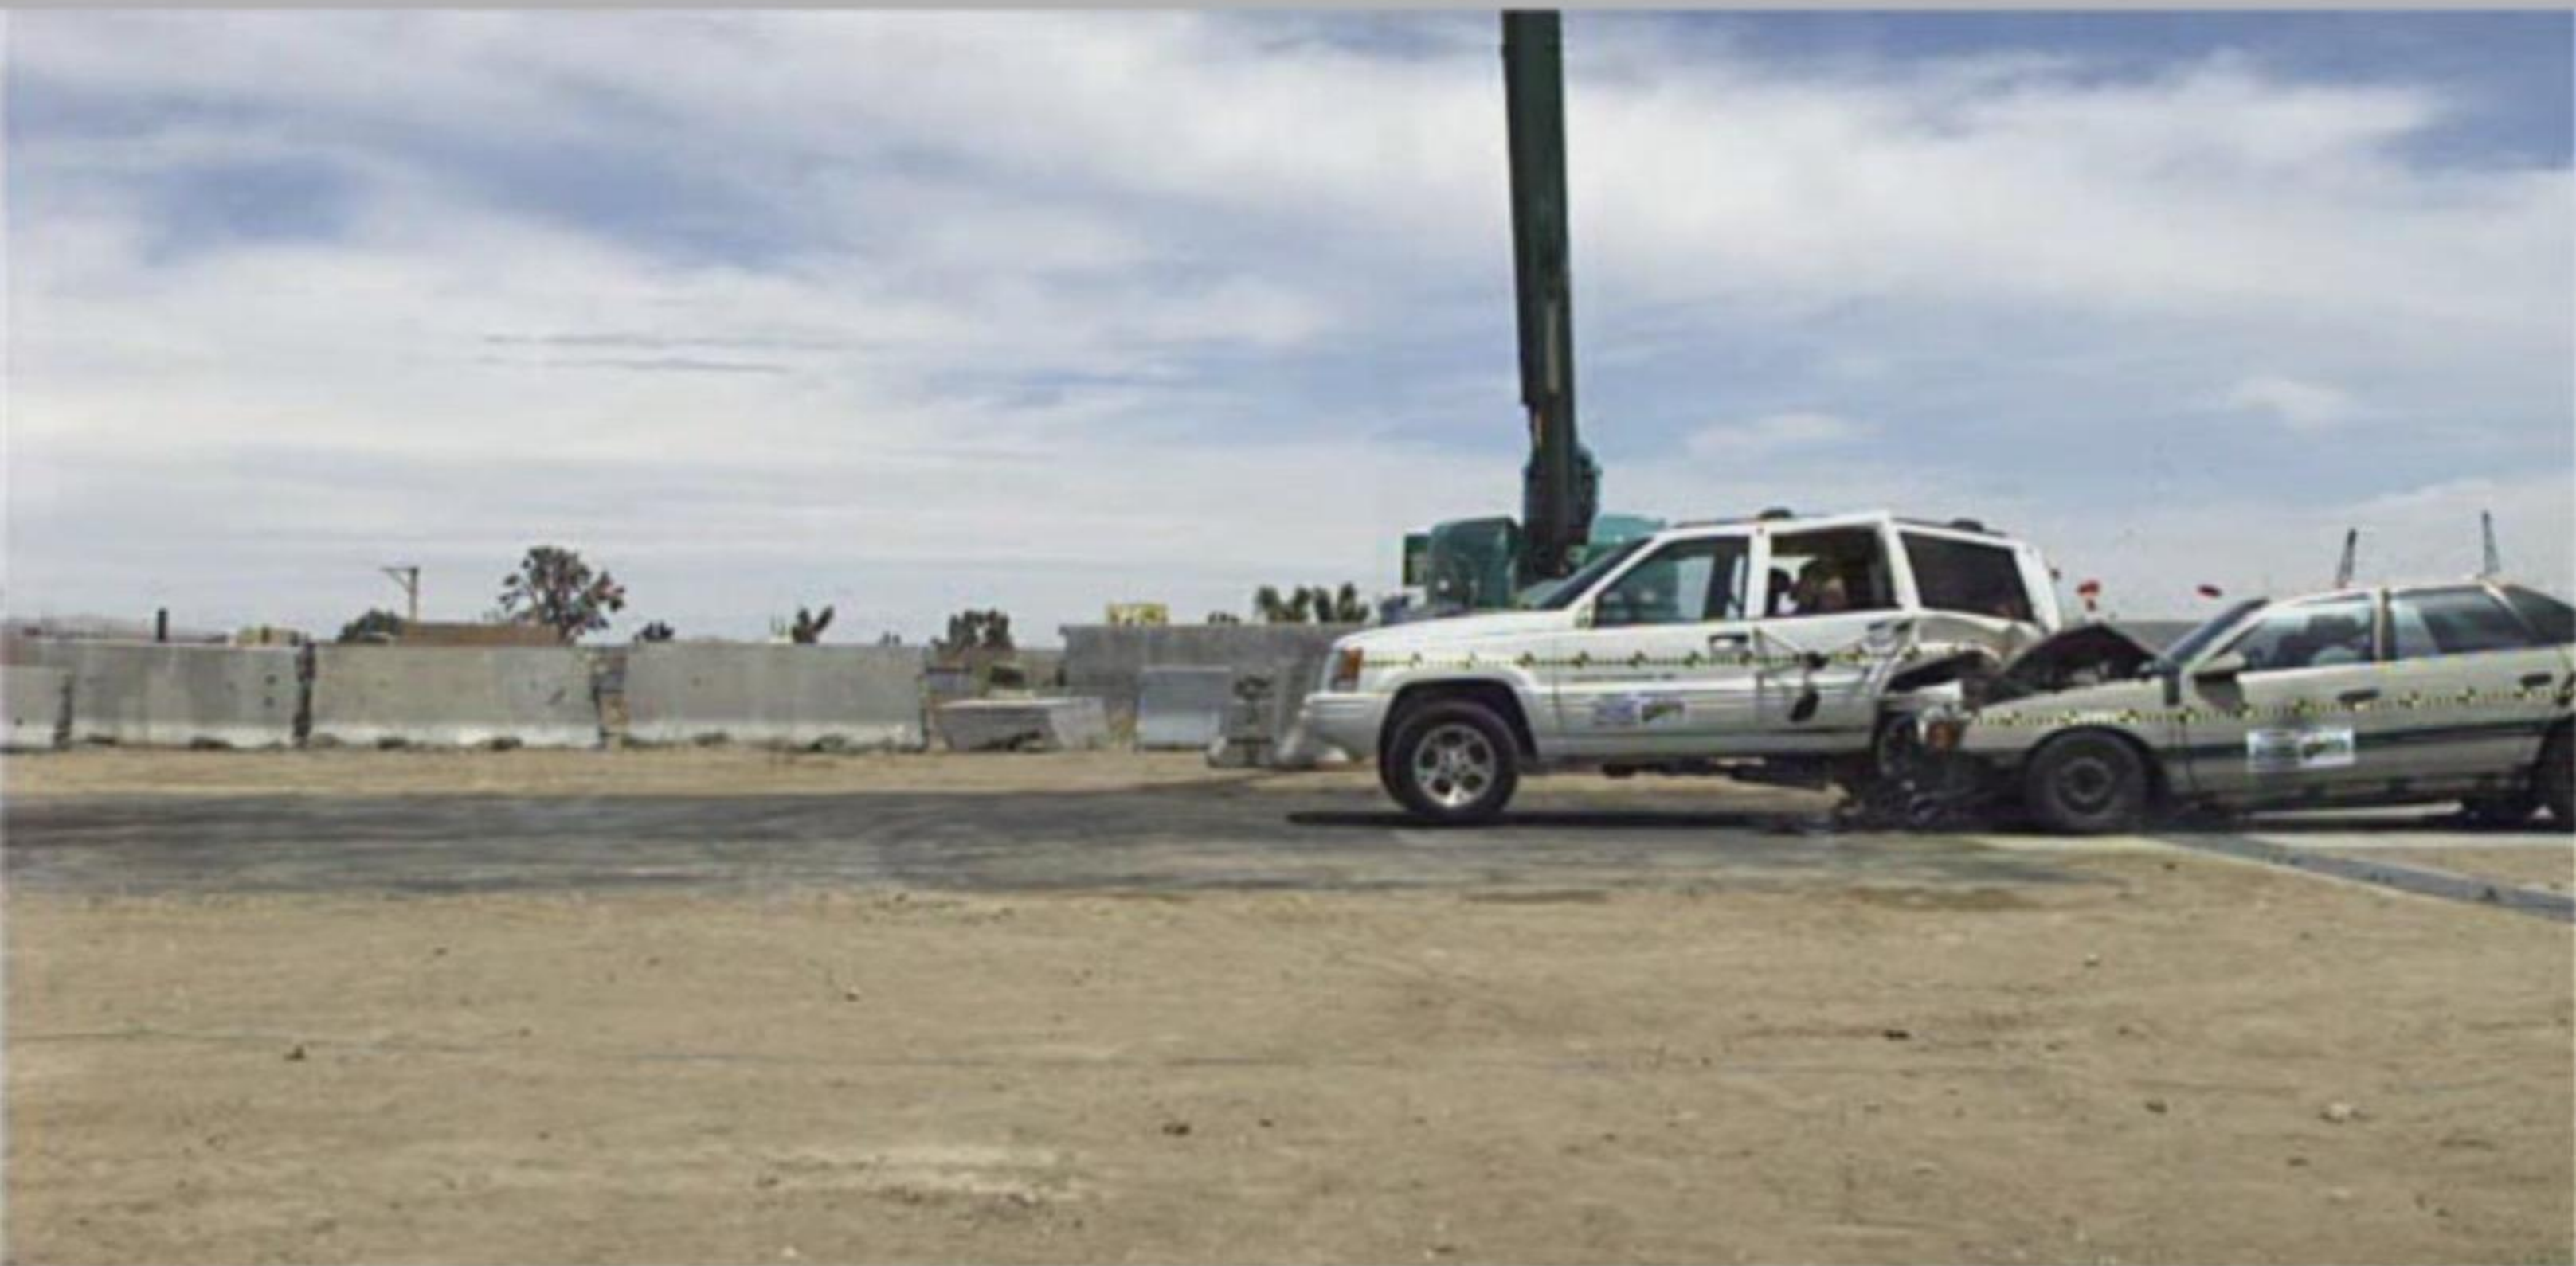
# Camera View-01

At T = +0.119, the target vehicle has commenced appreciable movement in the X-axis direction. This separation sequence, which moves the target /bullet vehicles off the impact pad, exposes the surface, and accommodates viewing of the stoddard evidence of a fuel tank breach which I assert occurred back at T = +0.052.

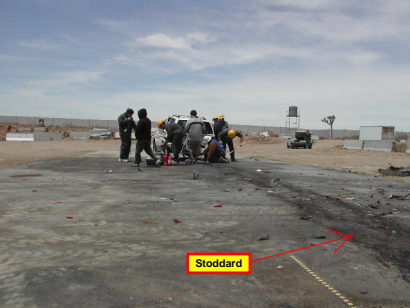
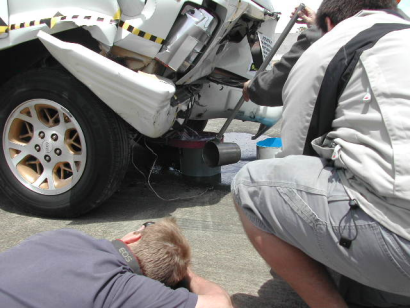
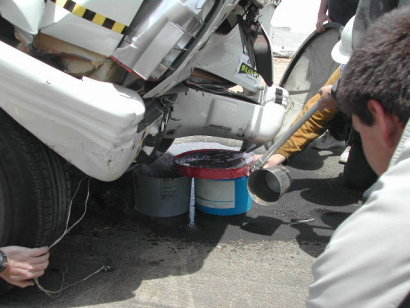
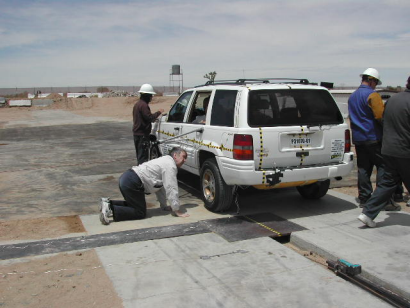
These photographs are part of my expert reports to the exemplar accident. The breaches to the unprotected Jeep Grand Cherokee fuel tank did not result in minor leakage; it was so severe that, as the person representing CAS at this test, I recommended that time/resources not be wasted on the FMVSS-301 rollover protocols (last page).

**Stoddard Evidence Trail  
from Two Breaches in  
Jeep Grand Cherokee  
Target Vehicle Fuel Tank  
Two Breaches Occur at  
Not Later Than  $T = 0.052$**
