Subject: Expert Report - White / Campbell versus FCA, et al

This report presents the results of a vehicle to vehicle rear impact test conducted with a 2002 Cadillac Seville SLS V-8 FWD automatic (Bullet Vehicle) and a 2003 Jeep Liberty 4WD V-6 automatic (Target Vehicle) which was equipped with a Fuel Tank Encapsulation Prototype (FTEP). The objective of this test was to evaluate the fuel tank crashworthiness integrity of a 2003 Jeep Liberty equipped with a Fuel Tank Encapsulation Prototype when subjected to the impact conditions described in this report. This test was conducted at Applus IDIADA KARCO Engineering's test facility in Adelanto, California on December 3, 2018.

Applus IDIADA KARCO Engineering, LLC – Test Report Number : TR-P38306-01-NC

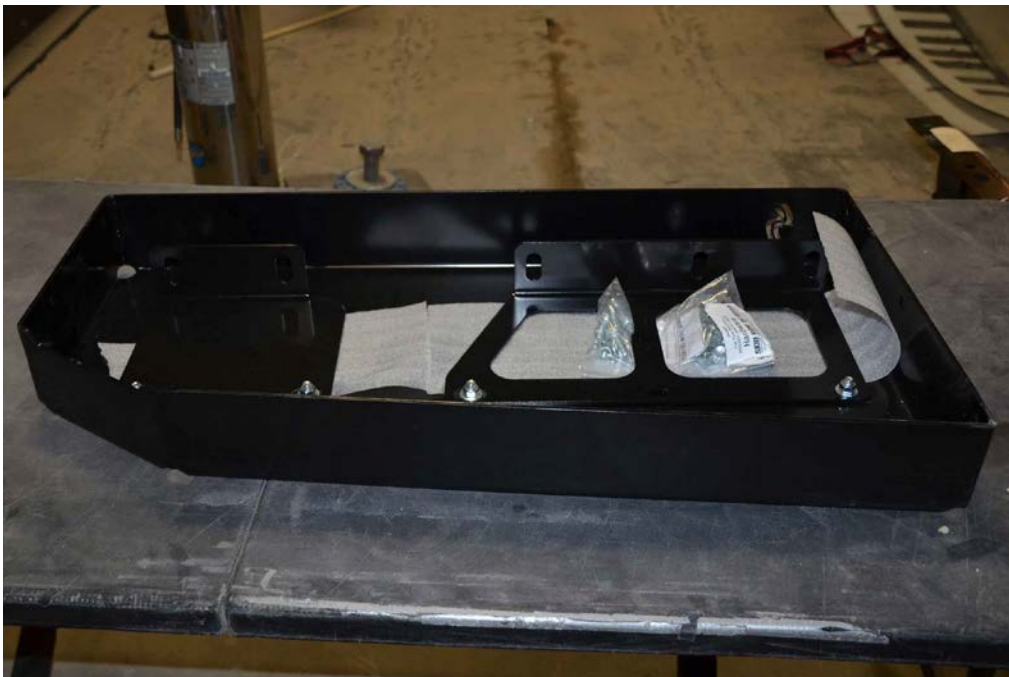
The mechanical base of the FTEP fabrication was an aftermarket skid plate offered by SFK Manufacturing for 2002 thru 2007 KJ Jeep Liberty fuel tanks, part JP-4002, pictured here:

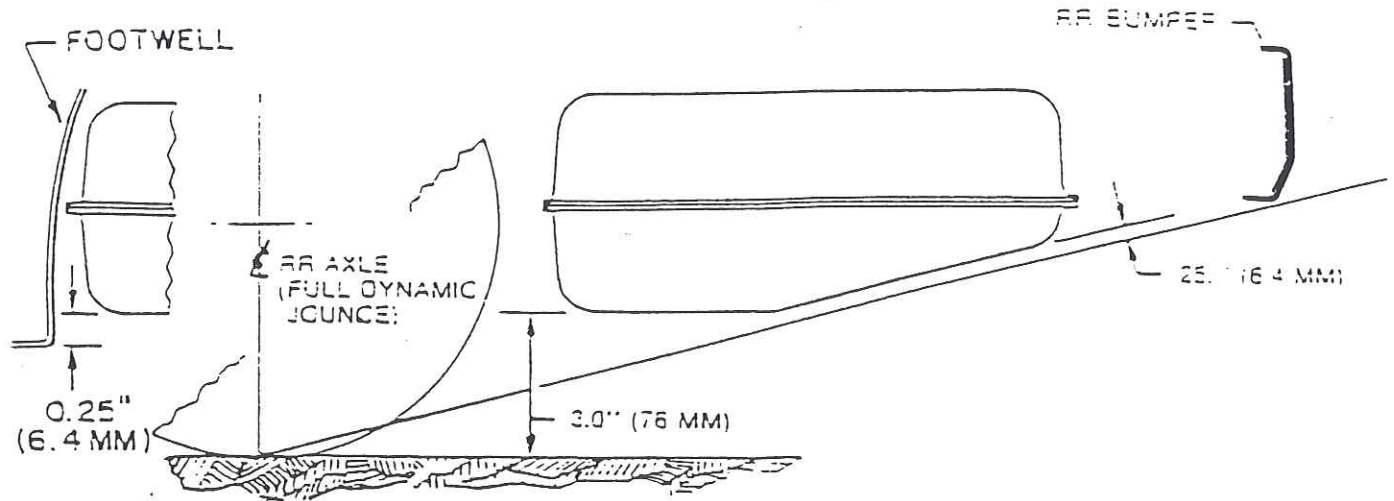
Figure 1.2

the tire centerline at full jounce and the bottom edge of the bumper, tie down skid plates or structurally sound license plate bracket.—see fig. 1.2.

The tank should not fall below a horizontal line drawn 0.25" (6.4 mm) above the tangent to the rear seat foot well or other nearby leading structural member.—see fig. 1.2.

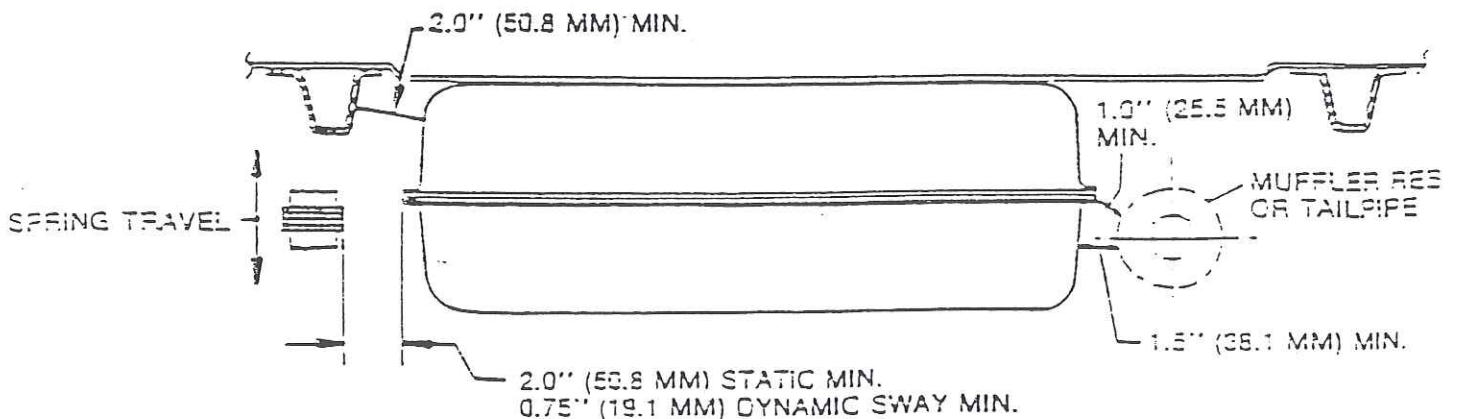
Figure 1.3

3. Spring Clearance—The minimum clearance to the tank flange is 2" (50.8 mm) static and 0.75" (19.1 mm) under dynamic sway deflection.—see fig. 1.3.

4. Rail Clearance—A minimum of 2.0" (50.8 mm) clearance between the fuel tank and underbody rail.—see fig. 1.3.

5. Exhaust Clearance—A minimum of 1.5" (38.1 mm) between exhaust component and tank, and 1.0" (25.5 mm) to tank flange.—see fig. 1.3.

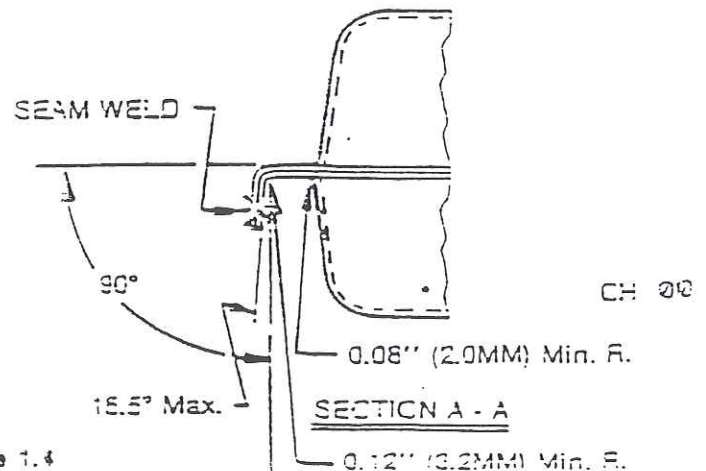
Figure 1.4

5. Flange bend radius to be 0.08" (2.0 mm) minimum. See fig. 1.4.

6. Flanges should not be folded, but where required, the transition from fold to normal will be 1.5" (38.1 mm). In general, all folds are to be in downward direction (see fig. 1.4). Folds :

7. Location of seam welds.
 - a. With fold—to be located outside of fold—see fig. 1.4.
 - b. Without fold—to be located .025" (6.4 mm) from wall of tank (ref. P.S.-1755).
8. All manufacturing pre-seam weld spot welds must be located outside of seam weld path.
9. Ribs
 - a. Ribs will be at least 0.25" (6.4 mm) deep.
 - b. Rib neutral axis should be at half rib depth.
 - c. Rib transition to normal surface should occur on vertical tank wall

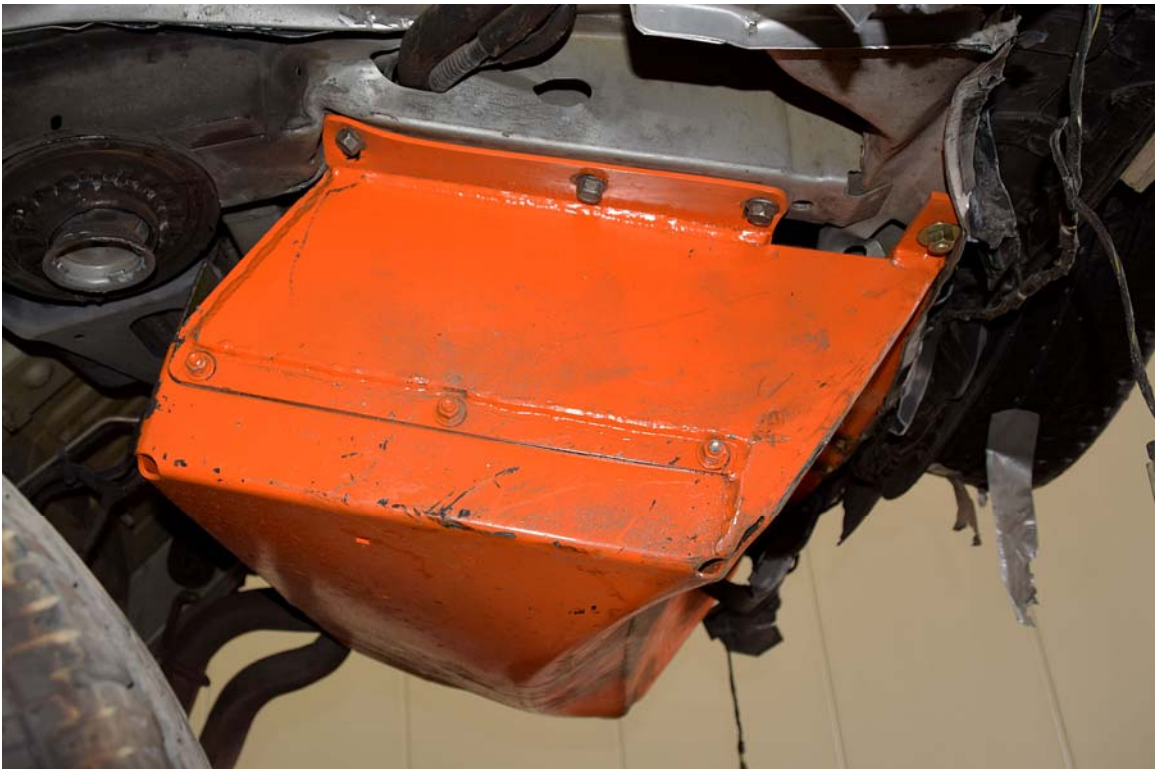
FIGURE 107. Post-Test Fuel Tank Inspection

A post-test inspection of the FTEP and the 2003 Jeep Liberty's fuel tank was conducted on December 21, 2018. The FTEP remained attached to the vehicle by all but the three right side frame rail bolts. The fuel tank remained attached to the vehicle by the OEM strap attachments. Upon removal of the FTEP and fuel tank from the vehicle, a plastic output nipple on the top of the fuel tank was found cracked. The Stoddard solvent was drained from the vehicle to confirm that no measurable amount of solvent leaked as a result of the impact test. The driver side doors on the target vehicle were operable after the impact, the outside door handle on the right front passenger door was broken but the door was operable using the interior door handle, the right rear passenger door was jammed shut.

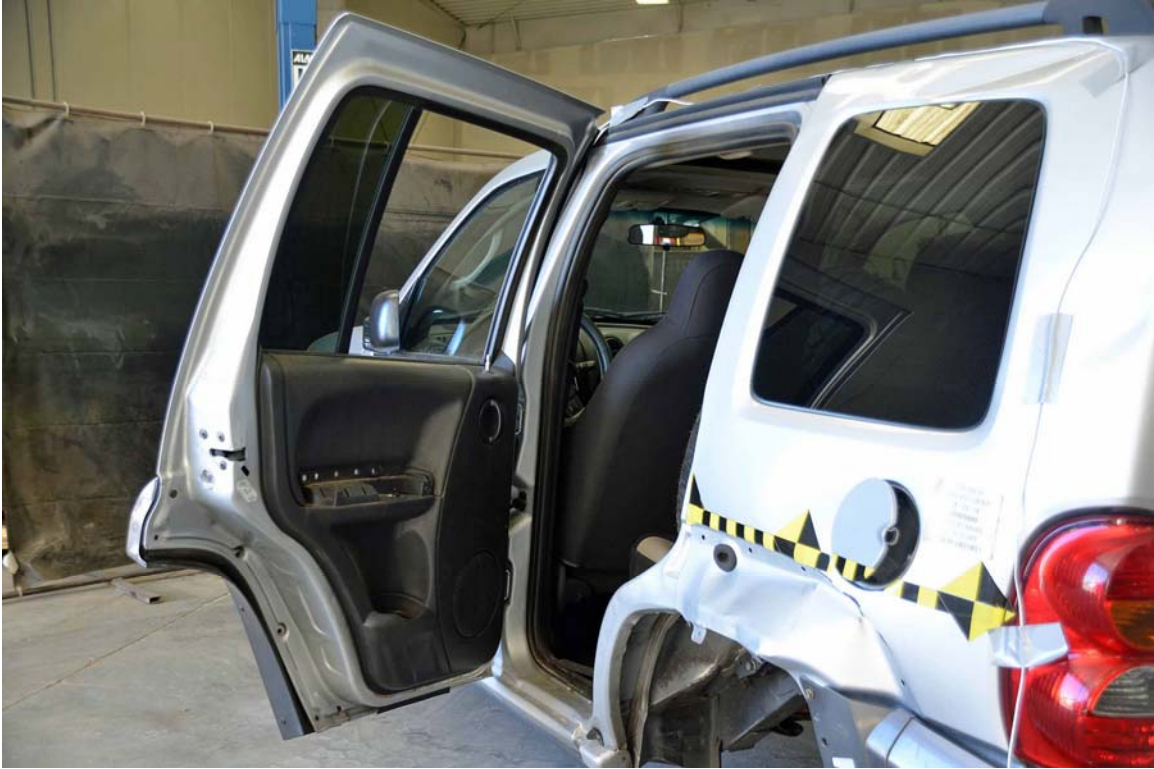
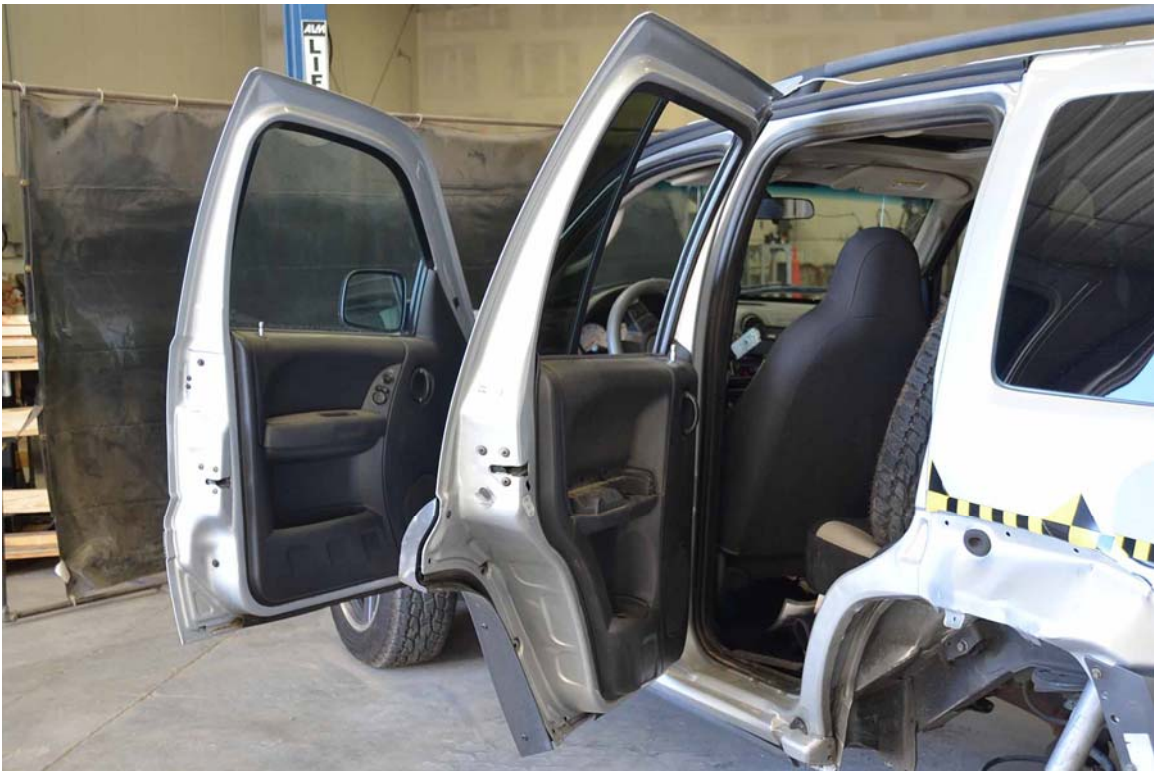
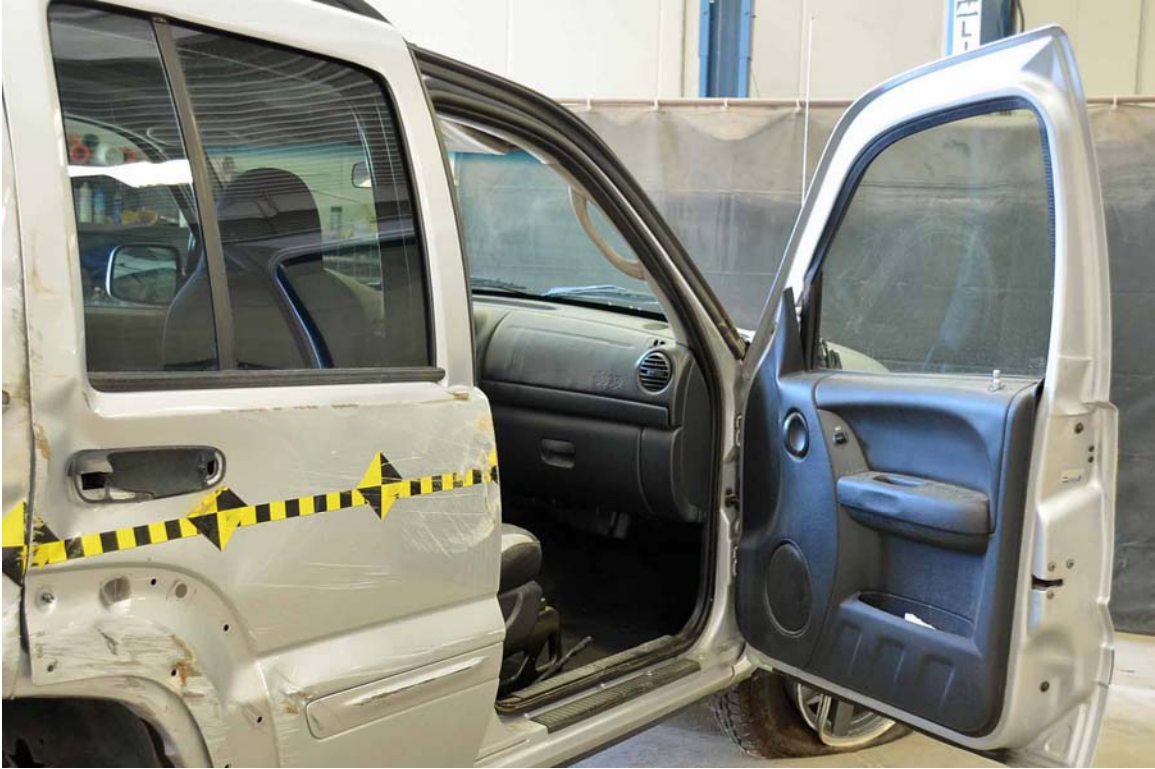
FIGURE 146. Post-Test Door Opening

FIGURE 147. Post-Test Door Opening

FIGURE 148. Post-Test Door Opening

Pages 4/5	no comments at this time
Page 6	Please see ‘Page 3 – Comment 1’ above.
Appendix A	Addition of Photographs #146, #147, #148, and #149 affirm report page 3 words relating to Jeep KJ door operations post-crash test.

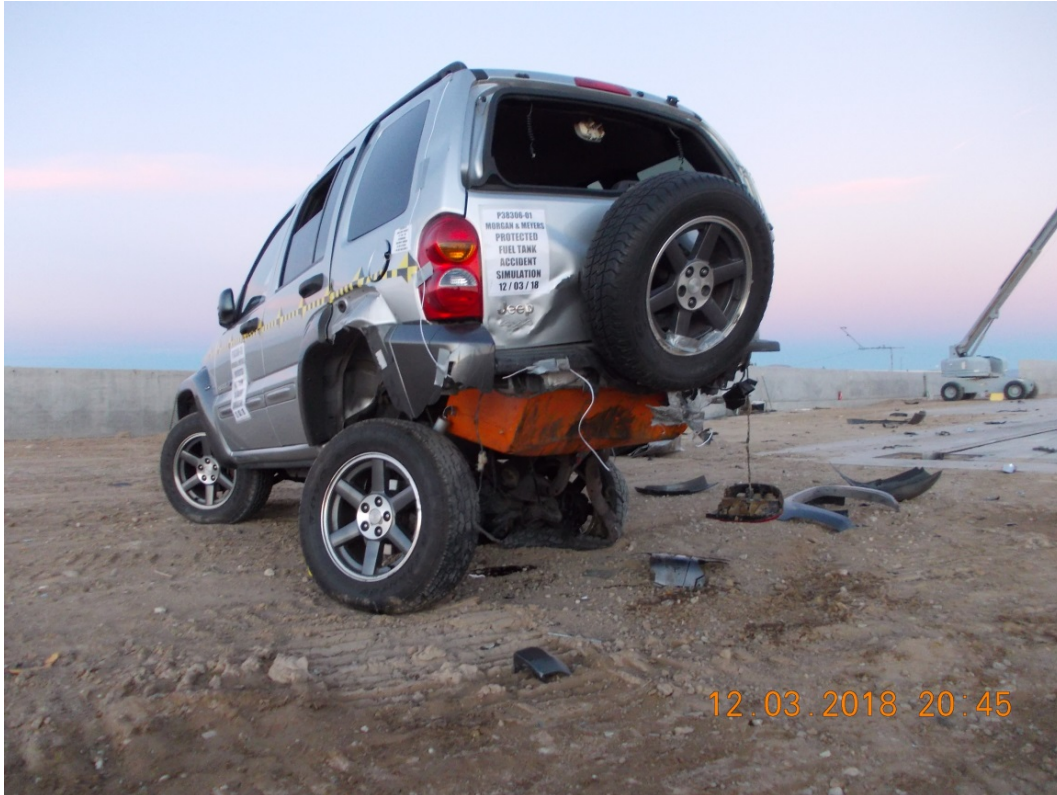
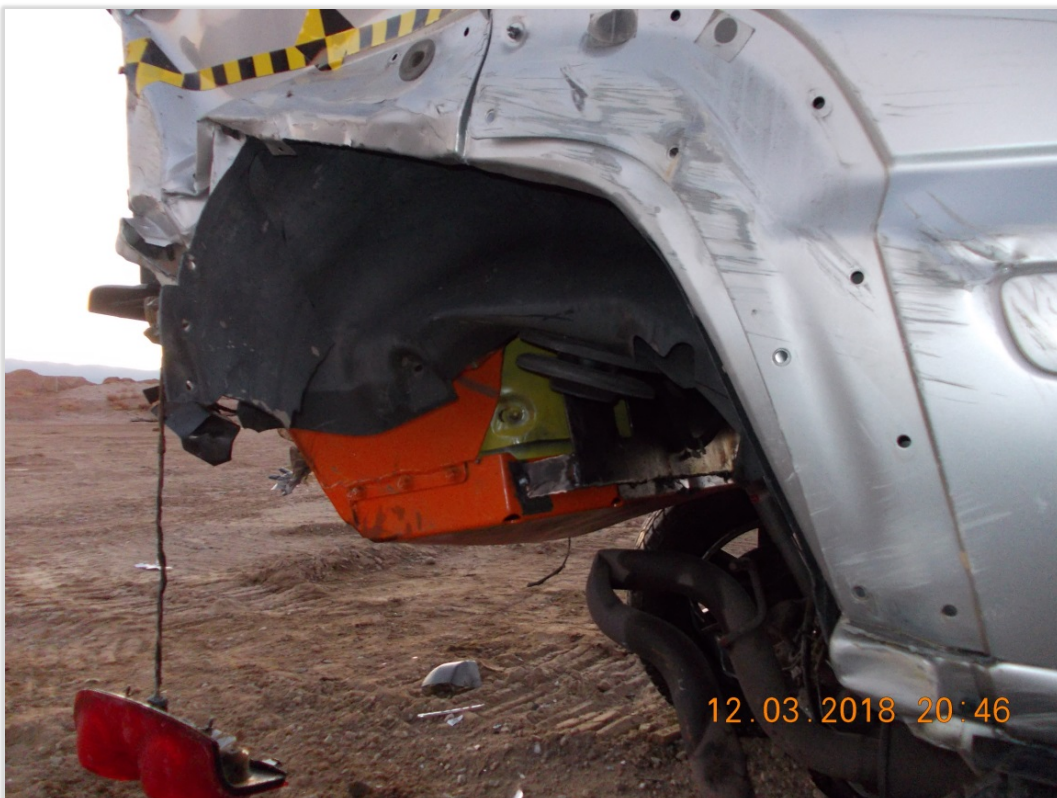
Following photographs relate to Page 3 – Comment 1, and Page 6 comment above:

Page 3 Comment 1	<p><i>" . . . Stoddard solvent was present and drops of solvent were observed on the ground near the rear end of the target vehicle."</i></p> <p>Undersigned was first-to-arrive at the Jeep KJ target vehicle rest location (post crash test), and did not observe any Stoddard solvent on the ground. Karco engineers and undersigned did not observe any Stoddard trail from the crash platform all the way to rest location. Observed and noted by all present were droplets of <u>black</u> differential oil, not <u>purple</u> Stoddard droplets. Addition of photographs (per Page ii comment above) was requested by undersigned to confirm that Karco photos do not show Stoddard droplets, but do show droplets of differential oil. Please see Exhibit 3 photographs #101, #102, and #104. Undersigned conducted a complete and immediate tactile inspection post-test of the FTEP and all adjacent underbody areas; this confirmed zero moisture / zero Stoddard present; completely dry condition.</p> <p>Photos taken by the undersigned, immediately at the conclusion of crash test, also do not show droplets of purple colored Stoddard; samples of the latter time-stamped photos are attached below.</p>

Page 3 Comment 2	Undersigned agrees with, “. . . the odor of Stoddard solvent was present.”
Page 3 Comment 3	Undersigned agrees with, “The amount of solvent observed was immeasurable..”
Page 3 Comment 4	<p>Page 3 paragraph 2, the undersigned was present throughout the post-test inspection, conducted on December 21, 2018.</p> <p>Report verbiage, “Upon removal of the FTEP and the fuel tank from the vehicle, a plastic output nipple on the top of the fuel tank was found cracked.”</p> <p>Two possibilities for this condition were proposed/reviewed:</p> <p>(1) Minor crack occurred during the crash test, provoking attention to an additional Jeep Liberty KJ issue.</p> <p>(2) Initial inspection of the fuel tank and pump assembly confirmed that these 16 year old components had never been removed/serviced.</p> <p>During a two-fold Karco removal/re-install of the fuel tank, the fuel pump access panel was not utilized. Karco technicians later admitted strain/difficulty with fuel pump liquid/electrical lines. It is possible that minor stress crack in the plastic fuel outlet nipple occurred during this difficulty. Crack is shown in report photos #131, #132, #133, #134, #135, #136, #137, and #138, which were taken at the post-crash inspection. It is possible that the crack did not occur during the crash test. Competitive use of steel fuel pump assembly, including steel nipples, such as used by Ford on vehicles such as the Crown Victoria, would have eliminated this additional KJ issue..</p> <p>The minor fumes that were present post-test appeared to originate from top of tank, where no crash ignition sources are present. No other tank surface had Stoddard staining. Photographs of Fuel Pump Assembly Access Panel and minor top of tank Stoddard trace-staining attached below.</p>

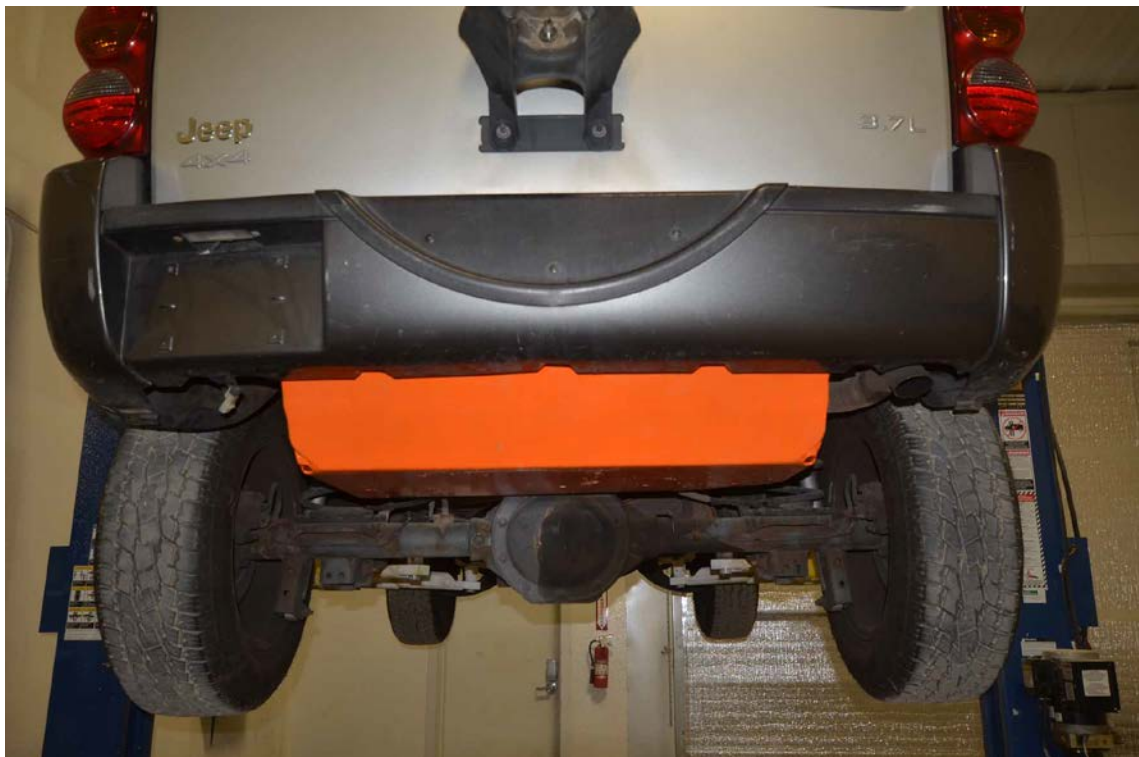
Had the 2003 Jeep Liberty driven by Ms. Kayla White been equipped with the FTEP crashworthiness system as tested under Exhibit 3, **the probability of the above conflagration approaches zero.**

Although an item for further development, the estimated OEM cost of an FTEP derived crashworthiness system is no more than \$40 - \$50.
