# NISSAN MOTOR CORPORATION in U.S.A.

Nissan Motor Co., Ltd. has authorized us to submit this letter to you which relates to reports of unintended acceleration by some owners of 280ZX and 300ZX vehicles equipped with automatic transmission.

## SERVICE PRECEDURE, 1984-1987 3002X Models

#### SERVICE PROCEDURE, 1979-1983 280ZX Models

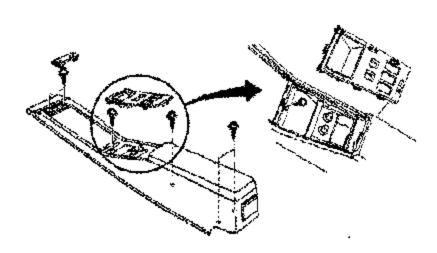
- 2. Remove the negative battery cable from the battery terminal.
- 3. Remove the center console box and Finisher. Se especially careful to use a thin pry tool to remove the finishers—avoid acratching or otherwise damaging the surface.

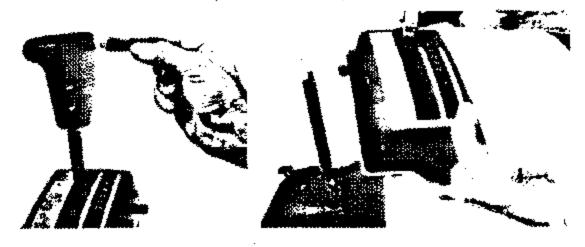
Take the control lever assembly to the bench. Use a fender cover or other pad to prevent scratches or damage to the parts as they ere disassembled. Remove the shift knob and gear indicator assembly from the control lever assembly.

CAUTION: The shift button or its return spring may pop out when the knob is removed. Be sure you do not lose parts.

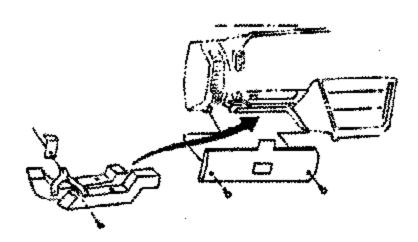
13. Remove the side and foot air ducts.

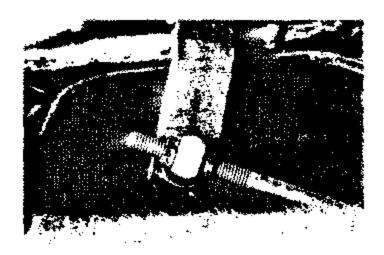
Install the new shift control assembly back into the vehicle. Be sure the shift indicator harness is routed properly on the under side of the indicator assembly and that the interlock harness is routed forward along the turnel. Place the shift rod into the shift lever and install the nut. Center the lever in the shift rod threads as shown below and tighten the nut to 25-30 kg/cm (22-26 in/lb). (The shift rod may have to be adjusted again from beneath the vehicle.) Use the acrews from the kit with blue sealant on the threads to boilt the shift control assembly back in place.

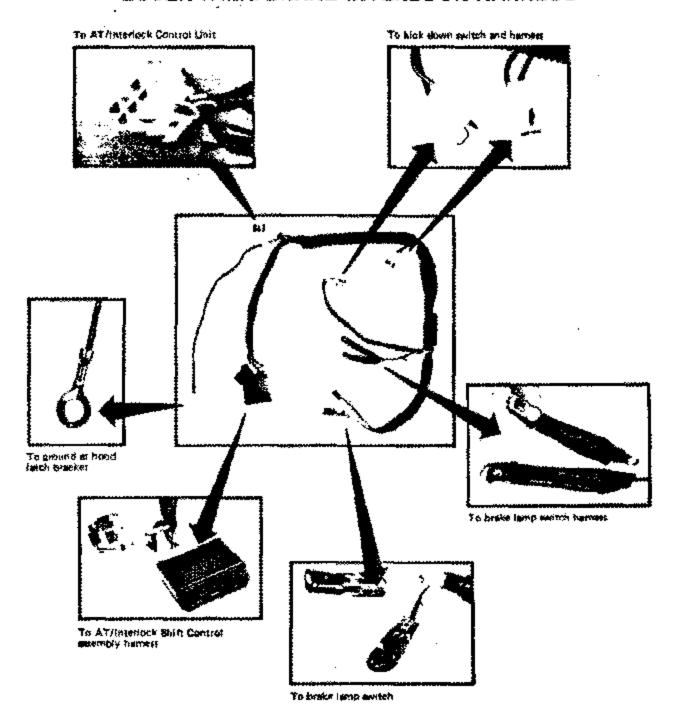
# 280ZX PARK/BRAKE INTERLOCK HARNESS

The eyelet goes to ground at the mount bolt for the hood latch. The six pin connector will plug into the interlock control unit. The two pin connectors go into the kick down switch and its harness at the top of the throttle pedal. The single spade connectors go into the brake light switch and its harness. The last two connectors plug into the interlock harness that comes from the shift control assembly.

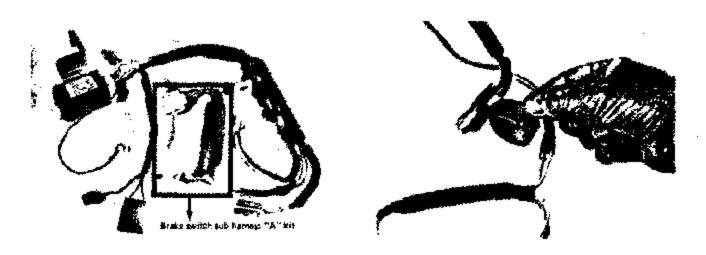
A brake switch sub-harmess is supplied with the "A" kit that will allow for a plug in at the brake light switch on certain models. When it is required, the sub harmess plugs into the interlock harmess as shown in the following photograph. Tape the female side of the harmess spade connectors up out of the way as shown.
