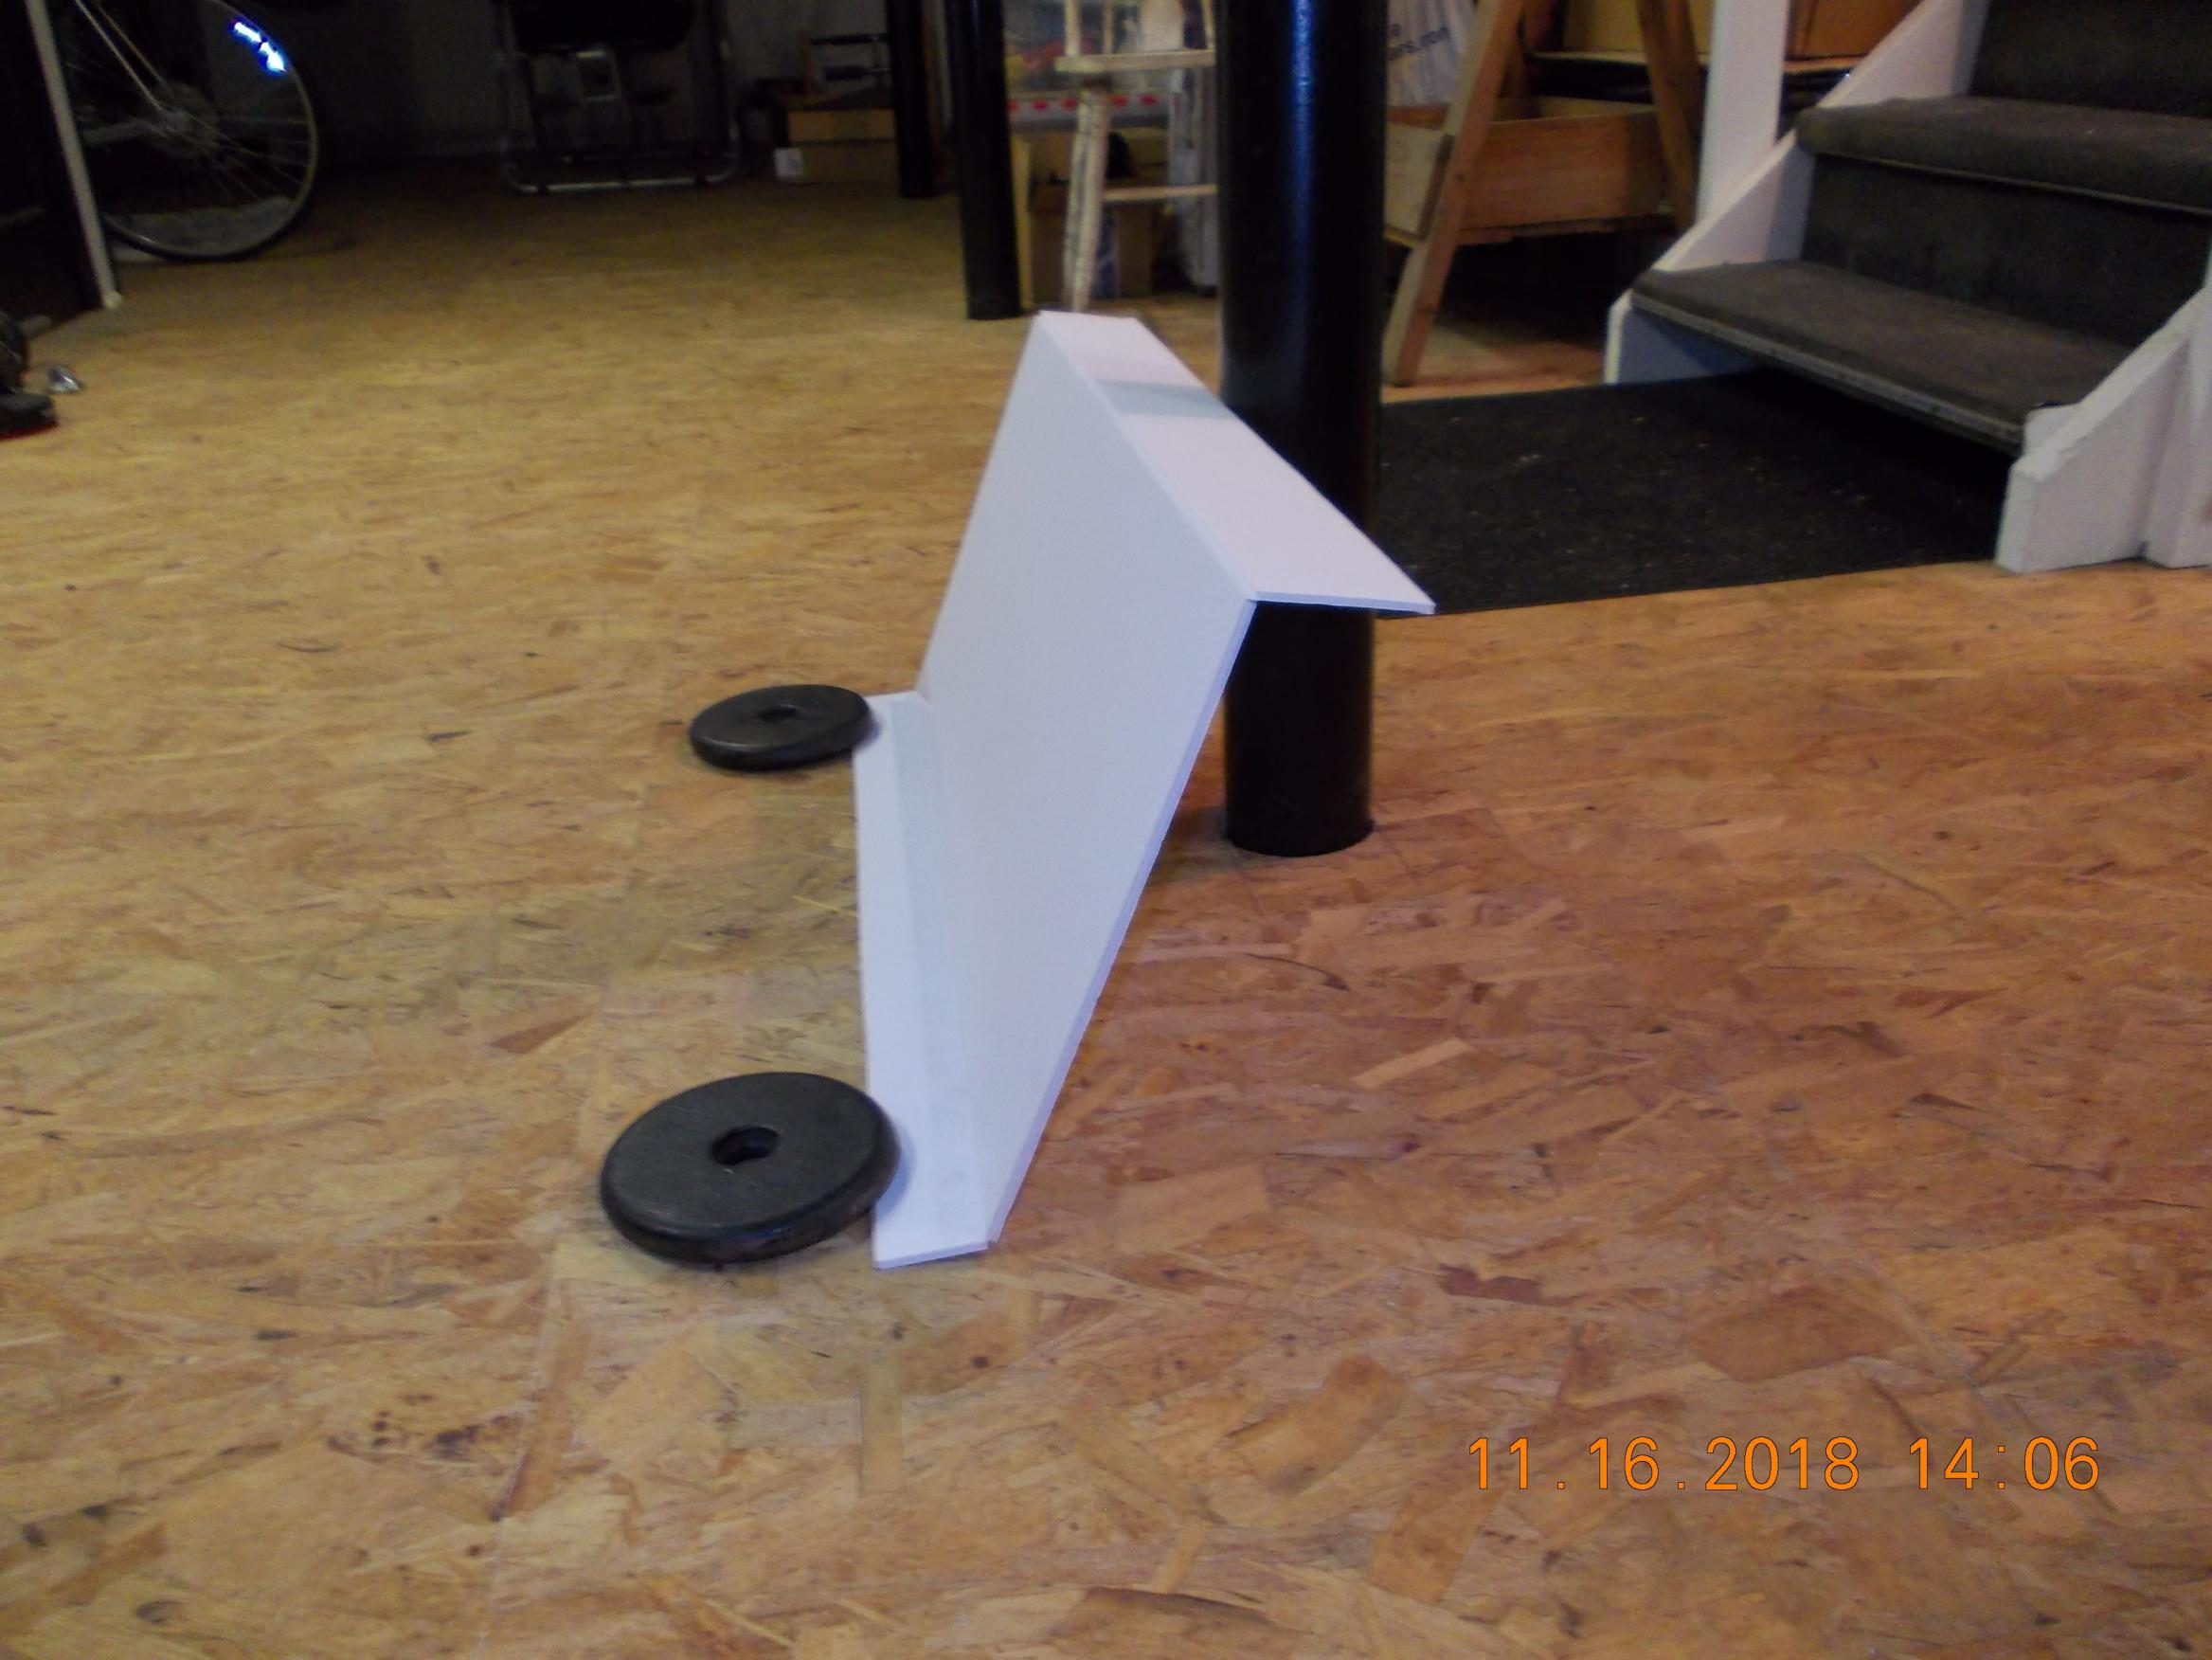
**UPPER TRANSVERSE
SURFACE BOLTS TO
REARMOST KJ TRANSVERSE**

**INCLINED SURFACE
FACES REAR**

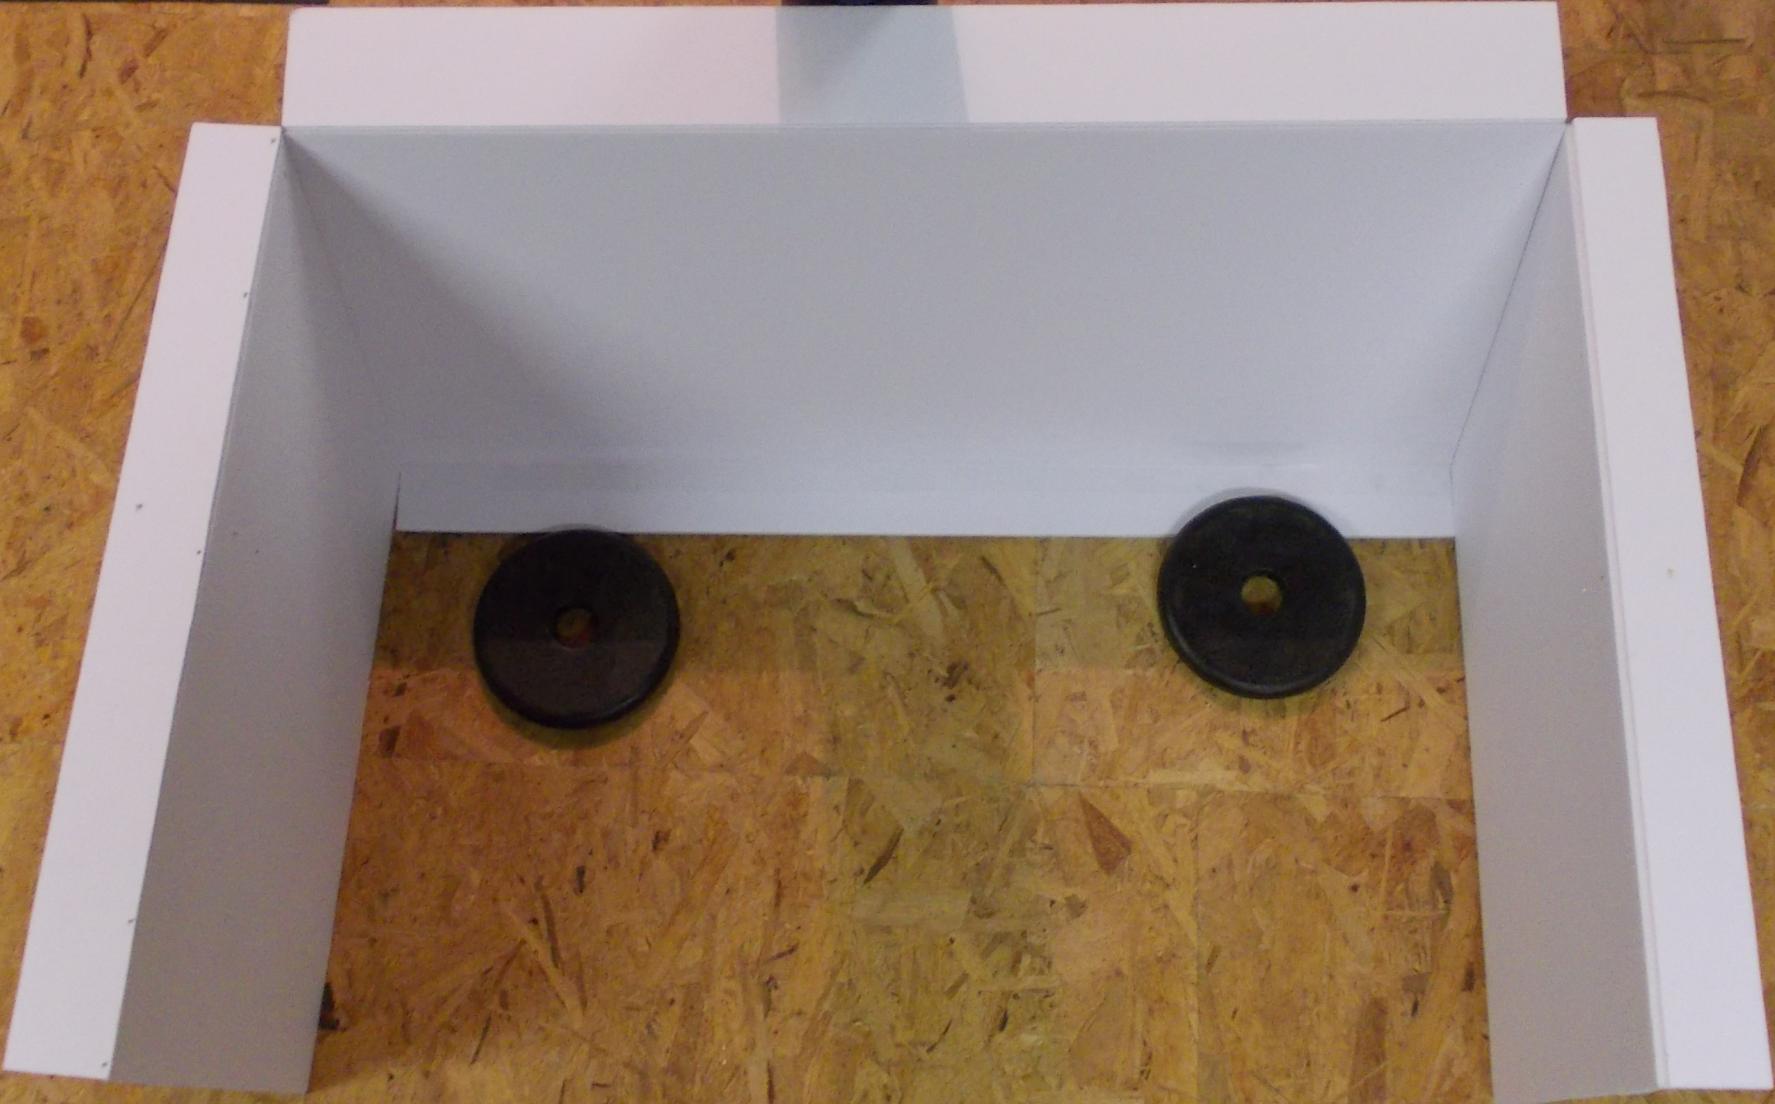
**DRIVER'S
SIDE.
FLANGE
BOLTS TO
LEFT-SIDE
FRAME
RAIL ALA
EXISTING
TRAILER
HITCH**

PASS SIDE

**TANK-SIDE INNER SURFACE
OF INCLINED PLANE**

**LOWER FLANGE WELDED
TO BOTTOM SURFACE OF
SKF SKID PLATE**

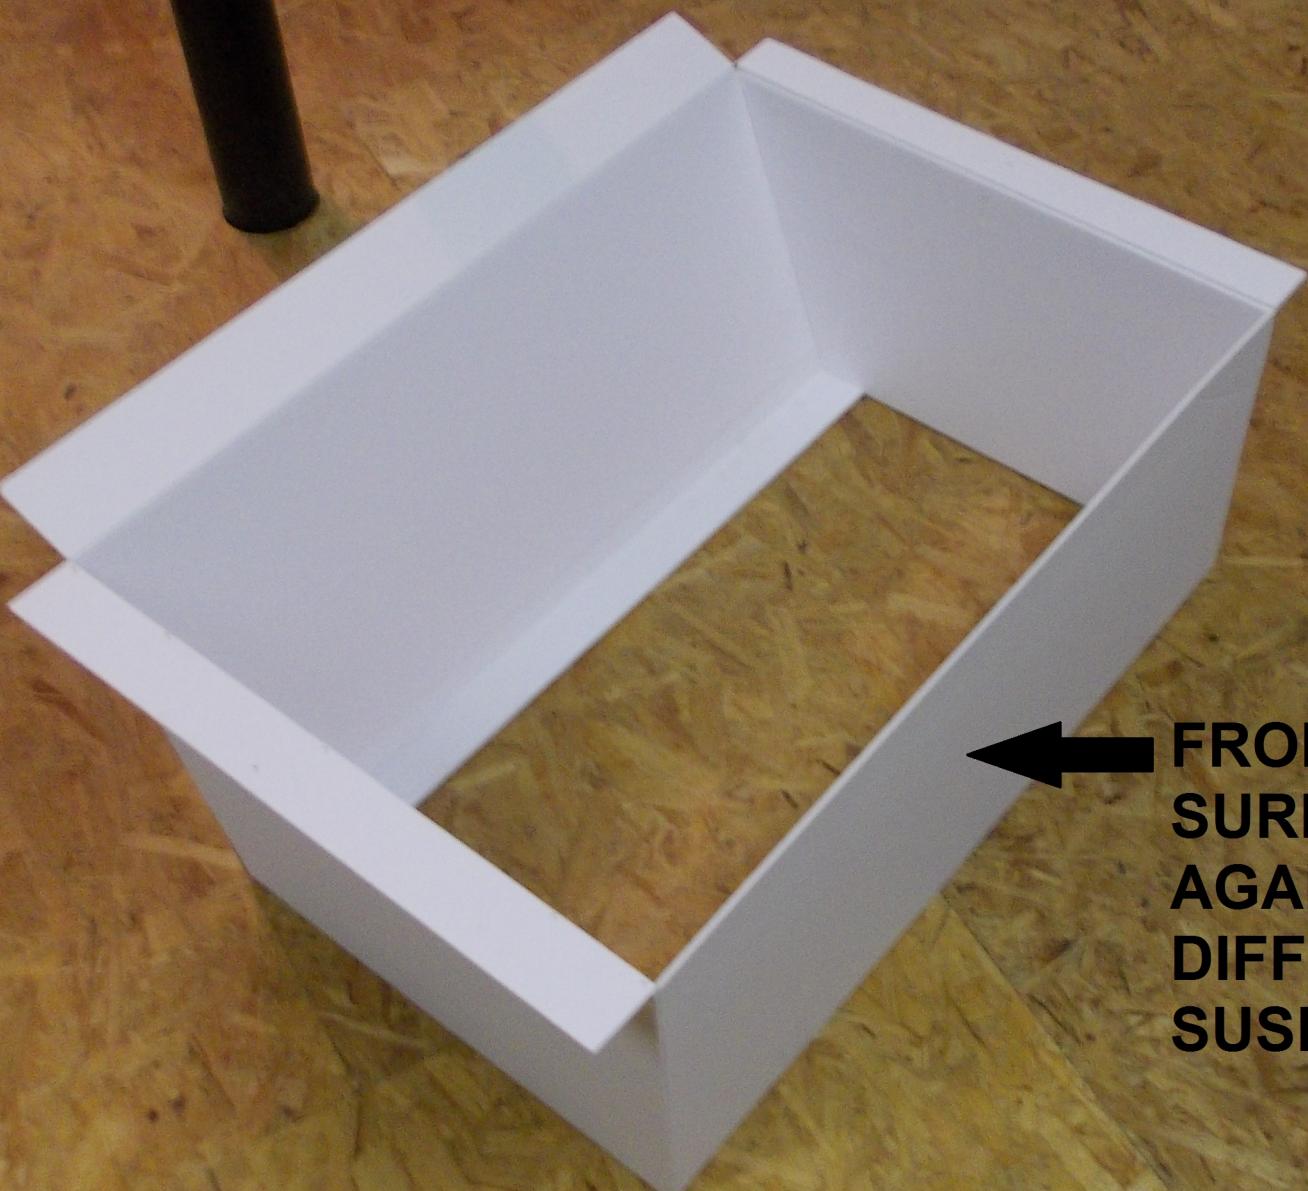
**FRONT VERTICAL
SURFACE PROTECTS
AGAINST REAR
DIFFERENTIAL AND
SUSPENSION PARTS**

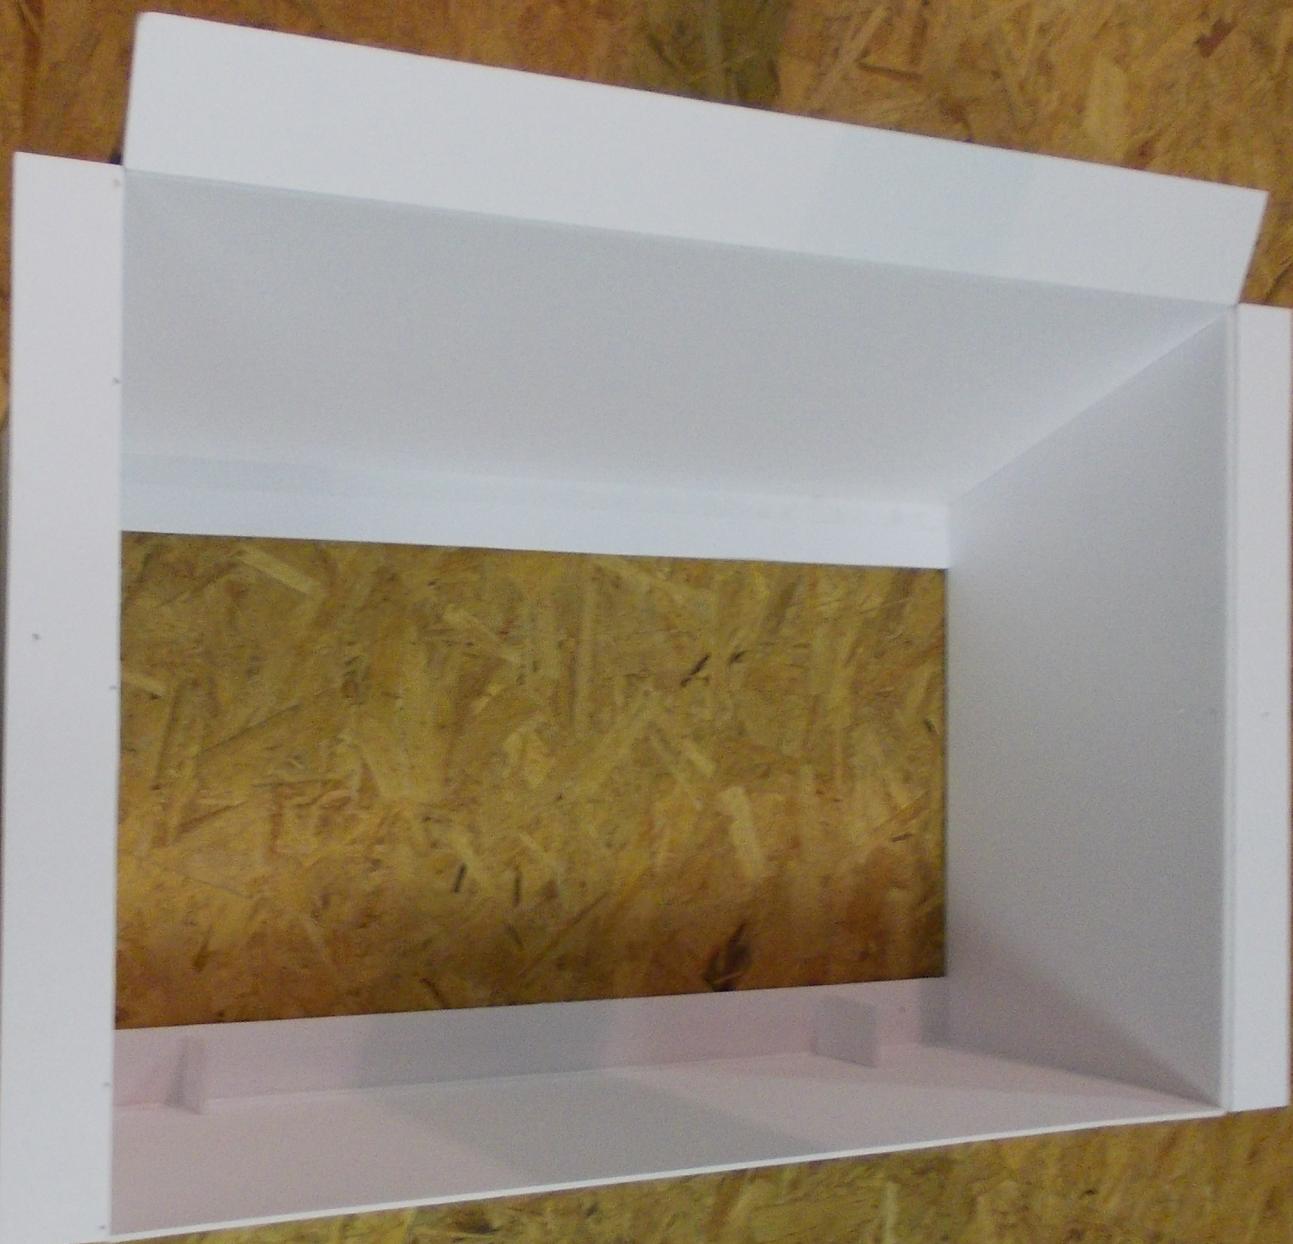
**FRONT VERTICAL SURFACE
FLANGE WELDED TO BOTTOM
SURFACE OF SFK SKID PLATE**
