ATTACHMENT 8

Subject: Chrysler Public Statements Regarding Reference – WUSA-9 News Report

Reference: EA12-005 File Update (Jeep Grand Cherokee, et al. Fuel Tank System Defect)

Typical ZJ-Body with factory installed light-gauge MOPAR "Skid Plate" but without trailer hitch option

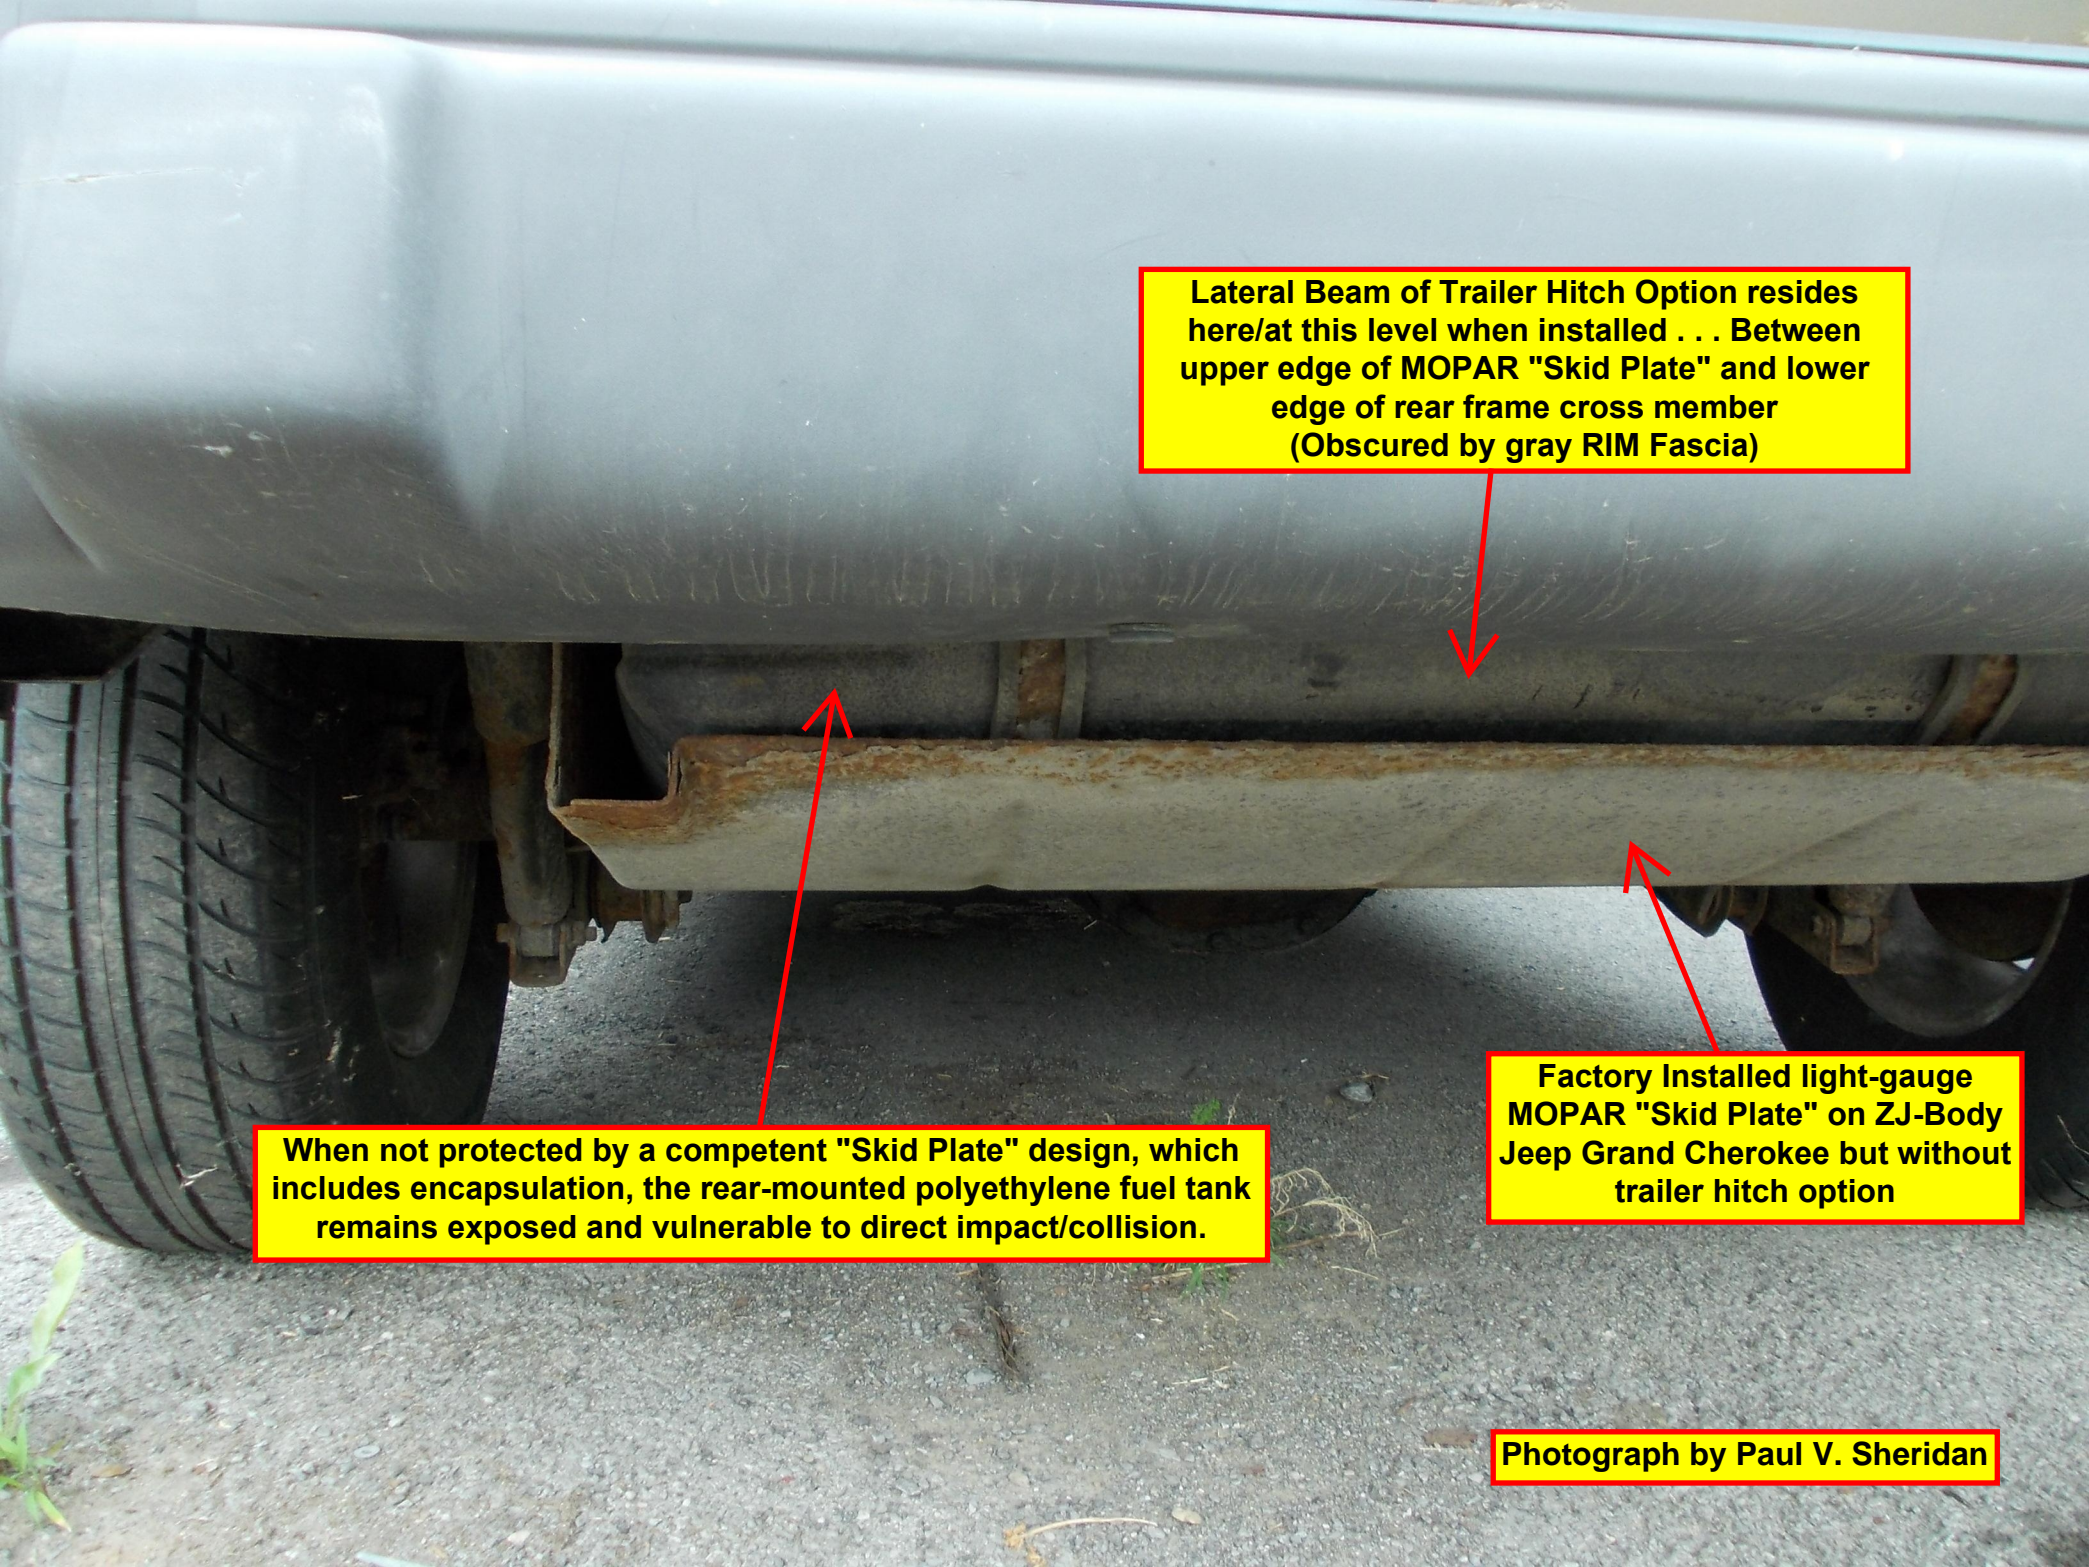
Lateral Beam of Trailer Hitch Option resides here/at this level when installed . . . Between upper edge of MOPAR "Skid Plate" and lower edge of rear frame cross member (Obscured by gray RIM Fascia)

When not protected by a competent "Skid Plate" design, which includes encapsulation, the rear-mounted polyethylene fuel tank remains exposed and vulnerable to direct impact/collision.

Factory Installed light-gauge MOPAR "Skid Plate" on ZJ-Body Jeep Grand Cherokee but without trailer hitch option
