# CENTER FOR AUTO SAFETY

## PETITION

The Center for Auto Safety (CAS) petitions the National Highway Traffic Safety Administration (NHTSA) to initiate a defect investigation into and recall all 1993-2004 Jeep Grand Cherokee with a fuel tank located behind the rear axle. Unlike the earlier Jeep Cherokee, the fuel tank of the Grand Cherokee is plastic and extends below the rear bumper so there is nothing to protect the tank from a direct hit in a rollover or by a vehicle with a low front profile or one lowered by pre-impact braking.

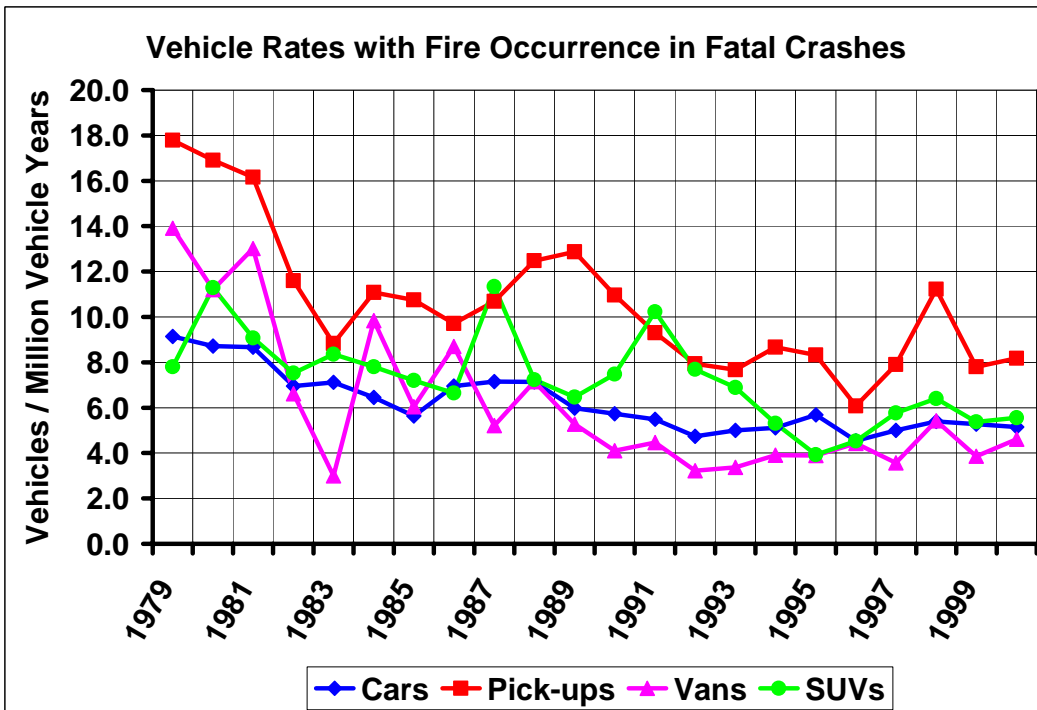
Figure 2. Rates per million vehicle registered years of vehicles involved in fatal crashes where a fire occurred in that particular vehicle (fatality did not necessarily occur in the vehicle with the fire). Data is from FARS 1979-2000, vehicle age is 0-4 years, and distributions are by vehicle type.

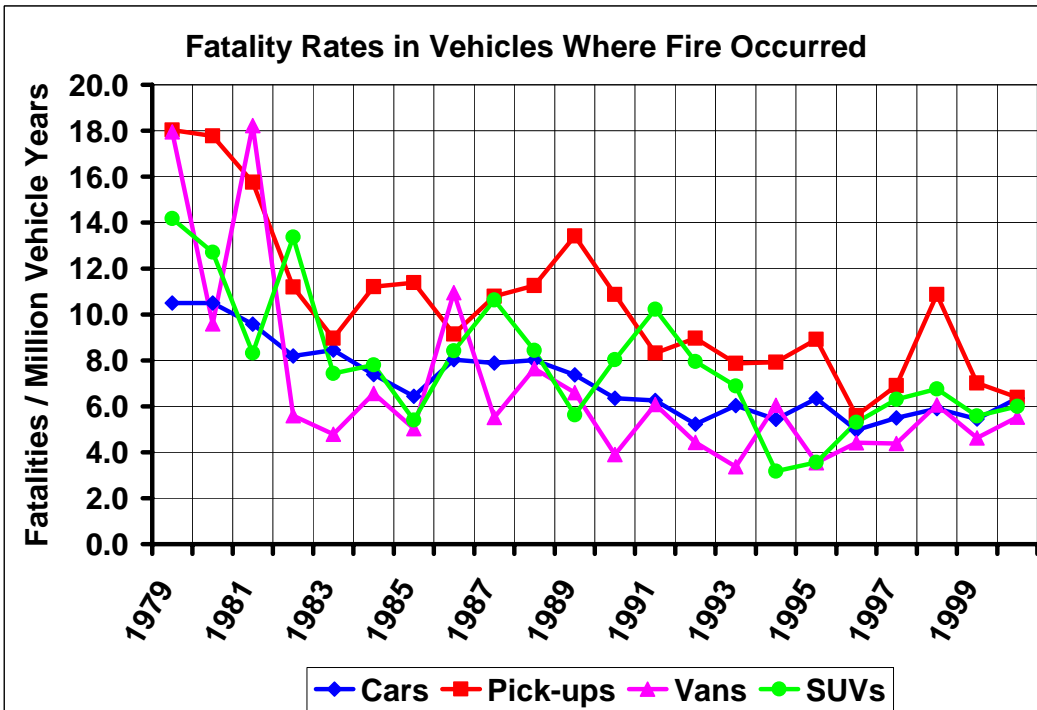
Figure 4. Fatality rates per million vehicle registered years in vehicles where there was the occurrence of a fire/explosion (fatality is not necessarily attributed to the fire event). Data is from FARS 1979-2000, vehicle age is 0-4 years, and distributions are by vehicle type.

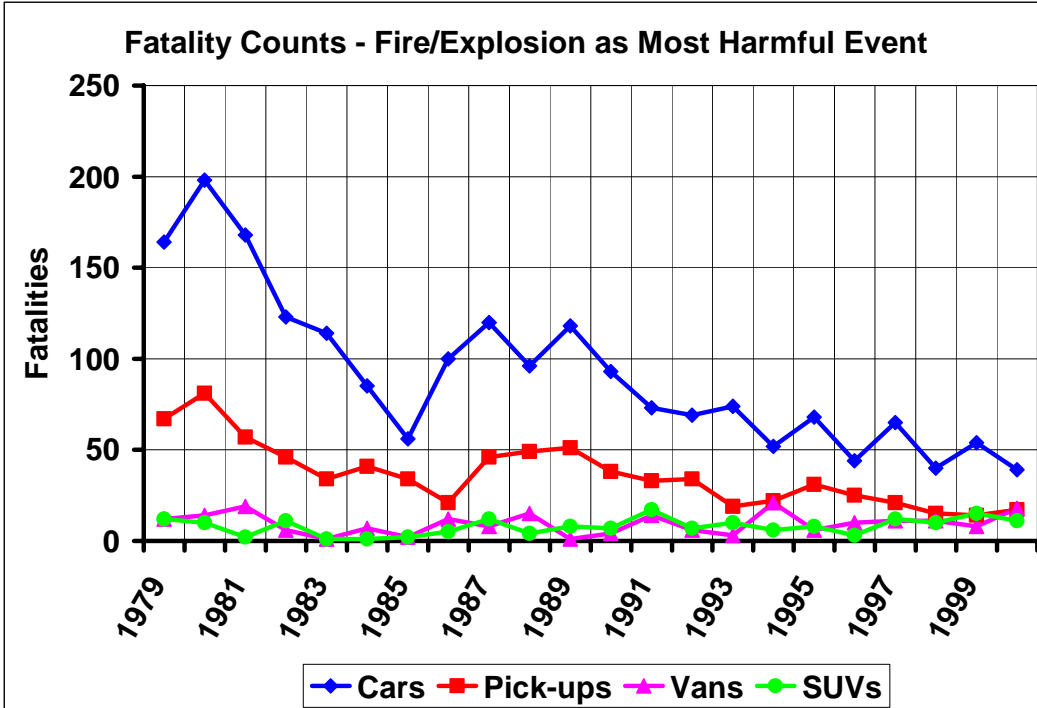
Figure 5. Fatality counts in vehicles where there was the occurrence of a fire/explosion and the fire event has been coded as the most harmful event (i.e. cause of death). Data is from FARS 1979-2000, vehicle age is 0-4 years, and distributions are by vehicle type.

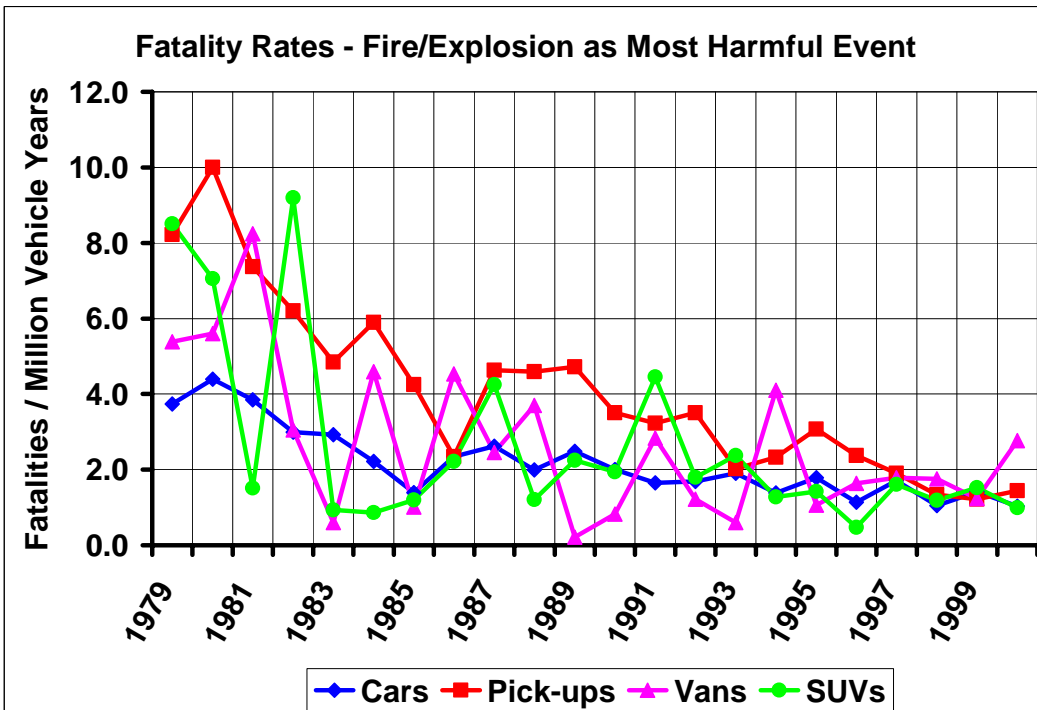
Figure 6. Fatality rates per million vehicle registered years in vehicles where there was the occurrence of a fire/explosion and the fire event has been coded as the most harmful event (i.e. cause of death). Data is from FARS 1979-2000, vehicle age is 0-4 years, and distributions are by vehicle type.

This study looks at vehicles of age 0-4 years; therefore, FARS year 2000 includes models years 1996-2000. A significant occurrence took place during model year 1976 with the introduction of the FMVSS 301 standard for fuel system integrity. Based on data in these figures, FARS year 1981 would be the first year with all vehicles FMVSS 301 compliant.

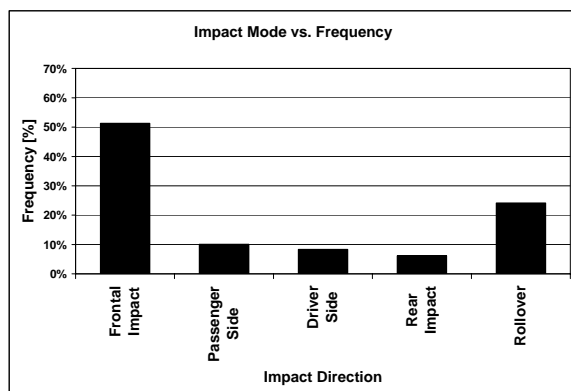
**Figure 7. Distribution of fire events by impact direction.**

When looking at impact direction, the cases were divided into categories of impact that would be associated with the fire event. For example, if a frontal impact occurred with another vehicle followed by a side impact to a tree, and the tree impact was the source of a ruptured fuel tank, this would be classified as a side impact for this study. Based on this criterion, frontal impacts accounted for 117 cases (51.3%), side impacts 42 cases (18.4%), rear impacts 14 cases (6.1%), and rollovers 55 cases (24.1%). These results can be seen in Figure 7. It is interesting to note that rear impacts had the lowest frequency of fire events.
